General Motors plant fire changes roofing practices

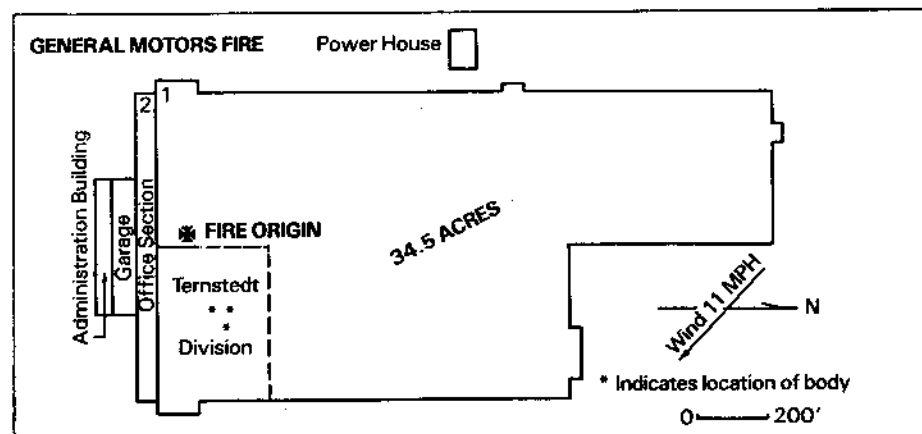
A diagram of the plant showing where the fire began.

▶ The General Motors Hydra-Matic transmission plant in Livonia, Mich., during the fire that destroyed the structure and changed roofing practices in the 1950s.

Sometime before 3:50 p.m. on Aug. 12, 1953, sparks from a plumbing contractor's oxyacetylene torch ignited a fire in a drip pan beneath a conveyor that ran just beneath the lower chord of the roof trusses; the contractor's crew had been working on ladders and immediately tried to extinguish the fire with standby carbon dioxide extinguishers handed up to them. The extinguishers were emptied before the blaze was under control, while the lack of sprinklers and roof vents contributed to its spread. The NFPA *Quarterly* relates the horrifying scene that resulted.

"While employees were making an ineffective attack, the drip pan, roof trusses and roof deck were gradually becoming hot. At about the time the drip pan warped and spilled its flaming contents on the floor, the oily condensate on steel roof members in a nearby heat-treatment area ignited, adding fuel to heat the roof deck.

"... Soon hot tar and asphalt were flowing through cracks between strips in the heat-warped roof deck and igniting. The fire then spread laterally behind the increasing area of melted tar that oozed through the roof and simultaneously several fires broke out on machinery, in flammable liquid containers and on the wood floor as hot tar dropped down."

"The major change in the national building codes was the demand for smoke and heat vents," he relates. "The metal deck industry faltered, because within six months, neither GM nor any other manufacturer was using metal decking; we were specifying cement or concrete tile. And the major industrial plants would no longer put combustible materials under combustible insulation; it was the asphalt under the insulation mopped to the metal deck that began to melt.

Factory Mutual noted the amount of asphalt present on the metal deck at Livonia, and began advocating strip, or serpentine mopping to attach insulation to the deck. Strip-mopped roofs did not present adequate wind resistance, however; now FM requires the first layer of insulation to be mechanically fastened to a steel deck rather than strip-mopped.
