Dome restoration gives hall new lease on life

Statues get fiber glass facelift

Philadelphia's Memorial Hall. Hamada was contracted by the Fairmount Park Commission, City of Philadelphia, to restore the roof's ornamental metal work.

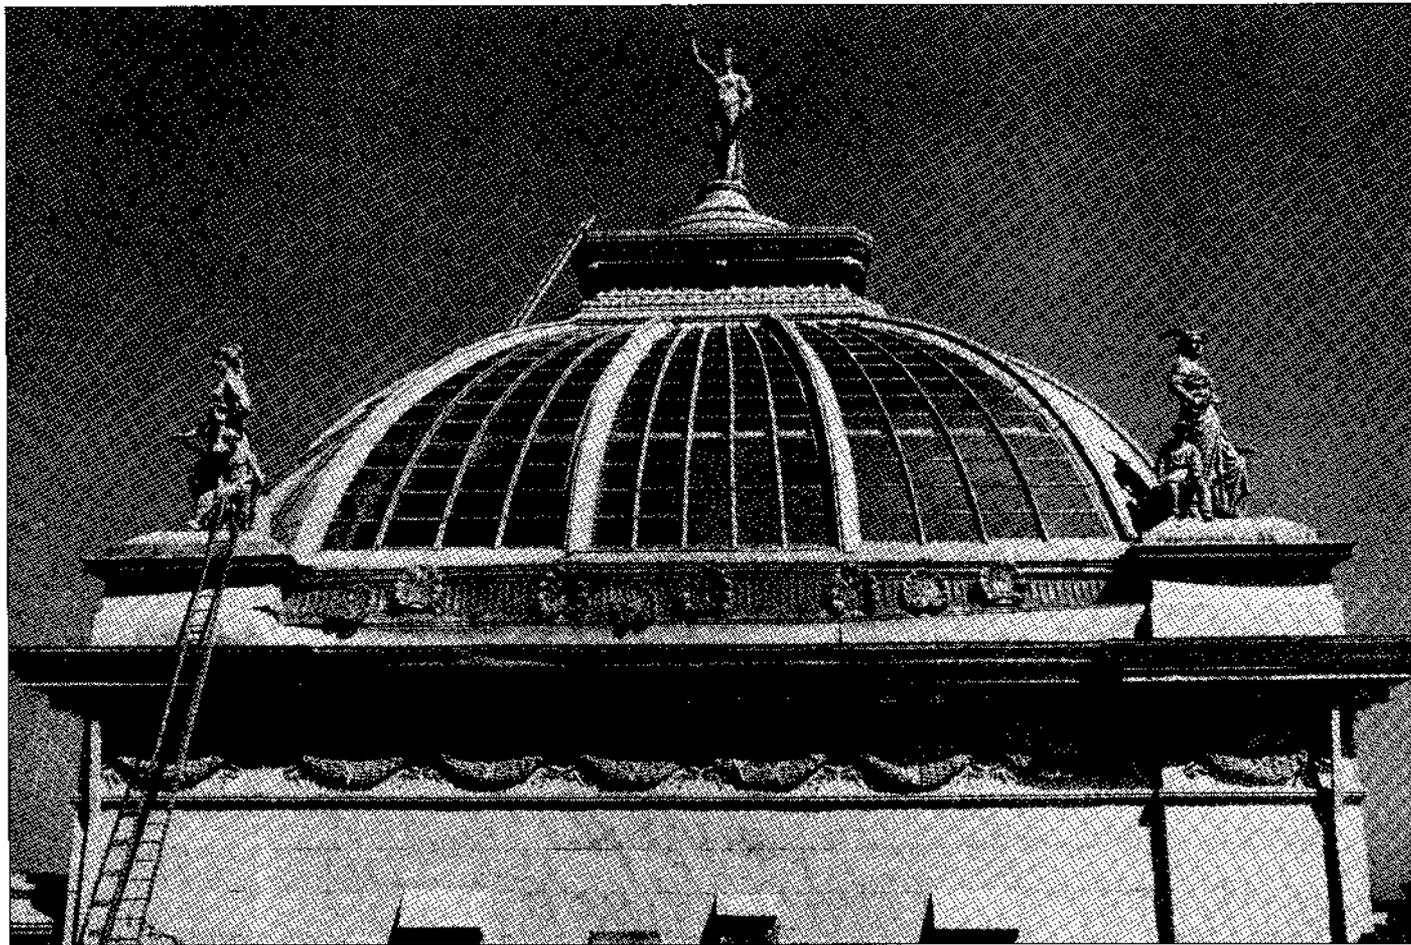
Hamada's renovation of Philadelphia's Memorial Hall begins with a trail of ladders leading to the top of the Hall's dome.

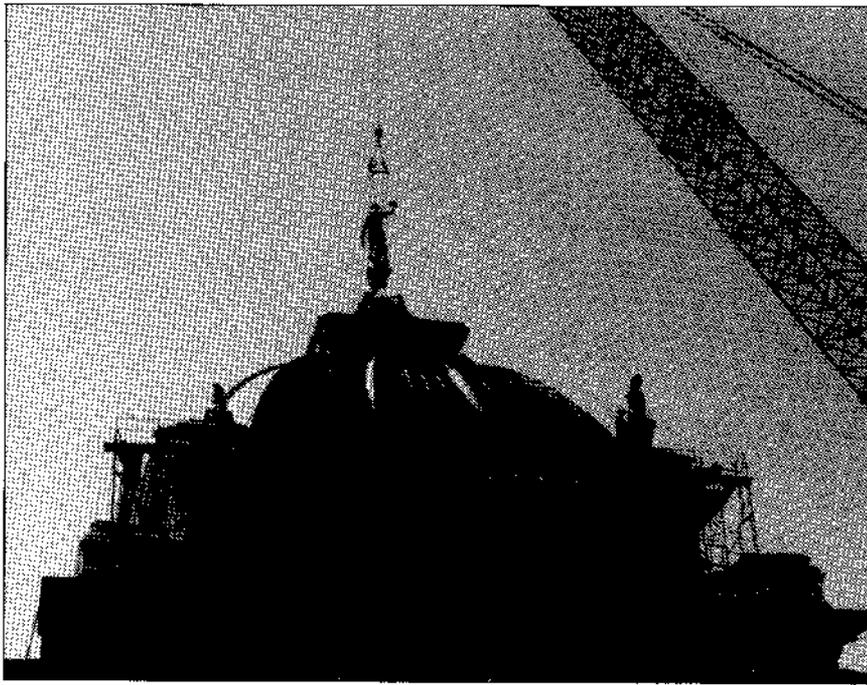
The statue "Columbia" rises from its moorings during the hoisting operation that brought five of the dome's statues to the ground for repairs.

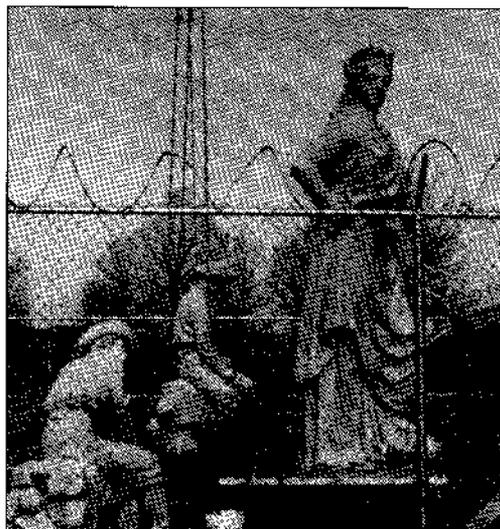
The statues were set down inside a fenced compound where workers refurbished them with solder and fiber glass-reinforced epoxy.

The cast-zinc corner statues were repaired by soldering where it was feasible. For repairs too large to solder, Carroll researched and proposed that a two-component epoxy resin reinforced with a fiber glass mesh be used. To protect the statues from exposure to the weather, they were painted with a ply-lastic vinyl coating.

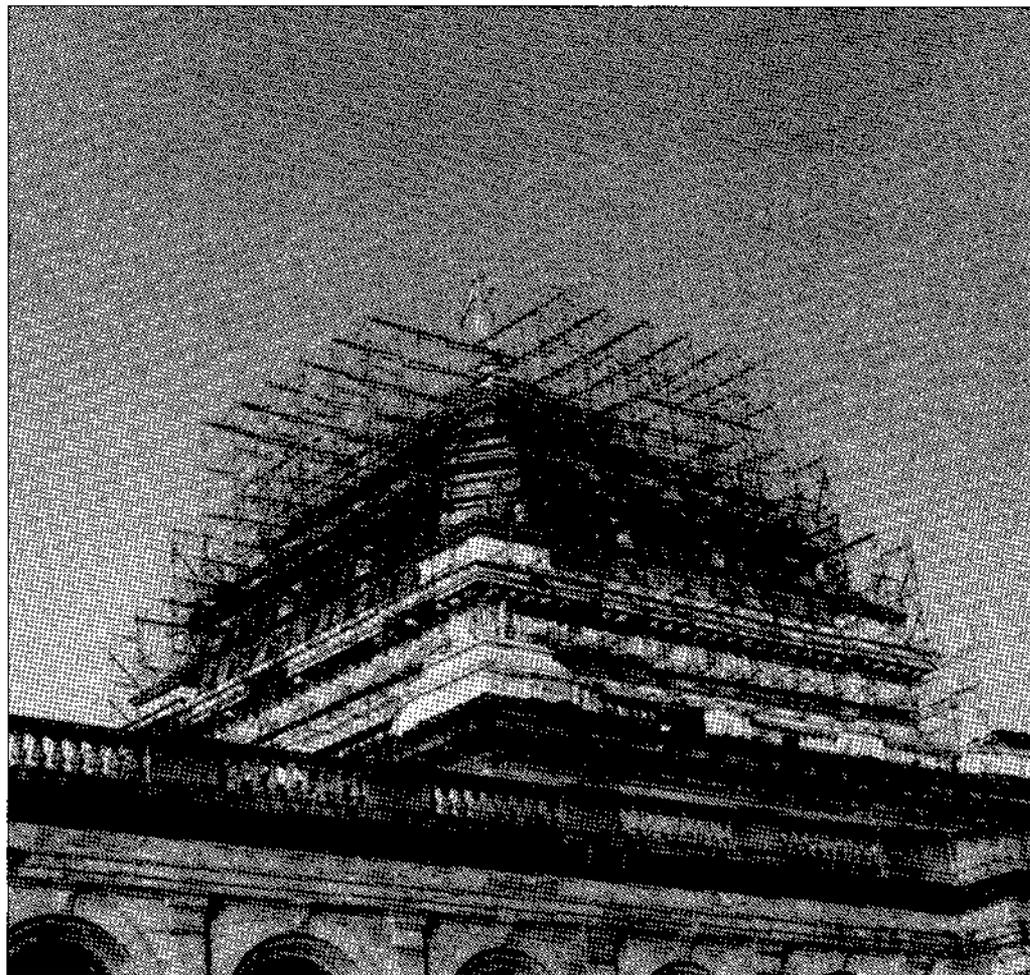
The dome peeks out through a thicket of scaffolding, erected to give workers access to the dome's broken glass.

With the statues back in place, the crews could erect a scaffold from the balustrade level to the top of the dome. This allowed workers to replace the dome's broken and cracked glass, install new flashings at the top of the dome, and repair or replace girter and mullion covers. The workers also cut out and re-

placed all the weathered sealant installed around the existing glass. The dome was finished with a ply-lastic vinyl coating.
