Thermal Roof Systems Performance Study

March 1983

CONTRACT NO. ORNL/Sub-86X-95006C
THERMAL ROOF SYSTEMS PERFORMANCE STUDY

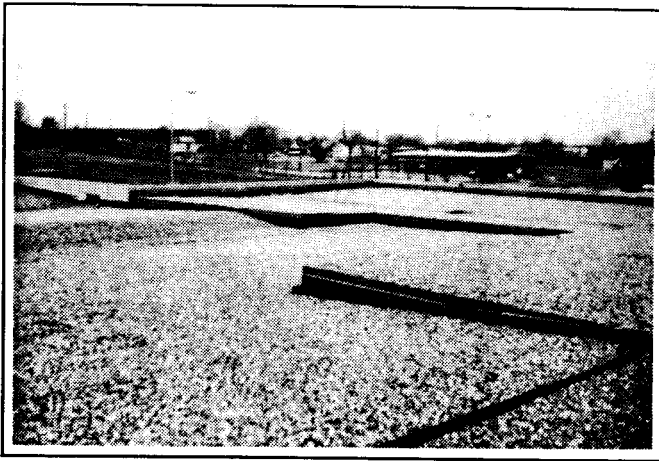
Illustration 1

The built-up roof, gravel surfacing, flashing and other items seemed to be in excellent condition. No blisters or other defects could be found. The flashing receiver is surface mounted and needs to be recaulked.

West View of Roof

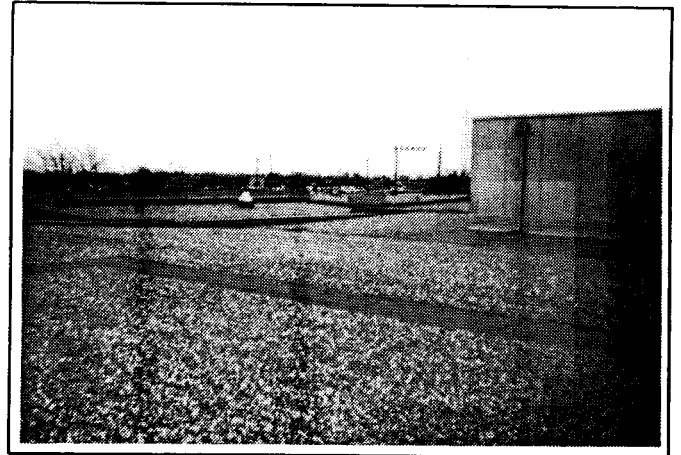
Illustration 2

South View of Roof

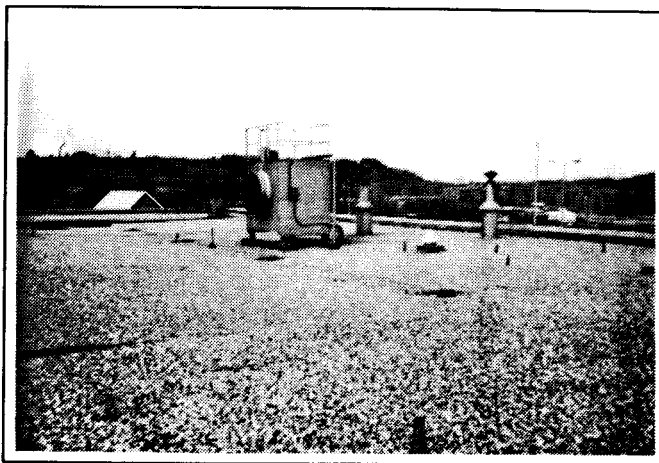
Illustration 3

North View of Roof

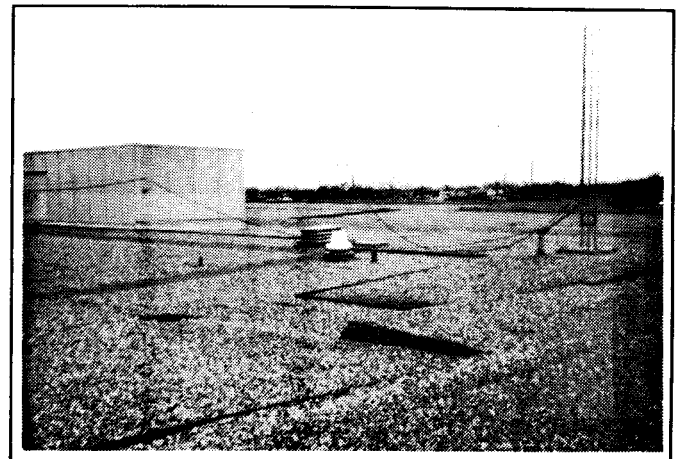
Illustration 4

East View of Roof
