# ON INVESTIGATING THE MECHANISM OF WEATHERING OF CHLOROSULFONATED POLYETHYLENE ROOFING AND EXPLORING MAINTENANCE TECHNIQUES

WILLIAM A. KIRN, DONNA S. GRECIAN, RICHARD J. KETZ, THERESA R. POWELL,  
and JOHN A. SIMMONS

The Rohm and Haas Company  
Spring House, Pennsylvania

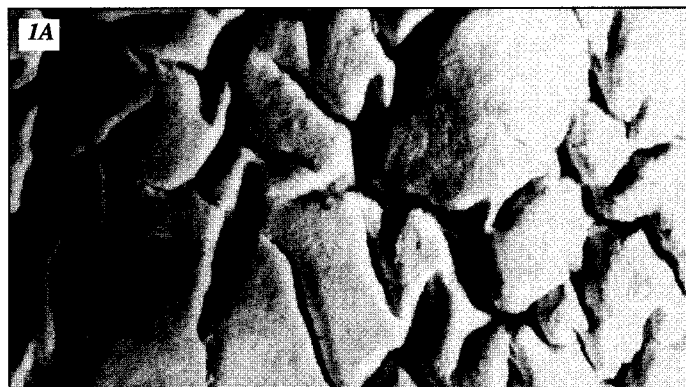
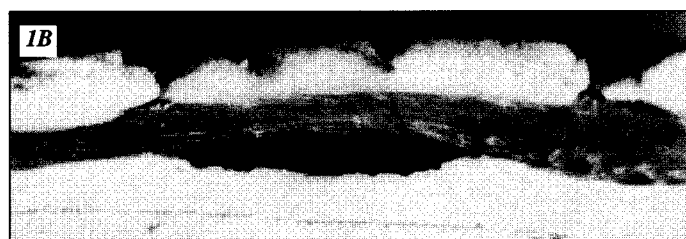
Low magnification (63x) optical microscopy shows extensive cracking on the surface of the weathered chlorosulfonated polyethylene. In cross section, it can be seen that some of the cracks in chlorosulfonated polyethylene sample extend all the way through the membrane to the reinforcing scrim (Figure 1). The top and edge views of the protected CSPE membrane show no cracking at the same magnification (Figure 2).

**Figures 1A and 1B.** Optical micrograph (63x) of weathered CSPE single-ply roof membrane: 1A surface view, 1B cross-sectional view.

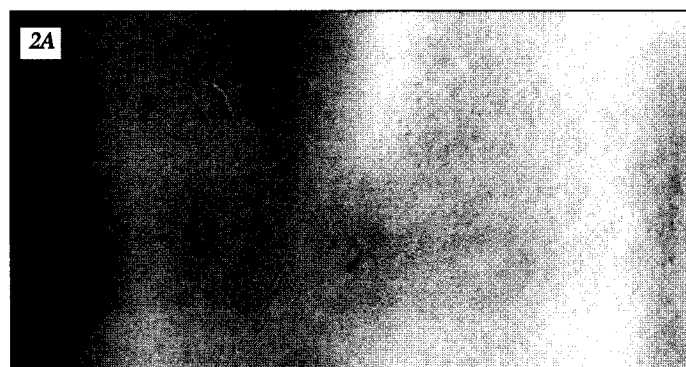
**Figures 2A and 2B.** Optical micrograph (63x) of protected CSPE single-ply roof membrane: 2A) surface view, 2B) cross-sectional view.

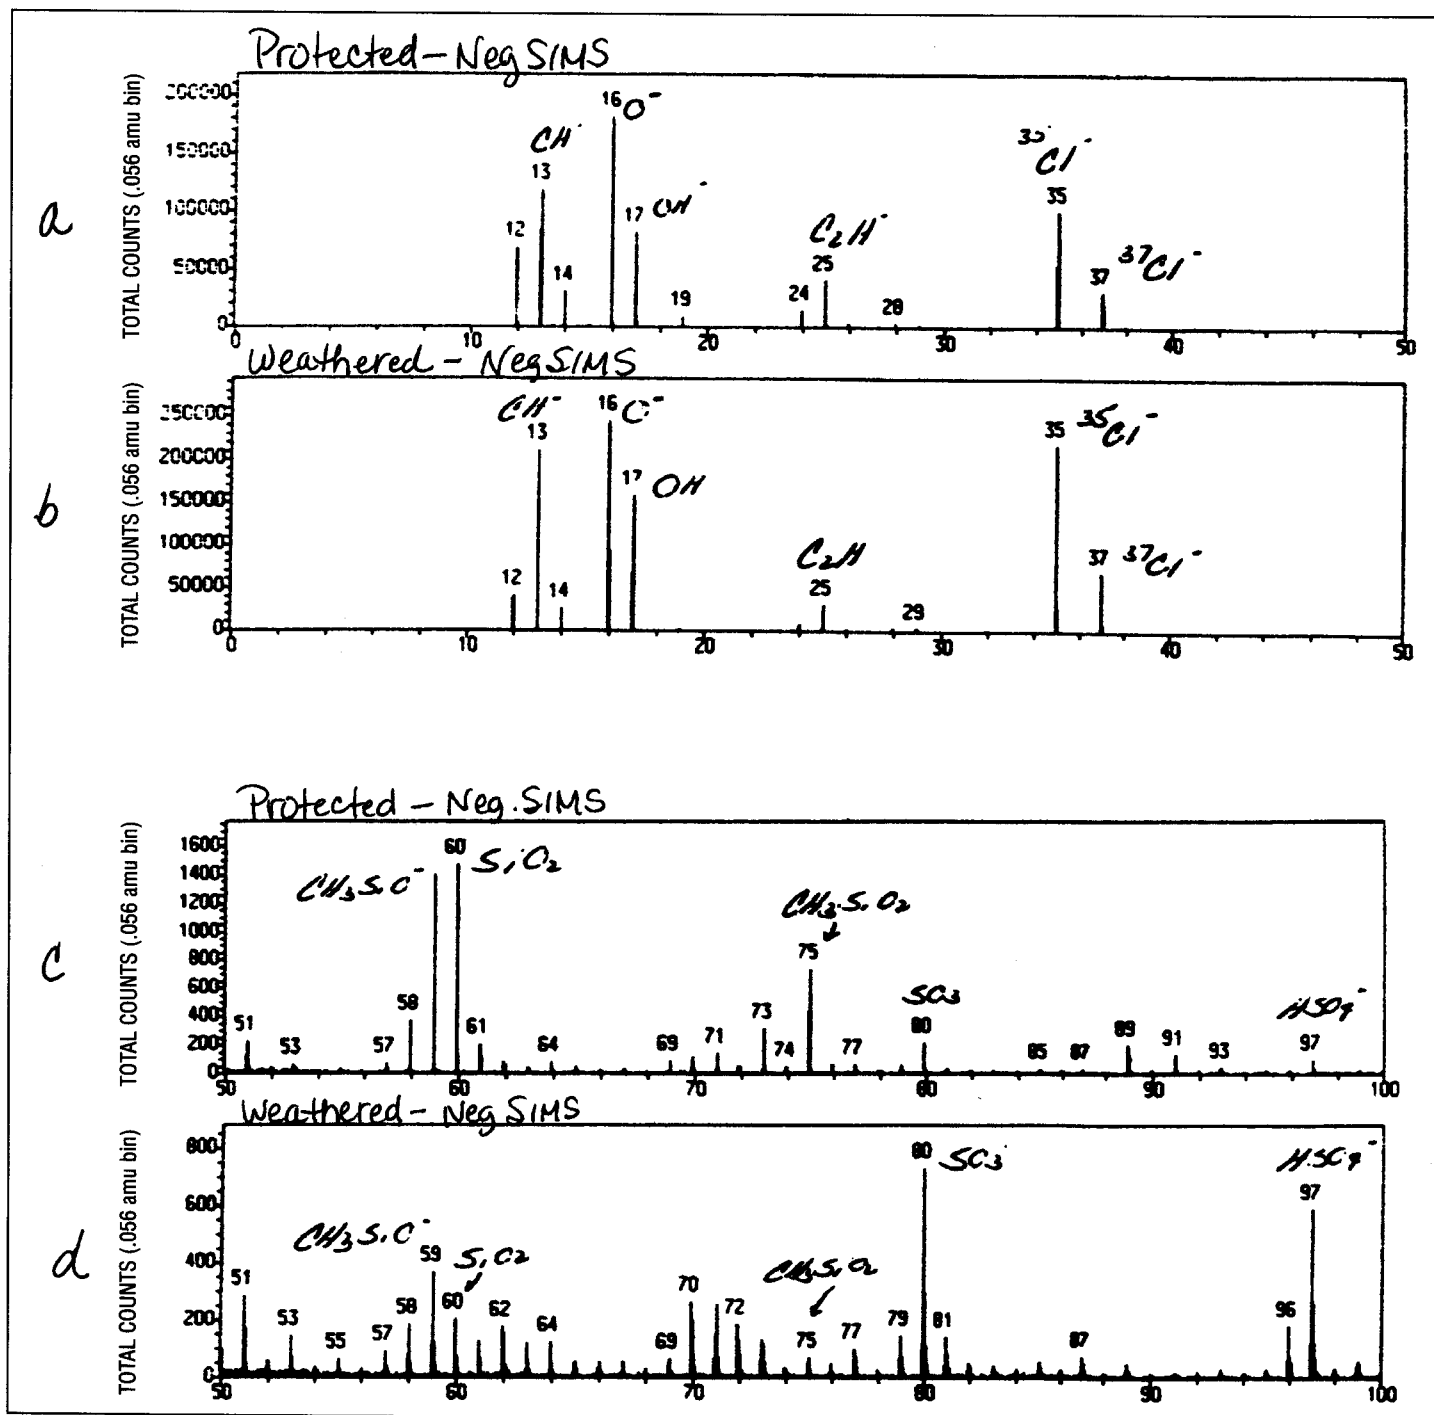
Both positive and negative ion SIMS spectra were collected from the protected and weathered surfaces and their cross-sections. Figures 3 and 4 contain negative SIMS spectra collected from the surfaces of the samples. The Cl from the CSPE polymer is evident on all samples and is more intense in the cross-sectional areas than in the protected and weathered surfaces. Ions emanating from dimethylsiloxane (DMS) dominate the surface and are observed at mass 59(CH<sub>3</sub>SiO),

Figures 3A, 3B, 3C, and 3D. Negative SIMS spectra showing key ions of interest: 3A) protected surface, mass range 0 to 50; 3B) weathered surface, mass range 0 to 50; 3C) protected surface, mass range 50 to 100; 3D) weathered surface, mass range 50 to 100.

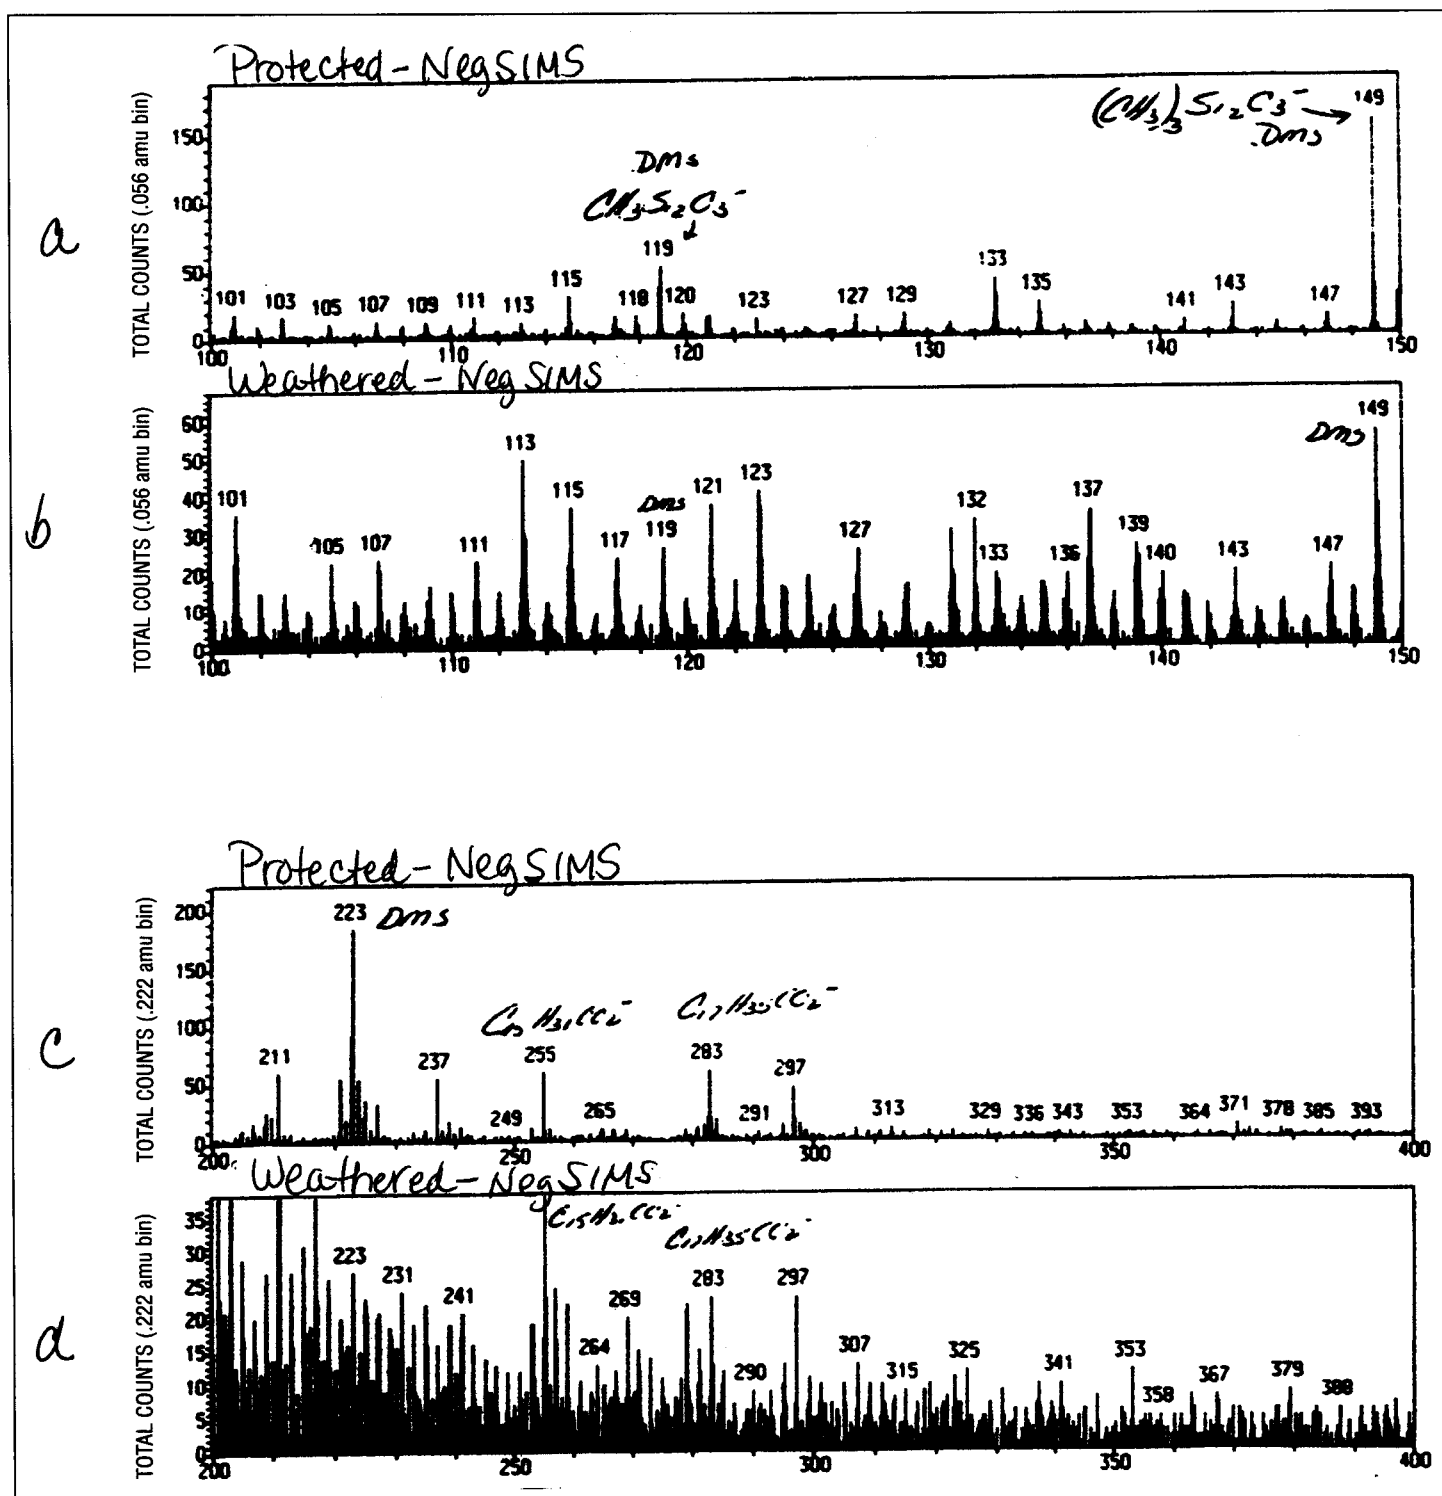
and 255 ( $\text{C}_{15}\text{H}_{31}\text{CO}_2^-$ ; palmitic) are observed on all of the samples but are more intense on the surface of the protected sample (Figures 4C and 4D) and in its cross section. These fatty acids may be due to processing aids used during compounding and calendaring.

Figures 4A, 4B, 4C, and 4D. Negative SIMS spectra showing key ions of interest: 4A) protected surface, mass range 100 to 150; 4B) weathered surface, mass range 100 to 150; 4C) protected surface, mass range 200 to 400; 4D) weathered surface, mass range 200 to 400.

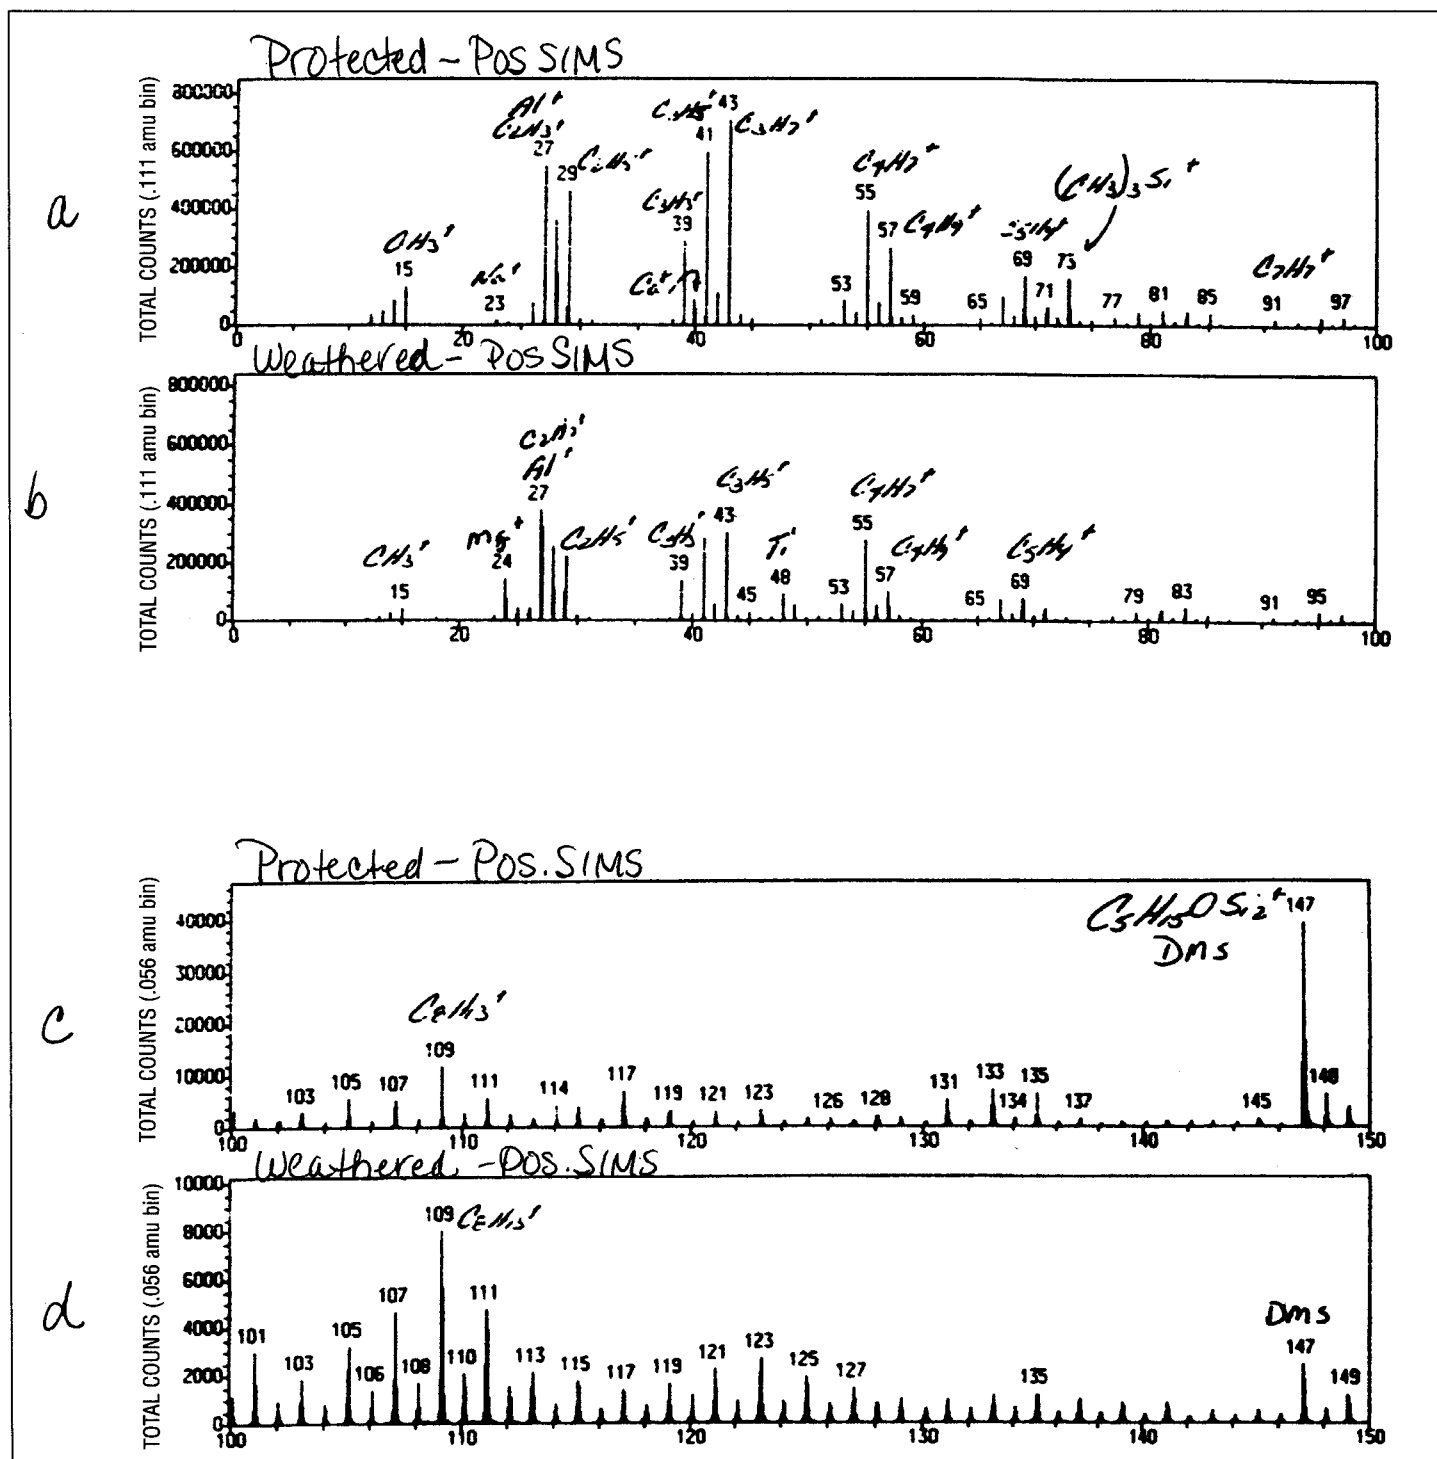
191(C<sub>4</sub>H<sub>9</sub>SO<sub>3</sub>Cl<sub>2</sub><sup>+</sup>) are ions emanating from CSPE polymer because of fragmentation along the polyethylene backbone. The intensity of these ions is greatest in the protected surface and cross-sectional areas. The intensity of these ions on the weathered surface is decreased by at least a factor of three, indicating that polymer degradation is occurring upon weathering. Polymer degradation can also be observed by monitoring the Mg and Ti levels in the formulation. The ions at mass 48(Ti<sup>+</sup>) and 24(Mg<sup>+</sup>) can be observed on the weathered surface but not on the protected surface, indicating that the polymer is wearing away and exposing the inorganic species (Figures 5A and 5B). This data directly corroborates that obtained in the ESCA analyses.

Figures 5A, 5B, 5C, and 5D. Positive SIMS spectra showing key ions of interest: 5A) protected surface, mass range 0 to 100; 5B) weathered surface, mass range 0 to 100; 5C) protected surface, mass range 100 to 150; 5D) weathered surface, mass range 100 to 150.

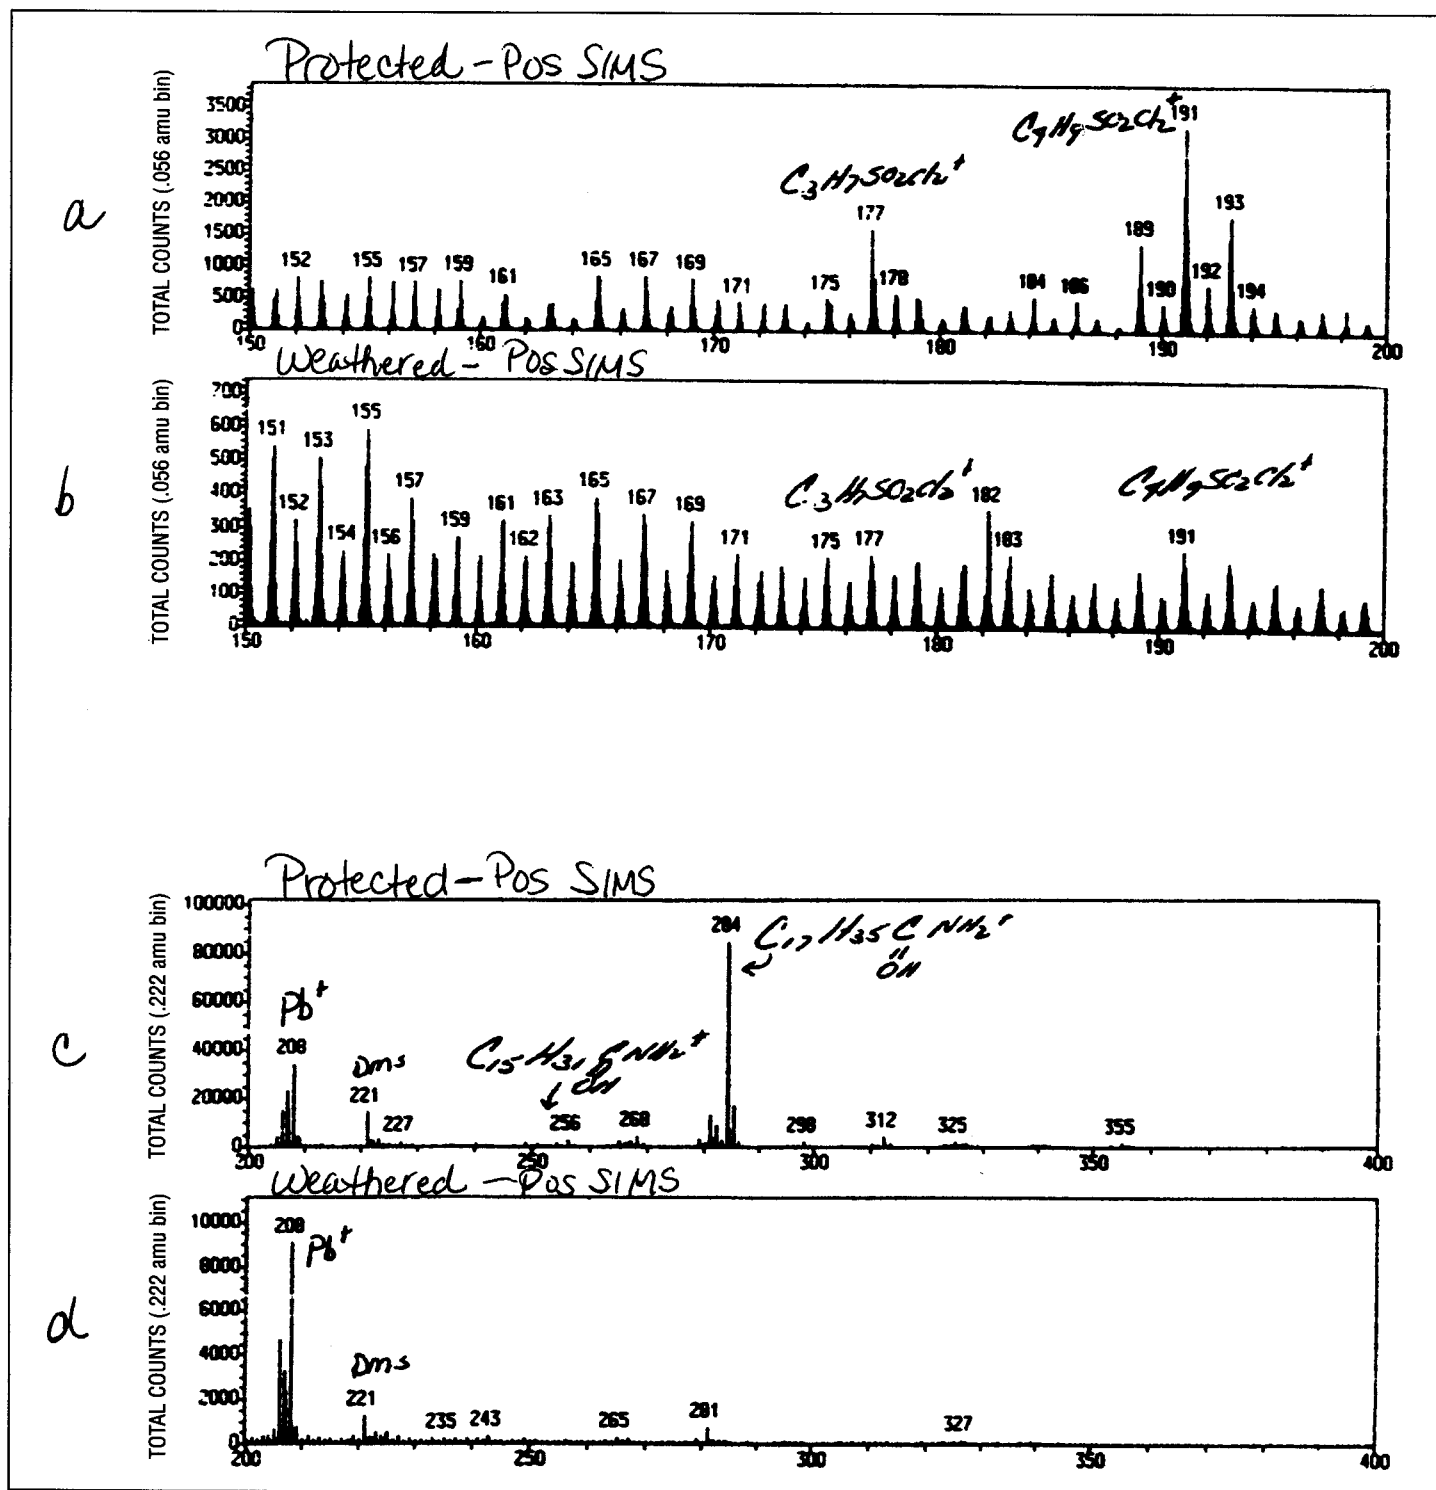
sheet (Figures 6C and 6D), corroborating the ESCA data. Ions at mass 256 ( $\text{C}_{16}\text{H}_{32}\text{ONH}_2^+$ ) and 284 ( $\text{C}_{18}\text{H}_{36}\text{ONH}_2^+$ ) are also found on the surface of the protected area (Figure 6C) but not on the weathered (Figure 6D) or cross-sectional areas. These ions, which are present at a significant intensity on the protected surface, are due to a fatty acid amide (e.g., stearamide). Centered at mass 177 ( $\text{C}_5\text{H}_7\text{SO}_2\text{C}_2^+$ ) and mass

Figures 6A, 6B, 6C, and 6D. Positive SIMS spectra showing key ions of interest: 6A) protected surface, mass range 150 to 200; 6B) weathered surface, mass range 150 to 200; 6C) protected surface, mass range 200 to 400; 6D) weathered surface, mass range 200 to 400.

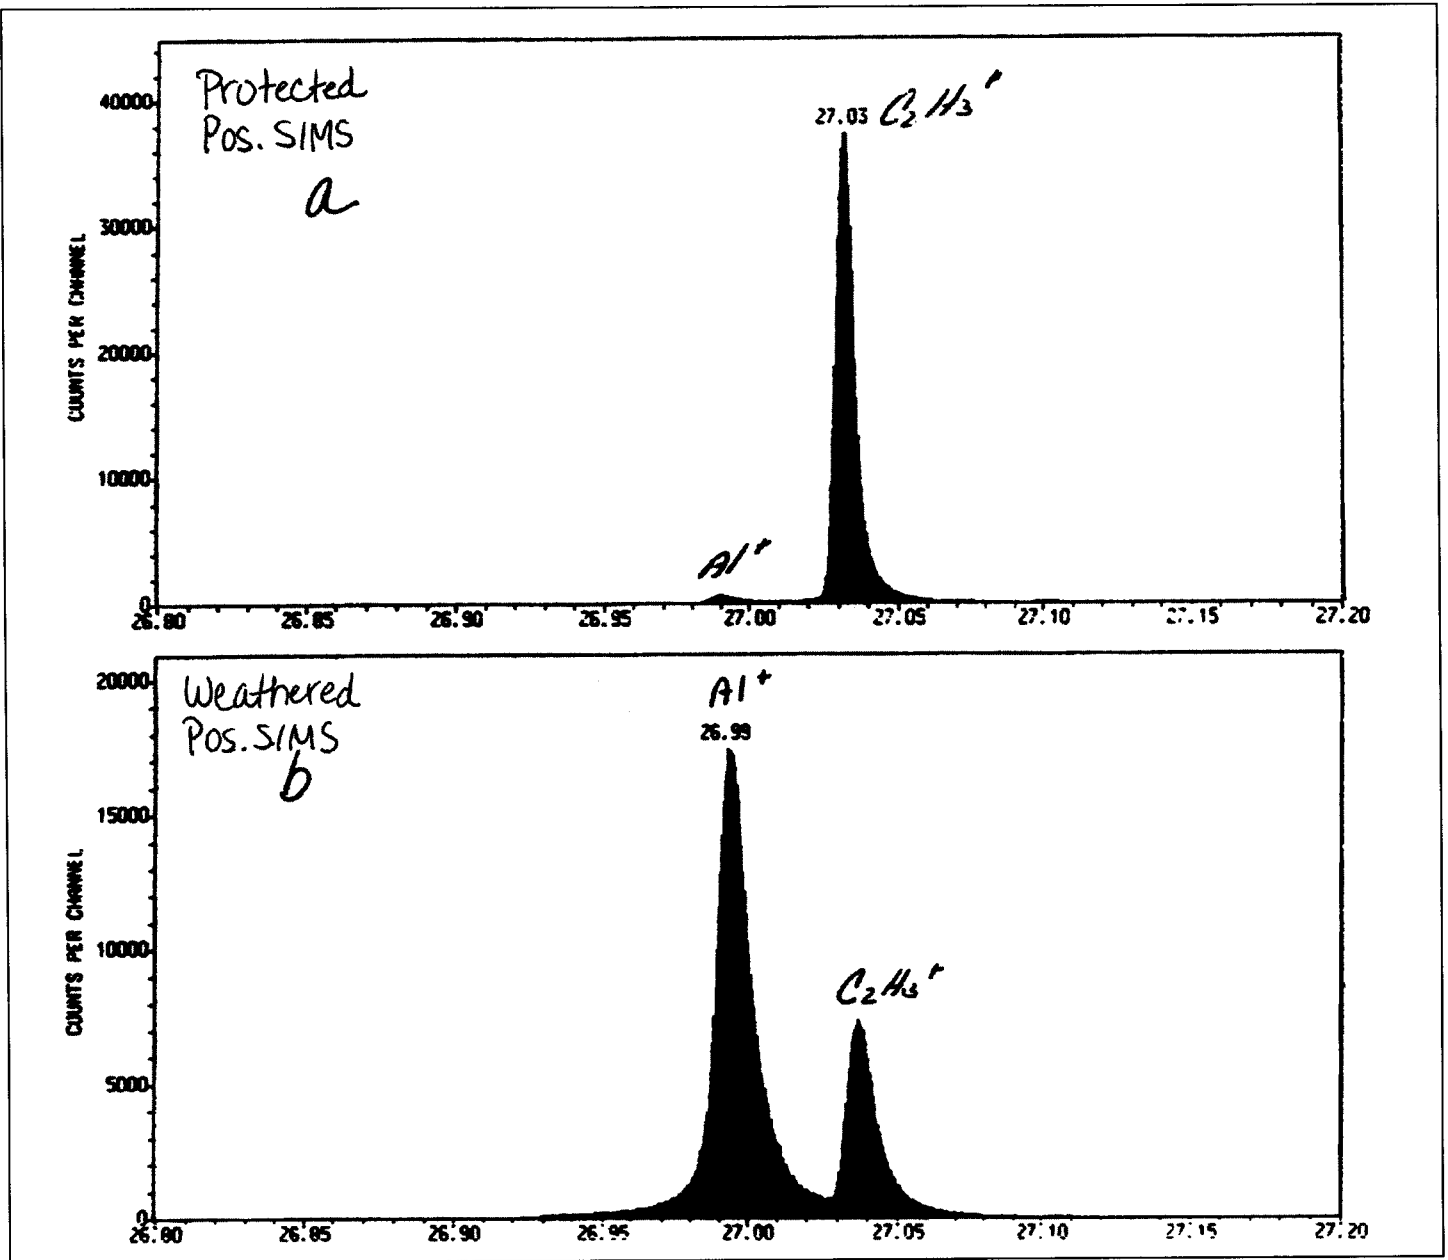
The degradation of the CSPE polymer upon exposure can be observed further by examining the ion at mass 27. There are generally two species—Al<sup>+</sup> and C<sub>2</sub>H<sub>5</sub><sup>+</sup>—that give rise to this ion, which is due to organic species. Figure 7 contains the positive SIMS spectra centered at mass 27 for the weathered and protected surfaces. On the protected surface, mass 27 is almost exclusively organic in nature (C<sub>2</sub>H<sub>5</sub><sup>+</sup>) with little Al<sup>+</sup> observed. Upon exposure however, the ratio of organic species (C<sub>2</sub>H<sub>5</sub><sup>+</sup>) to Al<sup>+</sup> changes dramatically with the surface now dominated by the Al<sup>+</sup> ion, indicative of polymer breakdown.

Figures 7A and 7B. Positive SIMS spectra of mass spectral region centered at mass 27, showing change in ratio of organic  $C_2H_3^+$  ions to  $Al^+$  ions on CSPE membrane surface as a result of weathering: 7A) protected surface, 7B) weathered surface.

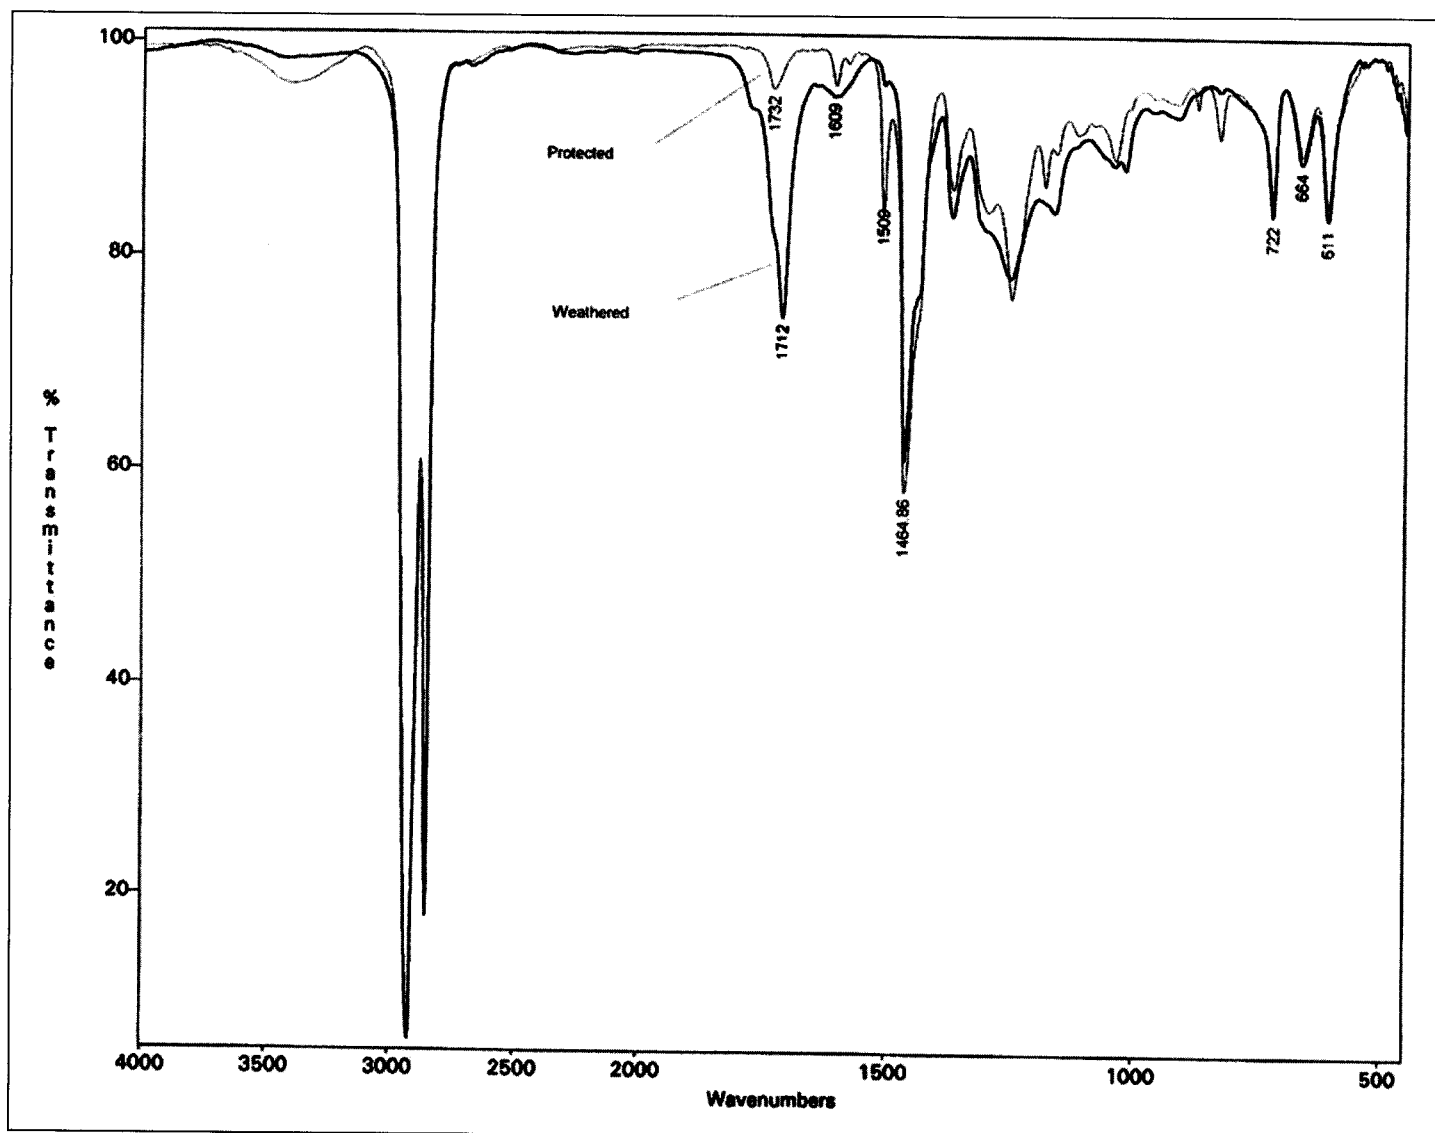
FTIR analyses of the THF extract of the membrane show a substantial amount of carboxylic acid (1712 cm<sup>-1</sup>), along with an increase in C-O functionality, in the weathered sample (Figure 8). Lack of appreciable C-Cl absorption at 664 cm<sup>-1</sup> in the IR spectra suggests incomplete solubilization of the base polymer in both samples. This is not surprising considering CSPE roof membranes are typically crosslinked after applica-

Figure 8. Transmission infrared spectra of the THF-soluble fractions of weathered and protected CSPE membranes. Samples were analyzed as cast films on AgCl plates.

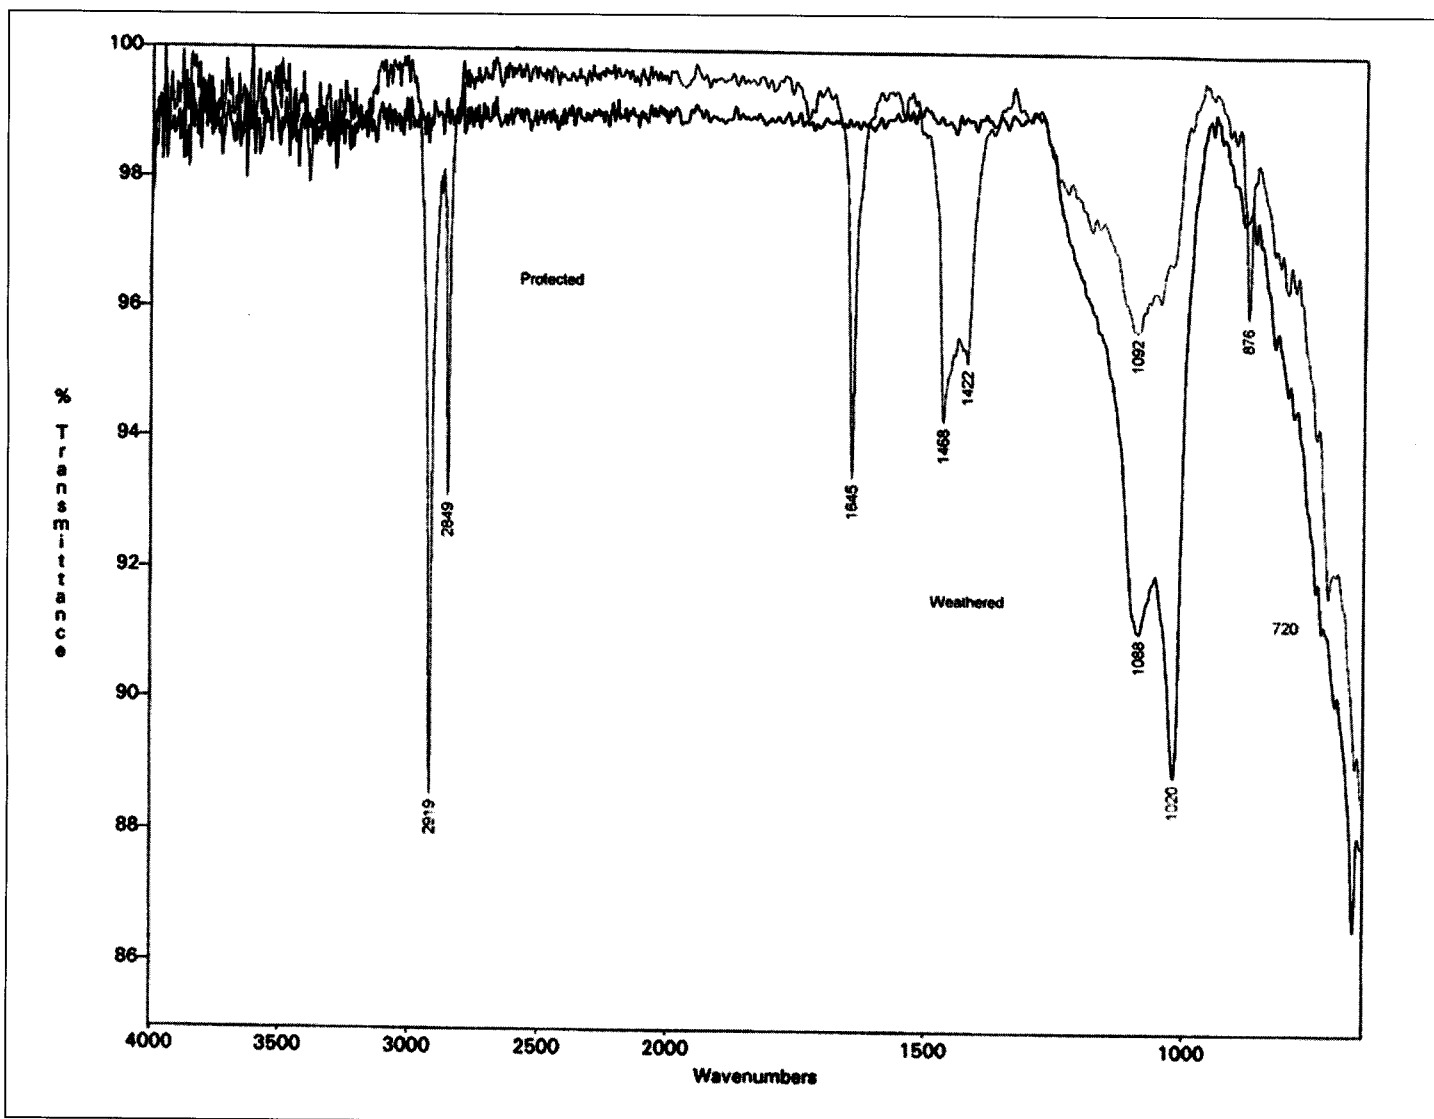
tion for increased durability. Also a decrease in aromatic functionality at 1509 cm<sup>-1</sup> in the weathered sample vs. the protected is likely due to the consumption of Epon 828 epoxy-based curing agent on aging.<sup>5,7</sup> Surface infrared analyses (Figure 9) show a loss of hydrocarbon functionality (2849 cm<sup>-1</sup> and 2919 cm<sup>-1</sup>) on the weathered surface as compared to the protected surface.

Figure 9. Surface infrared spectra of the weathered and protected CSPE membrane surfaces. Note the loss of long-chain hydrocarbon (2919  $\text{cm}^{-1}$  and 2849  $\text{cm}^{-1}$ ) and  $\text{CaCO}_3$  (1422  $\text{cm}^{-1}$  and 876  $\text{cm}^{-1}$ ) on weathering.

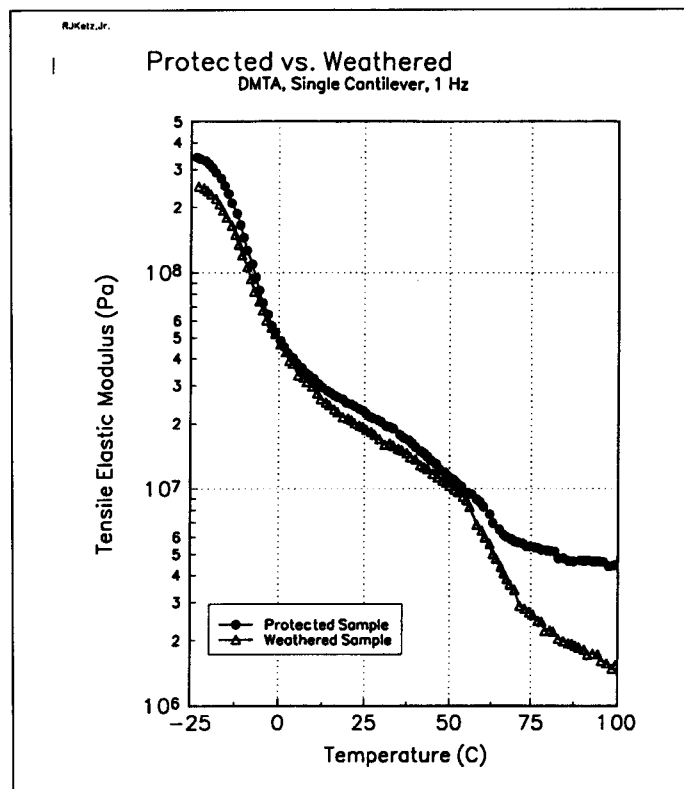
Figure 11. Tensile elastic modulus curves for the protected and weathered CSPE membrane.

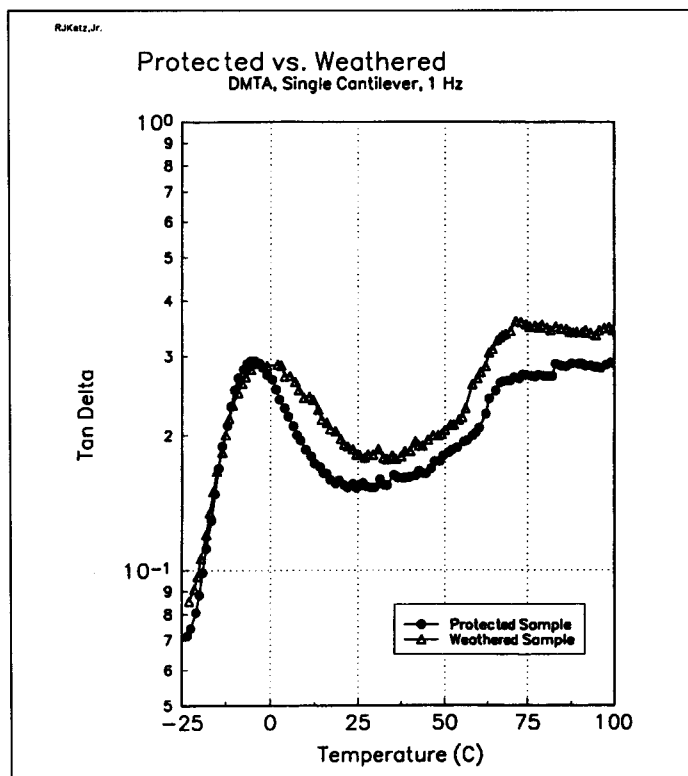
Using dynamic mechanical thermal analysis (DMTA), the weathered sample shows a shallower minimum in the tan delta curve than the protected sample; this suggests lower molecular weight in the weathered sample (Figure 10). Also, the weathered sample exhibits decreased modulus, and therefore, a decrease in the mechanical strength of the membrane relative to the protected sample (Figure 11). Unfortunately, the presence of the reinforcing scrim complicates the analysis and prevents the authors from obtaining more information about the polymer from the DMTA data.

Figure 10. Tan delta curves for the protected and weathered CSPE membrane.

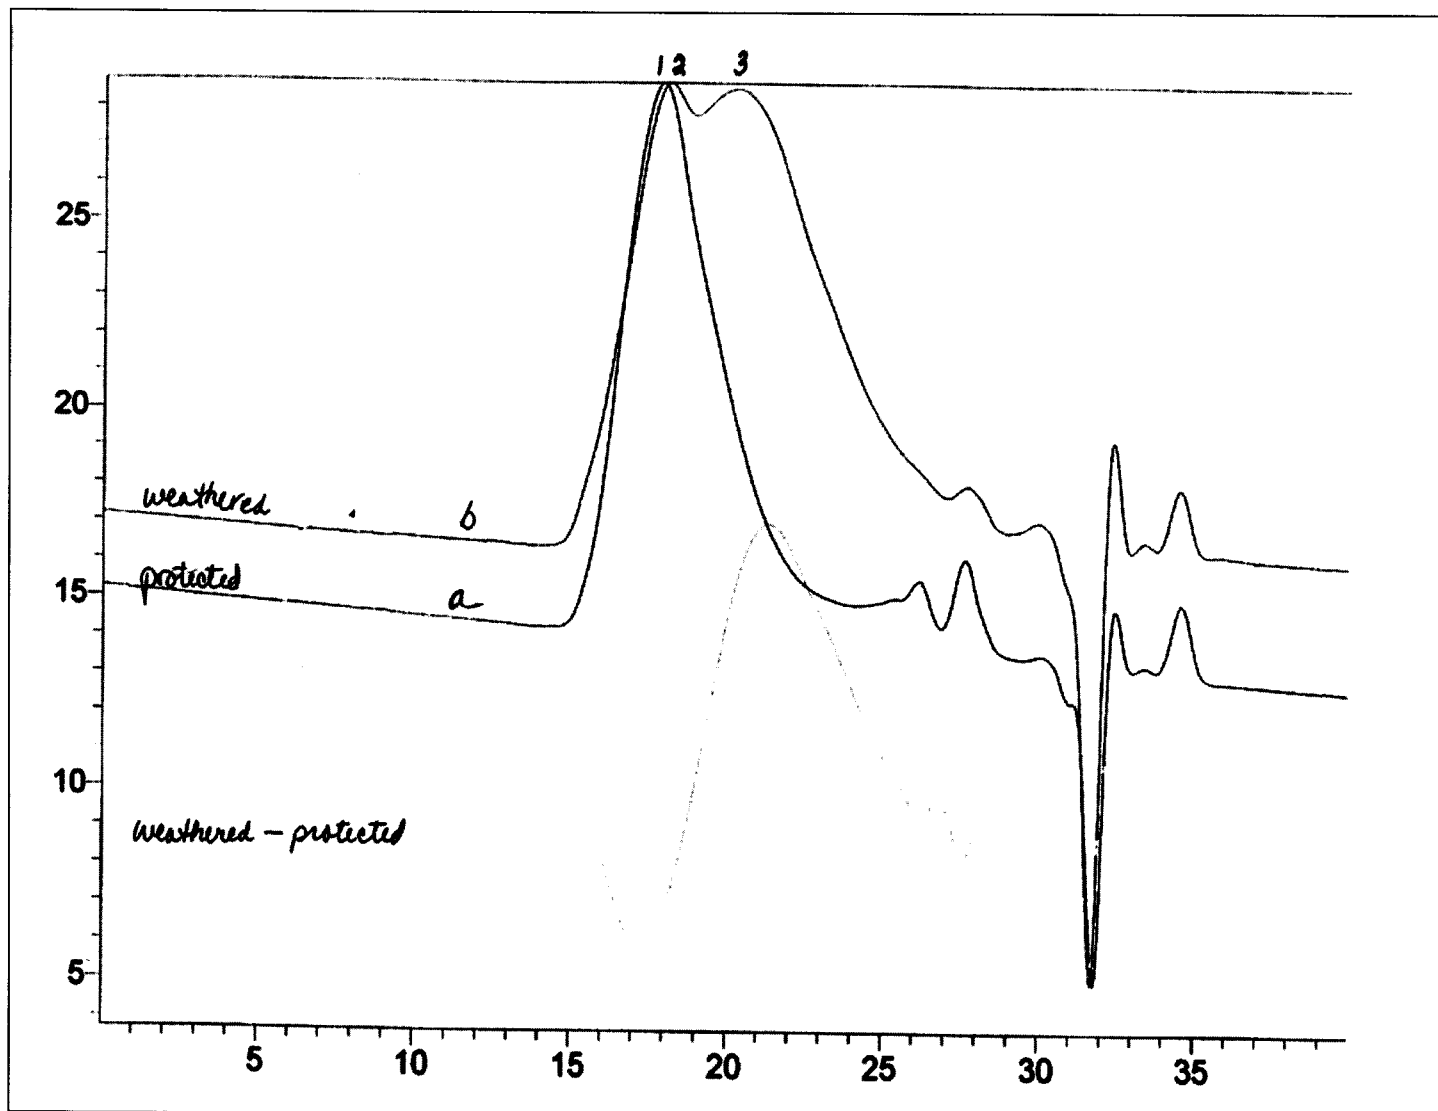
Gel permeation chromatography (GPC) analyses indicate a decrease in molecular weight on weathering. The THF-soluble fraction of the weathered sample shows two major components at 113,000 and 28,000 daltons, while the THF-soluble fraction of the protected sample shows one major component at 133,000 daltons (Figure 12). The GPC analysis only accounts for the part of the sample that is both soluble in THF and filterable. Previous work has shown the polymer is not completely soluble in THF. However, the GPC evidence for molecular weight decrease indicates the same trend towards polymer degradation as is indicated by the rest of the analytical data obtained.

Figure 12. Gel permeation chromatograms for THF-soluble fractions of protected (a) and weathered (b) CSPE membrane. Approximate molecular weights: Peak 1—133,000 daltons; Peak 2—113,000 daltons; Peak 3—27,900 daltons. Molecular weights are based on a polystyrene calibration.
