# Hurricane Hugo's Effects on Metal Edge Flashings

Thomas Smith, AIA, CRC  
NRCA  
Rosemont, Illinois

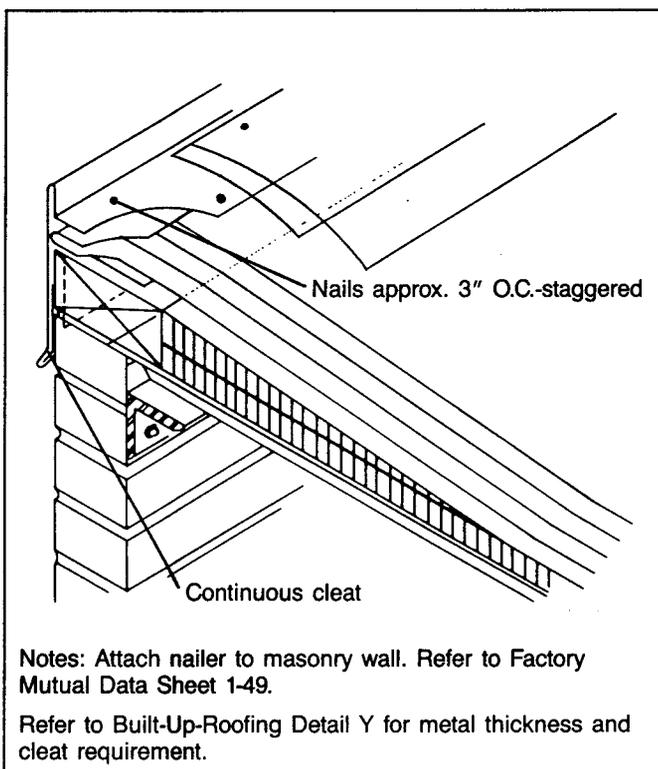
Figure 1 Light-metal roof edge (Source: The NRCA Roofing and Waterproofing Manual, BUR Detail D).

The NRCA manual<sup>7</sup> shows metal edge flashing and coping details (Figures 1 and 2) and a gauge selection guide (Figure 3). A 26 gauge (0.45 millimeter) steel cleat is permitted for a 6-inch (150-millimeter) vertical face, which is probably inadequate even under moderate wind loads. Also, the manual gives no criteria for cleat fastening. For the coping detail, the manual shows face fasteners for the inner leg, but gives no criteria for fasteners other than the 24-inch (600-millimeter) spacing, which may be too great for high wind loads.

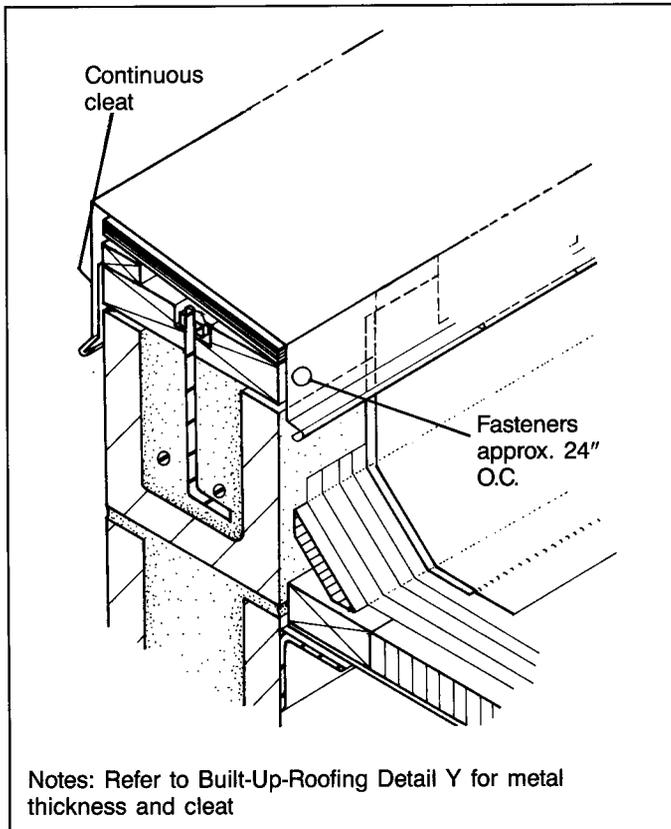
Figure 2 Light-metal parapet cap (Source: The NRCA Roofing and Waterproofing Manual, BUR Detail J).

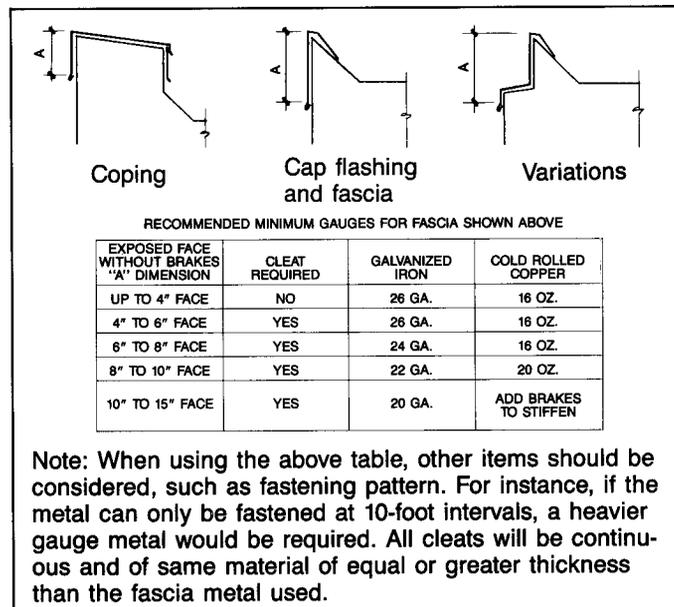
Figure 3 For metal fascia exposed to view (Source: The NRCA Roofing and Waterproofing Manual, BUR Detail Y).

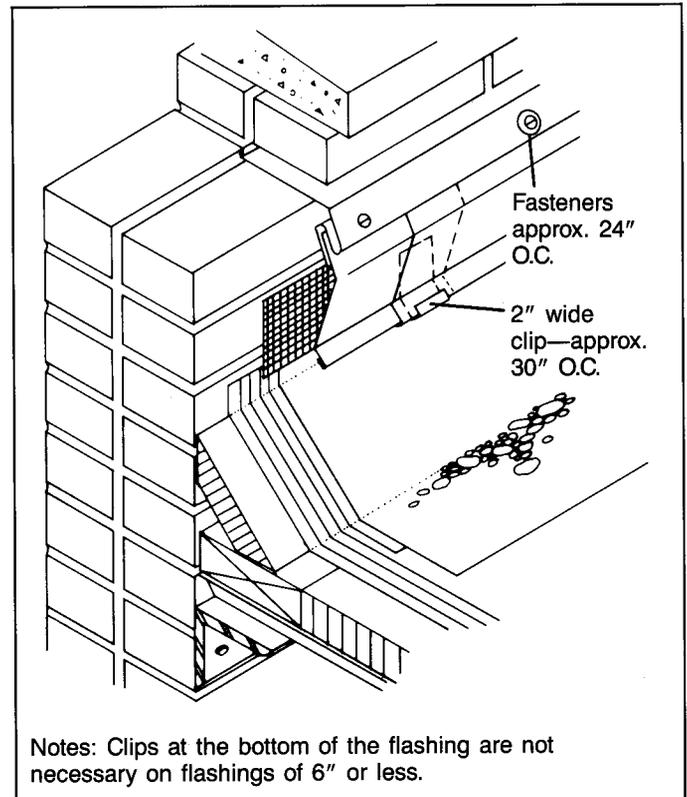
The manual also shows metal counterflashings (Figure 4), with 2-inch (50-millimeter) clips at 30 inches (750 millimeters), which may also be too great for high winds. This detail also allows elimination of the clips when the vertical leg is 6 inches (150 millimeters) or less, which could lead to problems in high wind areas.

Figure 4 Base flashing for wall-supported deck (Source: The NRCA Roofing and Waterproofing Manual, BUR Detail F).

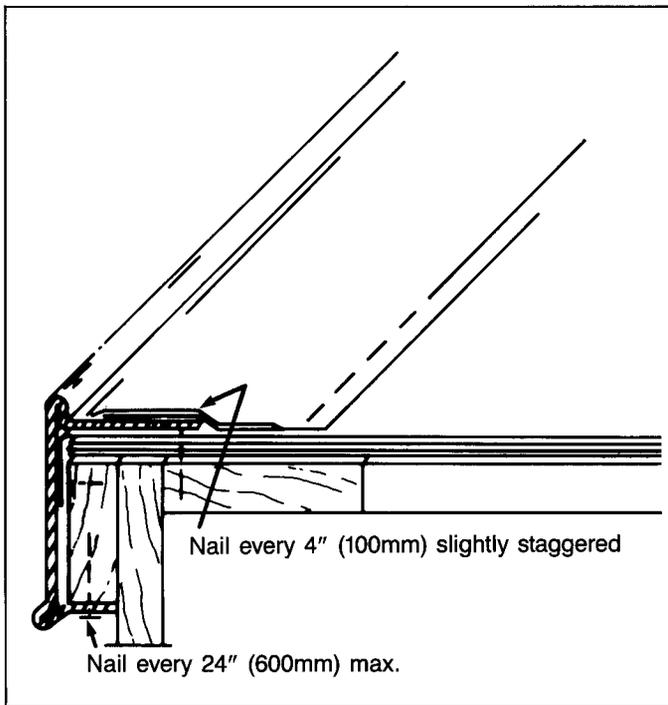
The CRCA manual<sup>8</sup> shows an interesting metal edge flashing (Figure 5). Rather than using a cleat, as is commonly done in the United States, the lower edge of the flashing is broken horizontally and nailed. This loads the fasteners in shear, thus eliminating the complex interaction between the cleat and flashing. Fasteners are specified to penetrate a minimum of 1 inch (25 millimeters) and to be spaced at 24 inches (600 millimeters). The manual also specifies a 24-gauge (0.56-millimeter) steel and gives data on other types of metal.

The design of this detail is probably suitable for high wind loads, even with these minimal dimensions. Although the manual shows copings, it does not give specific criteria for attachment.

Figure 5 Metal gravel stop-sloped edge, slopes 1:12 to 1:4 (Source: CRCA Roofing Specifications Manual, Detail FL504).

- For metal edge flashings and copings, the outer leg should be continuously cleated, face fasteners should be used or a detail similar to Figure 5 should be employed. For steel, cleats should be a minimum of 22 gage (0.80 millimeters), or thicker for very high wind loads, and have a minimum break leg length of three-quarters inch (19 millimeters). For very high loads, a break leg length of 1 inch (25 millimeters) should be considered. The break angle should be 30 degrees, as SMACNA recommends. Fasteners loaded in withdrawal should be annular or screw-shank nails or screws with a minimum penetration of 1¼ inches (32 millimeters). Spacing should meet the outward load, but no greater than 18 inches (450 millimeters). For a distance of 16 feet (4.8 meters) from the corner, the fastener spacing should be decreased by one half. Fasteners should be located about one-half inch (13 millimeters) above the cleat break.

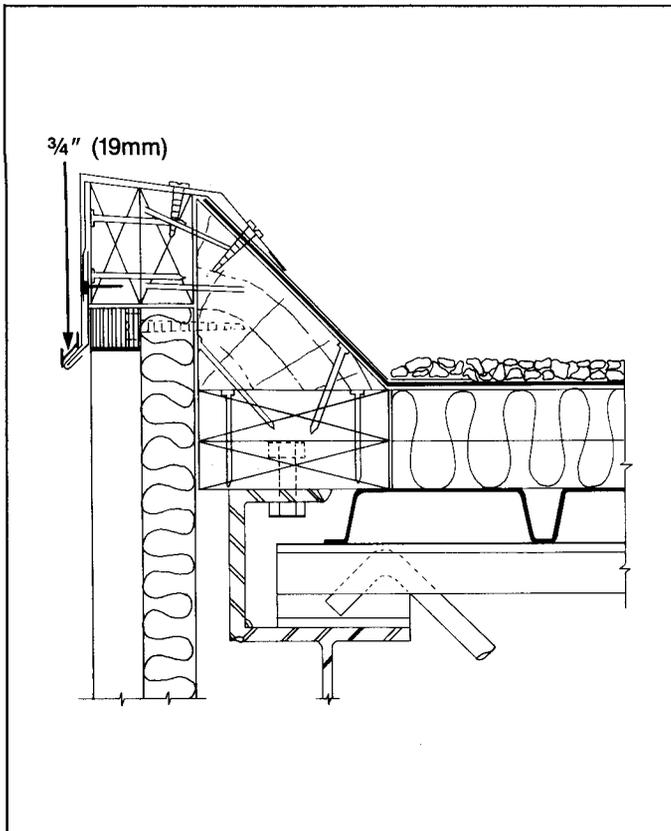
The manual specifies fastening the lower leg of metal counterflashings at 36 inches (900 millimeters), with fasteners having a minimum pullout of 200 pounds (91 kilograms). FM 1-49 shows several details, but only one of them dimensions the broken leg that receives the cleat (Figure 6). A three-quarter-inch dimension is given, which is not common, but may be appropriate in moderate and high wind areas. A critical aspect of the cleat/flashing or coping interlock is deformation under load. Likewise, a critical aspect of this deformation is the location of the cleat fastener, which is not dimensioned. To exacerbate the lack of dimensioning, the details typically show the fasteners near the top of the cleat rather than near the cleat break (Figures 6 and 7). Another critical aspect of the cleat interlock is that the flashing or coping should have maximum engagement of the cleat. Yet Figure 7 shows the flashing only engaging about half of the cleat leg.

Figure 6 Perimeter flashing (Source: FM Loss Prevention Data 1-49, Fig. 10).

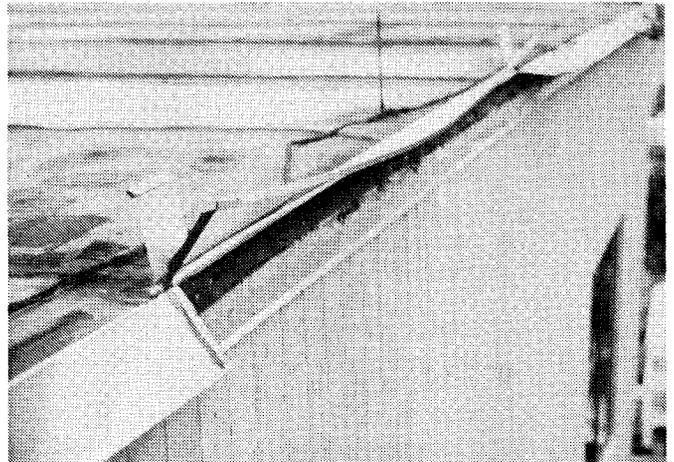
Photo 1 shows a metal edge flashing that disengaged from the continuous cleat and lifted up. On other portions of the building, the wind lifted and peeled the flashing and membrane. The flashing had a 7-inch (175-millimeter) vertical face. The flashing and cleat were 24-gauge (0.56-millimeter) stainless steel. The cleat was 2 inches (50 millimeters) high and had a three-quarter-inch (19-millimeter) break leg. The cleat was sealed to the wall. Cleat fasteners were located near the top of the cleat and were spaced 12 inches (300 millimeters) on center. Although the cleat and flashing were stiff, and the cleat had a long break leg, deformation of the flashing and cleat caused failure. Cleat fasteners closer to the break may have prevented failure. Although in this instance, an even longer cleat break leg may have been needed in addition to the fasteners' being located closer to the break.

Photo 1 Metal edge flashing disengaged from continuous cleat and lifted up.

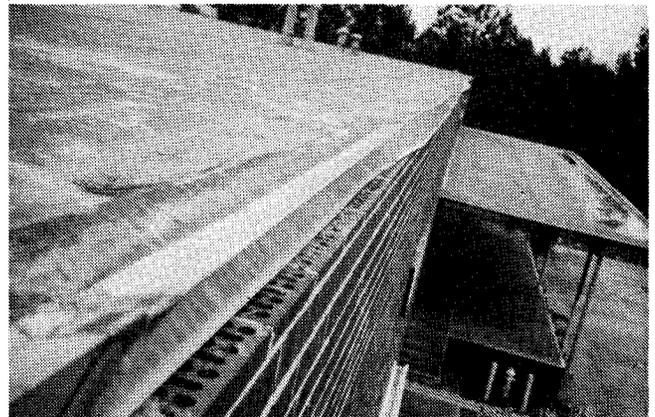
Photo 2 shows a nailer that was inadequately secured to a brick wall. A good cleat/flashing interlock (Photo 3) prevented peeling of the flashing and membrane.

Photo 2 Wood nailer inadequately attached to brick wall. See Photo 3.

- Because metal should not be directly attached to concrete or masonry, nailers should be used to attach metal components. They should be bolted to concrete, masonry, cement woodfiber and lightweight concrete. Nailers may be bolted or screwed to steel or wood. They may be nailed to wood, provided a sufficient number and length of nails are used. In all cases, nailer fasteners should be designed to meet the design uplift. With bolted connections, at least three-quarters inch (19 millimeters) of wood should be left below the washer.

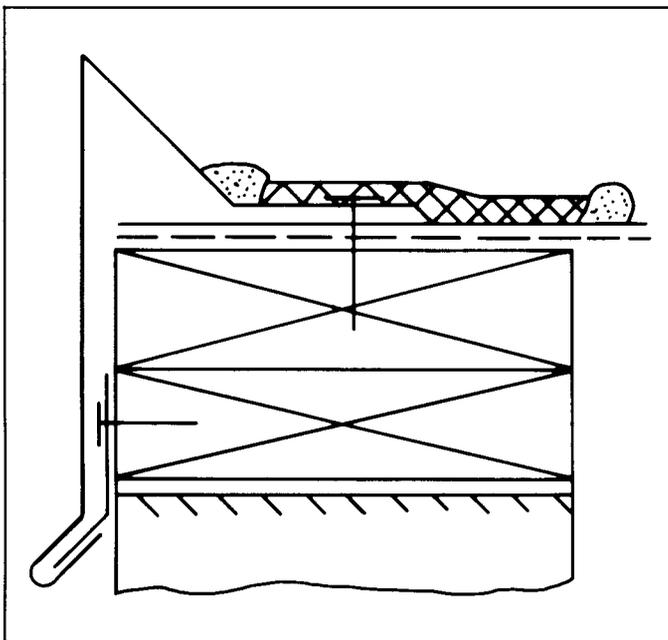
Figure 7 Membrane stopped at edge (Source: FM Loss Prevention Data 1-49, Fig. 14).

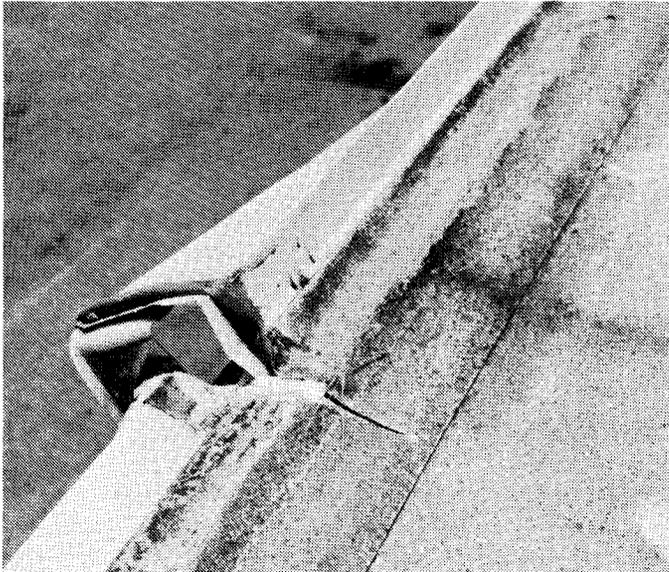
*Photo 3 Good cleat attachment and cleat/metal edge flashing interlock prevented the metal edge flashing and membrane from lifting and peeling.*

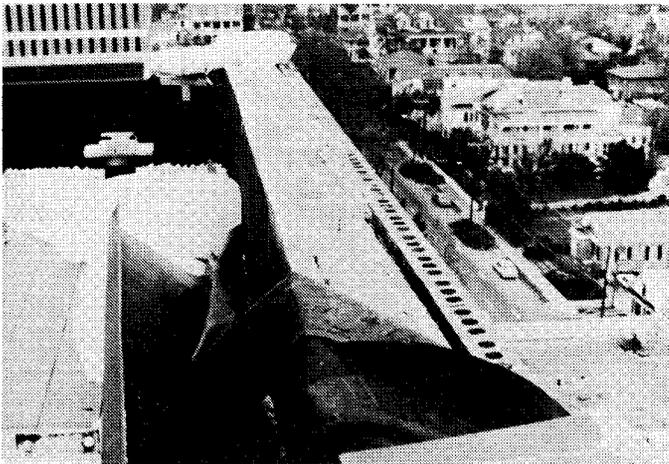
Photo 4 shows a preformed coping attached with clips that were adhered to EPDM. The EPDM was adhered to the concrete and brick parapet. Coping sections were 10 feet (3 meters) long, and two clips were installed per section. The adhesive connection was inadequate.

*Photo 4 Preformed coping clips were adhered to EPDM, which was adhered to the concrete and brick parapet. Several sections of coping were blown off.*

For heavy extruded sections, face fastening or cleats may not be needed. Adhesive should not be used to connect these components.

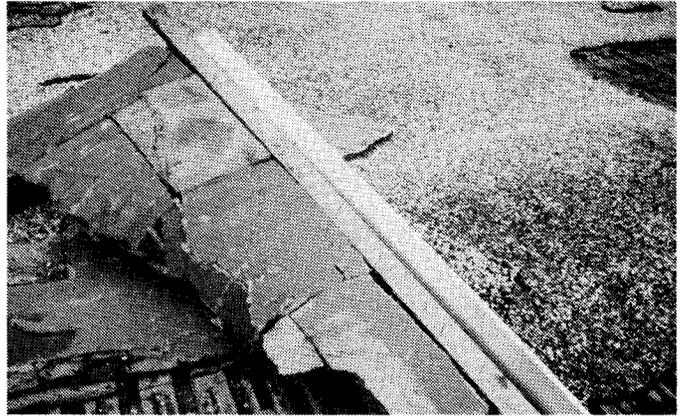
Photo 5 shows a metal edge flashing attached to a nailer that was 1½ inches (38 millimeters) thick. The nailer was fastened to a bottom nailer bolted to the wall. The top nailer was fastened with 10 penny nails spaced an average of 9 inches (225 millimeters) on center. This gives a calculated working load resistance of 90 pounds per lineal foot (124 kilograms per meter). Initial failure probably began several feet (meters) from the location where steel decking blew off. A secondary (progressive) failure was likely to be nailer lifting and peeling.

*Photo 5 Metal edge flashing attached to a nailer, which was nailed to a bottom nailer that was bolted to the wall. The nails attaching the top nailer had a calculated working load capacity of 90 pounds per lineal foot (124 kilograms per meter).*

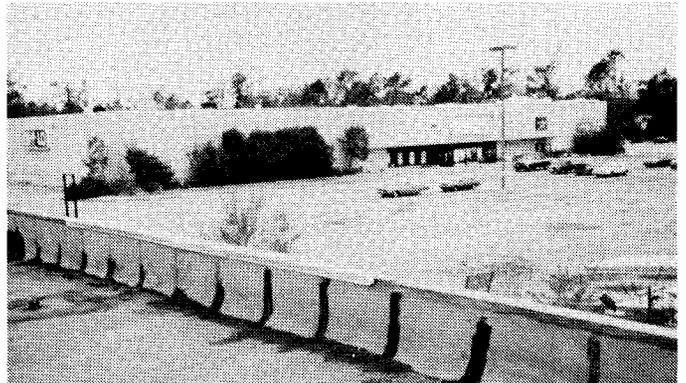
Photo 6 shows a parapet with only a few sections of coping remaining. Most coping sections were blown off. Very inadequate attachment (two nails at each end of each section) caused the failure.

*Photo 6 Ten foot long (3 meter) sections of 0.023-inch (60 millimeter) aluminum coping were attached with only two nails at each end. The coping had 2½-inch (62 millimeter) vertical legs. Most of the coping sections blew off.*
