## **Impact of air intrusion on the wind uplift performance of fully bonded roofing assemblies**

**NRCC-49721**

Baskaran, B.A.; Molleti, S.; Sexton, M.

February 2009

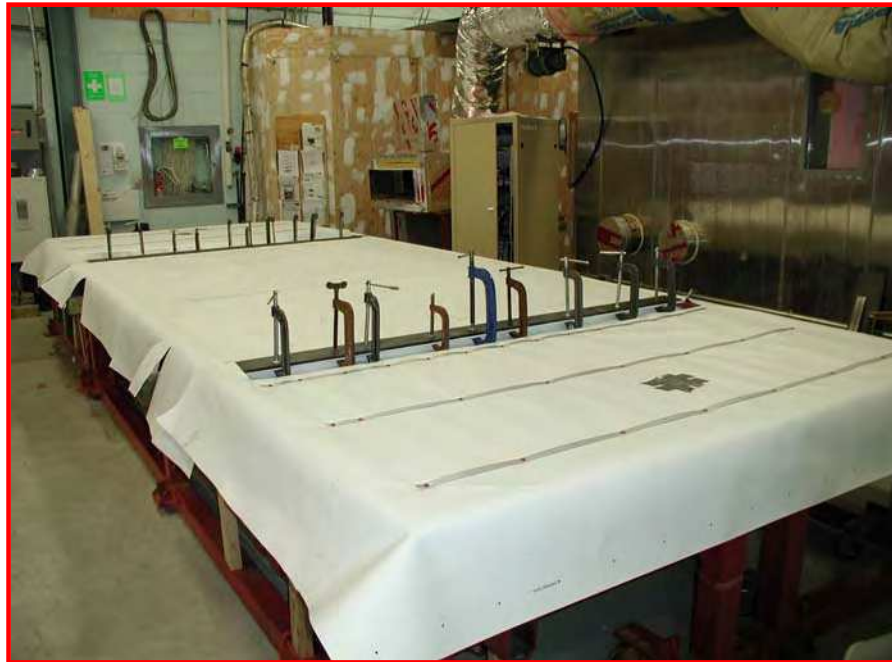
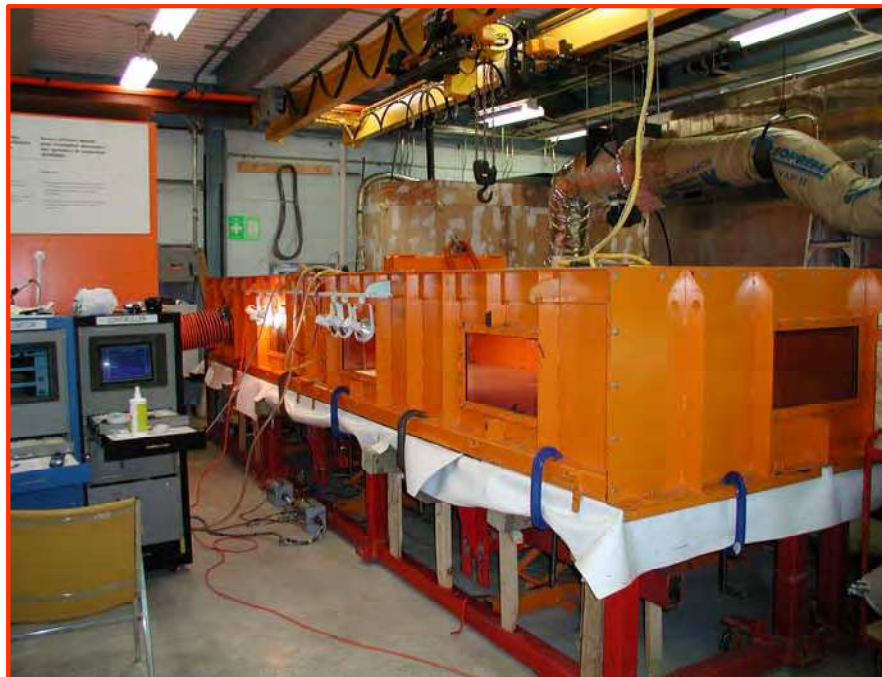
**Figure 2. FBA on the Dynamic Roofing Facility**

Experimental work was carried out at the Dynamic Roofing Facility (DRF) established at the Institute for Research in Construction at the National Research Council of Canada (IRC/NRC). DRF consists of a bottom frame of adjustable height upon which the roof specimen and a removable top chamber are installed (Figure 2). The design allows for the installation and study of roof assemblies of different thicknesses up to 500 mm (18") as well as the evaluation of sloped roofs. The bottom frame and top chamber are 6100 mm (240") long and 2200 mm (86") wide and 800 mm (32") high. The top chamber is equipped with six windows for viewing, and with a gust simulator, which consists of a flap valve connected to a stepping motor through a timing belt arrangement. Pressure suction as high as 10 kPa (209 psf) over the roof assembly is produced by a 37 KW (50HP) fan with a flow rate of 2500 L/sec (5300 cfm). A computer, using feedback signals, controls the operation of the DRF. The computer regulates the fan speed in order to maintain the required pressure level in the chamber. Operation of the flap valve simulates the gusts in the form of uniform cyclic pressure loading over the surface of the roofing system. Closing the flap valve allows pressure to build in the chamber, while opening the valve bleeds the pressure. Also, the test facility has instrumentation for measuring the dynamic response for the specimen. More information of the DRF features is given in Baskaran and Lei (1997).

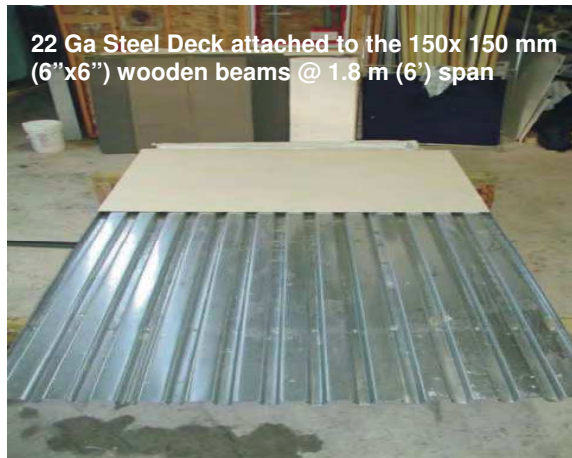
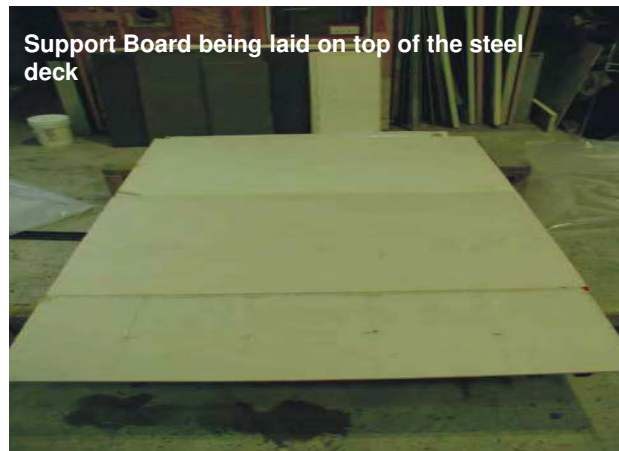
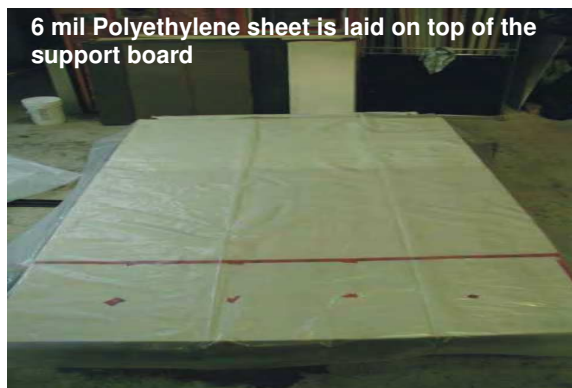
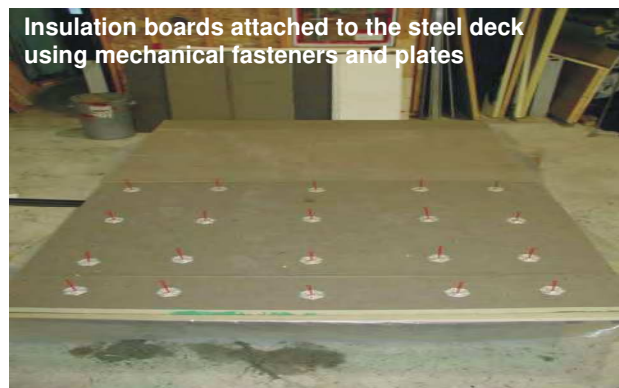
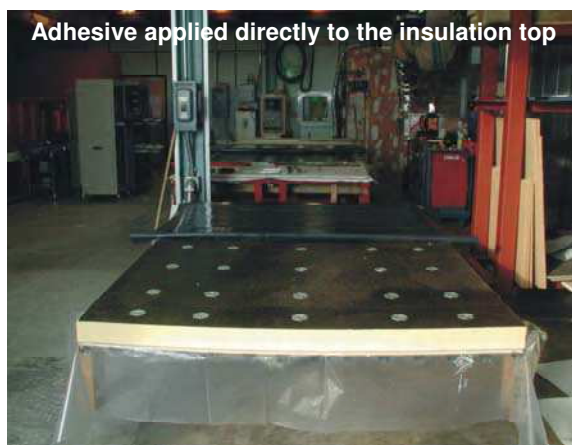
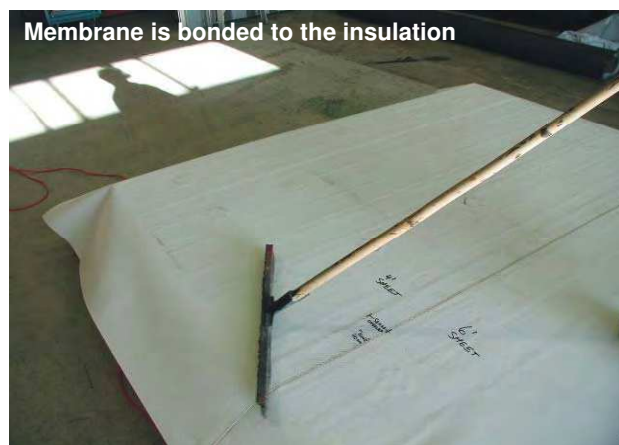
**Figure 5. Mock up Construction Process of FBA with Barrier**

**Deck Installation:** Two deck pieces cut at length of 3048 mm (120") and width of 1000 mm (39") were overlapped and fastened with two 150 mm x 150 mm (6" x 6") wooden beams spaced at 1830 mm (72") o/c using 12 mm (½") carriage bolts and 76 mm (3") wood fasteners.

**Barrier Installation:** Gypsum support boards of 1219 mm x 2438 mm x 13 mm (48" x 96" x 0.5") were loose laid on the steel deck. As the test assembly spanned 3048 mm (120") in length and 2000 mm (79") in width, the gypsum support boards were laid with the longer dimension parallel to the width of the assembly, thereby accommodating two full boards 1219 mm x 2006 mm (48" x 79") and one half board of 610 mm x 200 mm (24" x 79"). A continuous layer of 6 mil (0.006 in.) thick polyethylene sheet was then loose laid over the gypsum support boards, ensuring an adequate overhang along the sides of the assembly.

**Insulation Installation:** Two full insulation boards of 1219 mm x 2006 mm x 50 mm (48" x 79" x 2") and two partial boards of 305 mm x 2006 mm x 50 mm (12" x 79" x 2") were installed on the steel deck. The full boards are installed in the middle with the long edges perpendicular to the steel deck flutes and the partial boards are installed on the sides as shown in Figure 11. A2 and A3 had staggered two layers of 50 mm (2") thick insulation boards in arrangement. The boards were fastened using # 15 - 127 mm (5") long fasteners and 73 mm (2⅞") diameter hexagonal metal plate. For A1, A2 and A3 each insulation board had a fastener density of one fastener per 0.17 m<sup>2</sup> (1.8 ft<sup>2</sup>). Fastener density of A4 was 0.24 m<sup>2</sup> (2.6 ft<sup>2</sup>), and in the case of A5 the fastener density was 0.5 m<sup>2</sup> (5.3 ft<sup>2</sup>).

**Membrane Installation:** Two sheets of 1830 mm (72") wide 45 mil TPO membrane were hot air welded together to form a continuous waterproofing layer. The membrane was then laid out squarely over the insulation boards along the width of the assembly, and clamped at one end, ensuring minimum overhang of 203 mm (8") of membrane along the width of the assembly. The membrane is then folded in half, so as to expose both the membrane underside and the insulation facer surface. Each surface was then swept and cleaned. (Figure 5)

**Adhesive Application:** The adhesive was applied on both the membrane bottom surface and insulation top surface at a quantity of 1 Gal/70 ft<sup>2</sup>, using conventional paint rollers and sleeves. The surfaces were then left to cure for a period of approximately 30 minutes or until the surface is "tacky" to touch. At that point the membrane side is flipped and allowed to adhere to insulation surface using a spreading applicator as shown in Figure 5. All measures were taken to ensure that there was no air trapped under the membrane. The same procedure is repeated for the other half of the membrane.

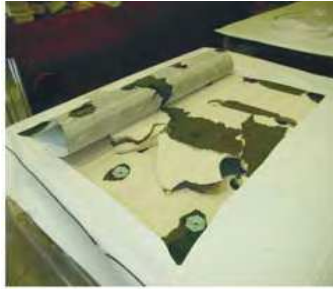
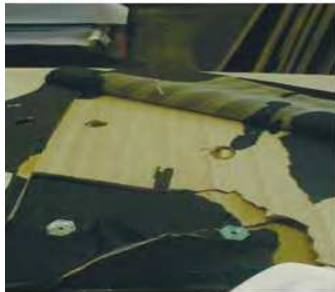
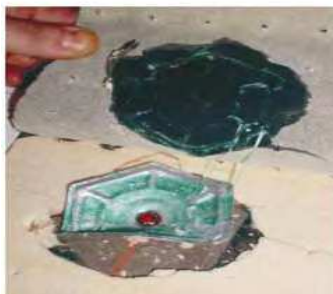
**A1: FD - 1.8 ft<sup>2</sup> / Fastener**

**A4: FD - 2.6 ft<sup>2</sup> / Fastener**

**A5: FD - 5.3 ft<sup>2</sup> / Fastener**

**Figure 15. Deformation of the FBAs with Different Fastener Densities**

This can be clearly demonstrated by comparing the failure modes of these two assemblies as shown in Figure 7. A key message is, in **Aref** air intrusion through the joints of steel deck and insulation was acting as a catalyst for the failure propagation of the insulation facer delamination. Note that that this assembly failed to have a barrier that can minimize air intrusion at the deck level. When it is subjected to suction at the membrane level, the bonding strength of the adhesive interface between the membrane and insulation causes the lifting of the insulation boards, which is resisted by the insulation fastener attachment. To equalize the suction pressures, the inside air will tend to move upward into the assembly. In the absence of a barrier, this air movement through the joints has a tendency to weaken the adhesive interface between the insulation and membrane, propagating delamination failure of membrane or insulation facer. **A1** failed due to structural foam failure of the insulations. In **A1**, the presence of barrier restricts the air intrusion into the assembly and reduces the stress (failure propagation) at the adhesive interface between the membrane and insulation. Due to this response, the load from the adhesive layer is transferred to the insulation. When the pressure is 5.5 kPa (115 psf), the wind-induced load at the fastener was 1.3 kN (295 lbf). High pressure might have induced loads in excess of the compressive strength [ $0.172 \text{ N/mm}^2$  (25 psi)] of the insulation board and ultimately leading to the cracking of the insulation foam. This will be further discussed under Figure 15.

All the three assemblies failed due to cracking of the insulation foam. Note that the measured load of the insulation fastener for all the three assemblies was in the neighborhood of  $1.1 \text{ kN}$  ( $250 \text{ lbf}$ ) and foam failure occurred above  $1.3 \text{ kN}$  ( $300 \text{ lbf}$ ). This can be attributed to the compressive strength of the insulation. During wind uplift, the upward deflection of the insulation is dependent on the insulation attachment with the deck as long as the adhesive interface between the membrane and insulation is intact. As discussed in the previous section, presence of barrier mitigated the effect of air intrusion into the assembly and thereby transferring the weakest link from the adhesive interface to the insulation attachment. Then the fastener density of the insulation attachment characterizes the deflection of the insulation board. **A1** with a fastener density of one fastener per  $0.17 \text{ m}^2$  ( $1.8 \text{ ft}^2$ ) has minimum upward deformation compared to others. The wind-induced load at the fastener might have exceeded the reported compressive strength [ $0.172 \text{ N/mm}^2$  ( $25 \text{ psi}$ )] of the insulation ultimately leading to the cracking of the insulation foam. Reducing the fastener density to  $0.24 \text{ m}^2$  ( $2.6 \text{ ft}^2$ ) in **A4** made the insulation susceptible to higher deformations, which elevated the stress on the insulation fasteners thereby subjecting the insulation to failure. Similar failure mode was observed in **A5**, however, with server degree of insulation cracking. With less fasteners and increased adhesive contact area between the membrane and insulation, the insulation boards were subjected to high shear loads compared to **A1** and **A4** as shown in Figure 15. As the force required to resist these loads surpassed the compressive strength of the insulation board, the insulation underwent foam failure. The maximum measured fastener force for **A5** was  $1.08 \text{ kN}$  ( $246 \text{ lbf}$ ) at a low-pressure of  $1.4 \text{ kPa}$  ( $30 \text{ psf}$ ) justifies the above fact. Based on the observed failure modes it can be concluded that the degree of cracking of the insulation board is inversely proportionate to the number of fasteners installed per board.
