## A New test method for quantifying air leakage of a mechanically-attached roofing assembly

A version of this document is published in / Une version de ce document se trouve dans:  
Proceedings of the RCI 22<sup>nd</sup> International Convention, Orlando, Florida, March 1-6,  
2007, pp. 105-116

# **A New Test Method for Quantifying Air Leakage of a Mechanically-Attached Roofing Assembly**

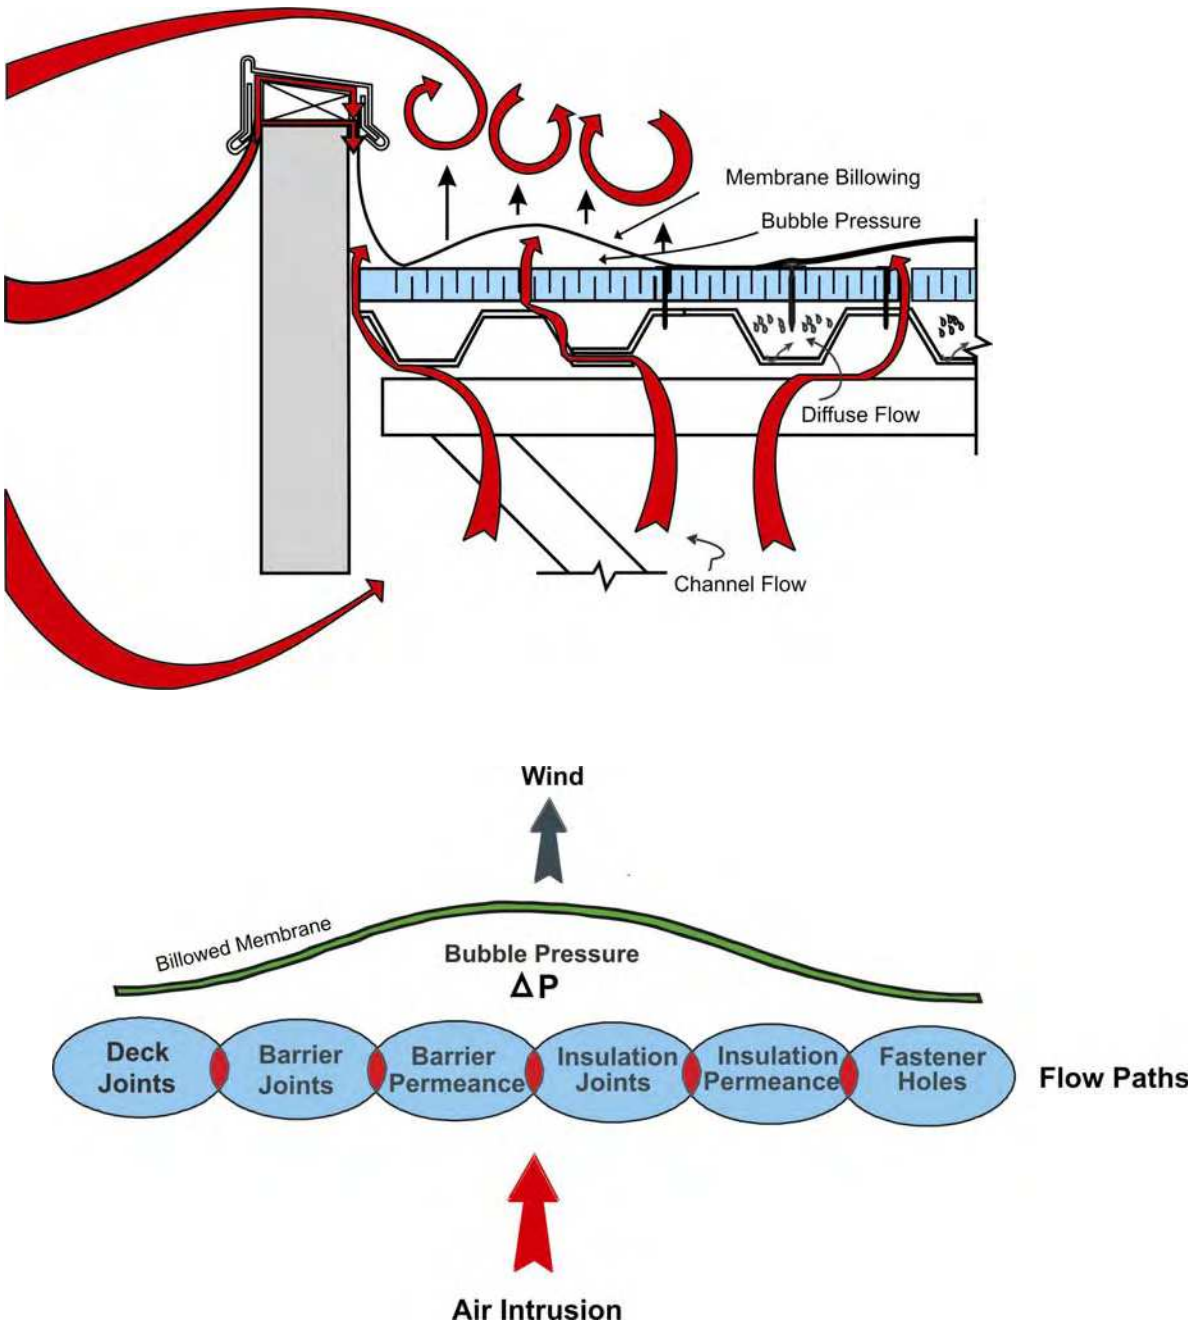
**Figure 1: Air leakage mechanism of MAA during wind uplift**

MAA meet these two prerequisites during wind uplift conditions. Figure 1 illustrates the airflow mechanism through MAA. The waterproof membrane, which acts as an air barrier/retarder, is placed on top of the insulation and attached to the structural steel deck using mechanical fasteners. The attachment locations are then overlapped and seamed. Wind induced suction lifts the membrane and causes membrane elongation and billowing between the attachments. The magnitude of the wind induced suction; the membrane's elastic properties and the fastening

pattern determine the deflection of the membrane billowing. The momentary displacement or billowing of the membrane creates a relative negative pressure below the lifted membrane and this draws indoor air into the roof, thereby satisfying the first prerequisite. The second prerequisite is met by the lack of airflow control at the deck level. Flow paths are created by the component's air permeability and joints/junctions/ penetrations in the roofing assembly.

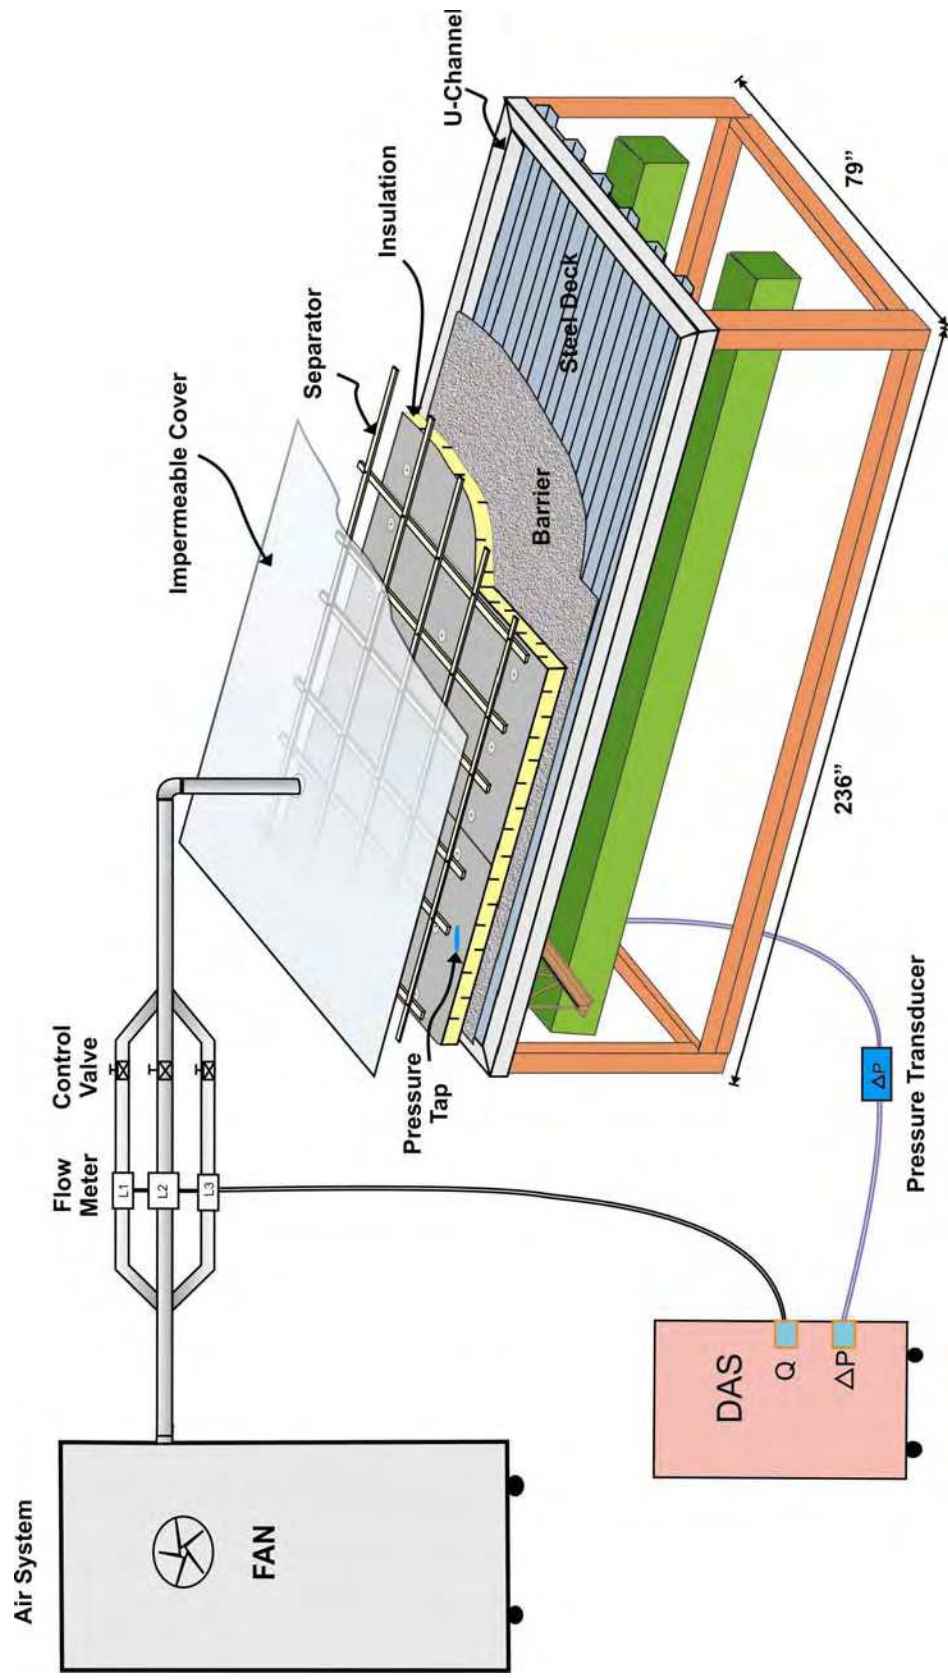
Figure 2: Experimental set-up for determination of air flow resistance of roofs

Recently, Molleti and Baskaran (2006) reported the details of the newly developed air leakage test method for roofing assemblies. Figure 2 illustrates the experimental setup developed for the air leakage quantification. As shown in Figure 2, the test frame has a dimension of 2 m x 6 m x 0.8 m (79" x 236" x 32"). The test specimen/roof assembly is installed in the frame, which is supported on a lifting mechanism with adjustable jacks. This feature allows for investigating different roofing assembly thicknesses accommodating different roofing components.

The relevant experimental quantities to be determined in an air leakage test method are the applied test pressure difference and the corresponding volumetric airflow rate. The applied test pressure difference across the test specimen is detected by using Setra differential pressure transducers, which have a measuring range up to 10 kPa (200 psf) and an accuracy of 0.14% of the full-scale reading, and the corresponding airflow rate is measured using Merriam laminar

flow elements with three flow ranges of 212 L/M (7.5 CFM), 1130 L/M (40 CFM) and 11300 L/M (400 CFM), depending on the air tightness of roofing assembly type. The output of the airflow and pressure measuring devices is connected to the data acquisition system (DAS), which records and plots the respective data on a GUI interface.

Following the above experimental setup (Figure 2) the present study quantified air leakage rate of five roofing assembly configurations. The five roofing assemblies are:

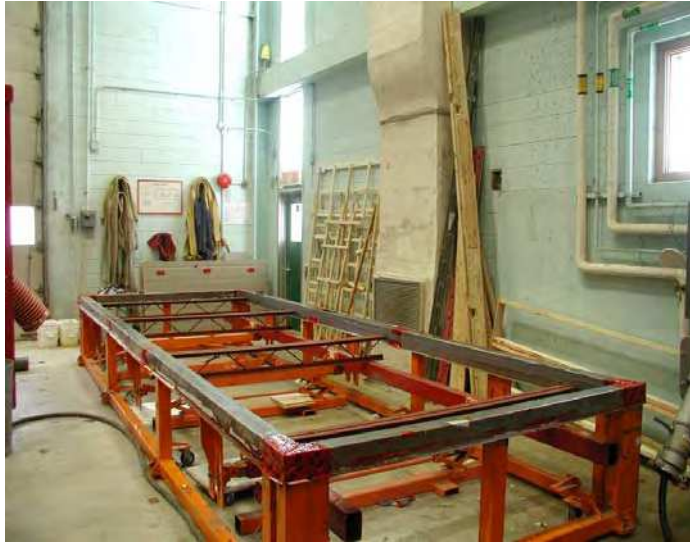
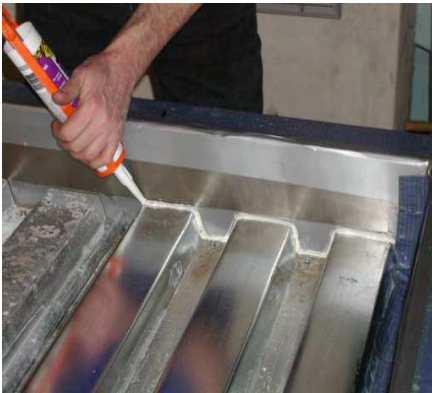
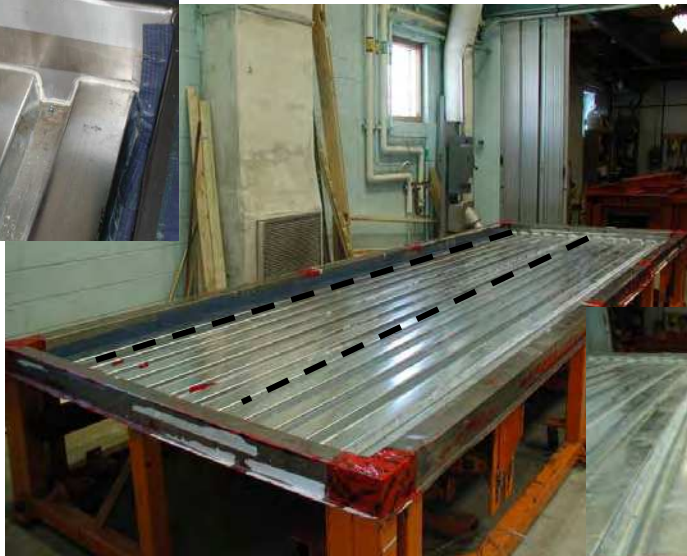
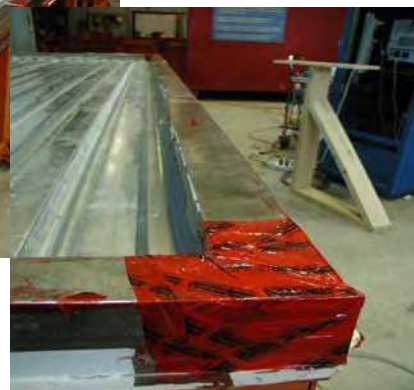
***Figure 3: Deck Installation and edge treatment***

This experimental set up is intended to measure the wind uplift resistance associated with the field zone of the roof. In order to achieve this, the edge treatment of the test assembly was handled by installing steel U-channels along the perimeter of the test frame as shown in Figure 3. As the width of table was 2006 mm (79”), one full sheet of 914 mm (36”) wide and two cut pieces of 610 mm (24”) and 483 mm (19”) wide steel decks were installed along the

table length as shown in Figure 5. The steel deck was 0.76 mm (22-Ga) thick with a profile height of 38 mm (1.5") and a flute width of 150 mm (5.9"). The black dotted lines indicate the deck overlaps. To eliminate the air leakage along the edges of the deck, the steel deck edges are butted to the U-channel, and the gap between them was sealed using sealant and adhesive membrane as shown in Figure 3. Thus, the field zone of the roof is simulated, assuring that the airflow occurs along the steel deck seams and not the deck edges.

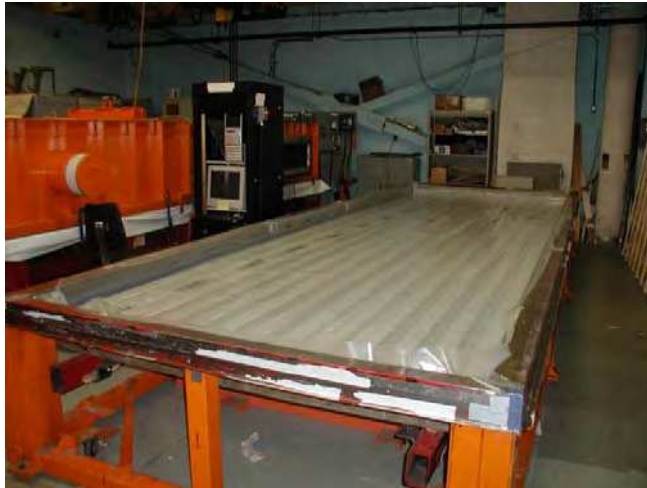
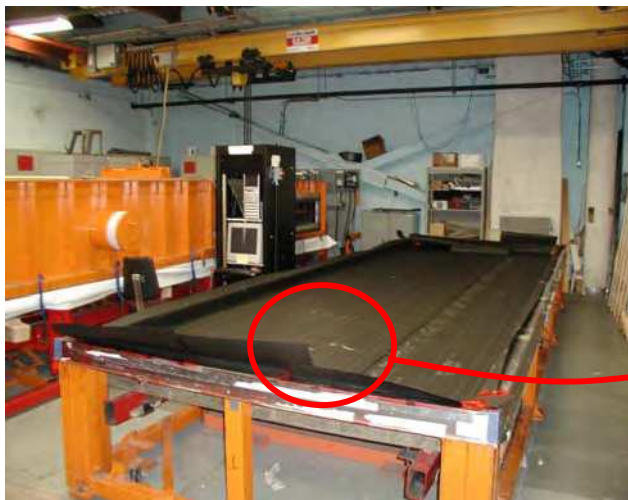
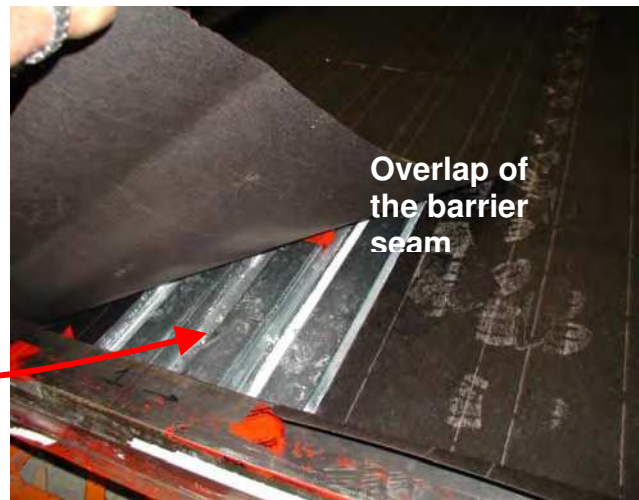
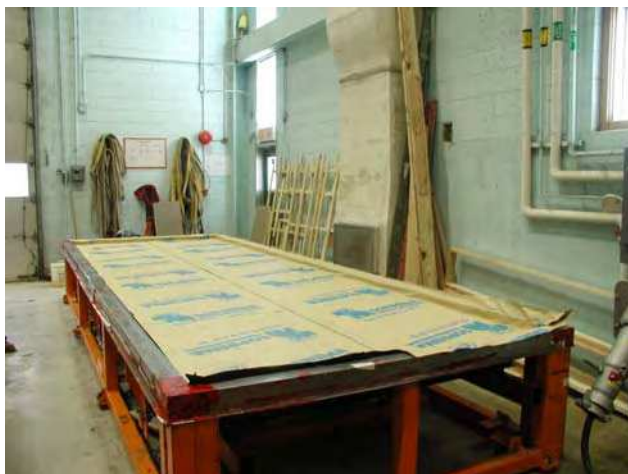
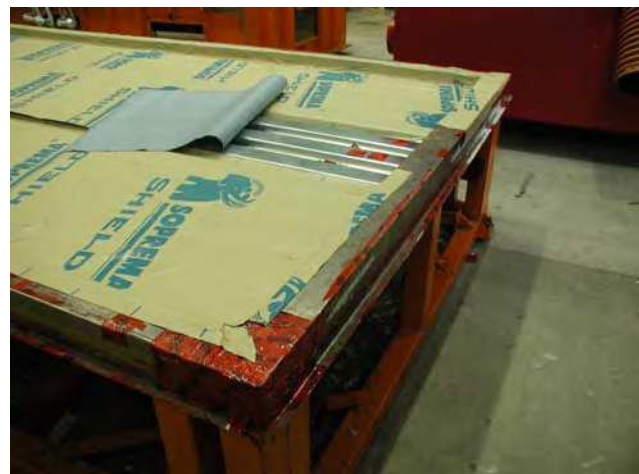
**Figure 4: Barrier Installation**

Figure 4 shows the installation of the three barriers/retarders. **A3** had building paper as the barrier/retarder and since the building paper comes in width of 914 mm (36") two full sheets of 914 mm (36") and one cut sheet of 457 mm (18") were laid on the steel deck. The sheets had an overlap of 152 mm (6") and by using adhesive (vapour-bloc glue) the overlaps were joined. The edges of the building paper were pulled and bent at 90° over the U channel and sealed to the U channel as shown in the Figure 4, and at the corners the building paper was cut at 45° and folded over the U-channel. **A4** had self adhered membrane sheet (SAM) as barrier/retarder and as SAM also comes in sheet widths of 914 mm (36") the installation procedure is similar to the building paper except this is a self-adhered film, which adheres directly to the top flange of the steel deck. For **A5**, a continuous sheet of polyethylene was

installed on the steel deck. The edges of the polyethylene sheet were pulled and bent at 90° over the U channel as shown in the Figure 4. The edge treatment of the polyethylene sheet was similar to the building paper in **A3**.

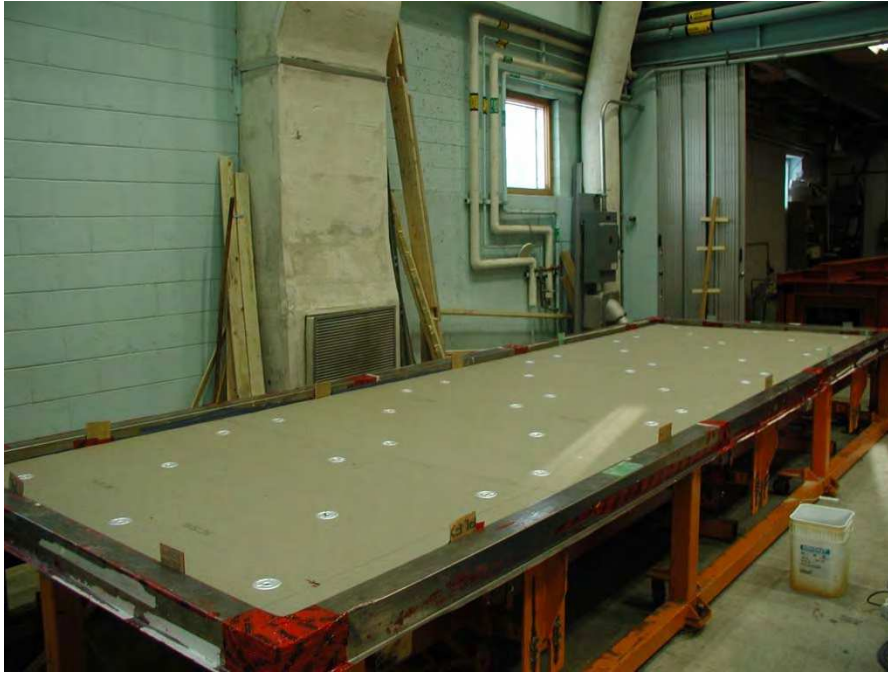
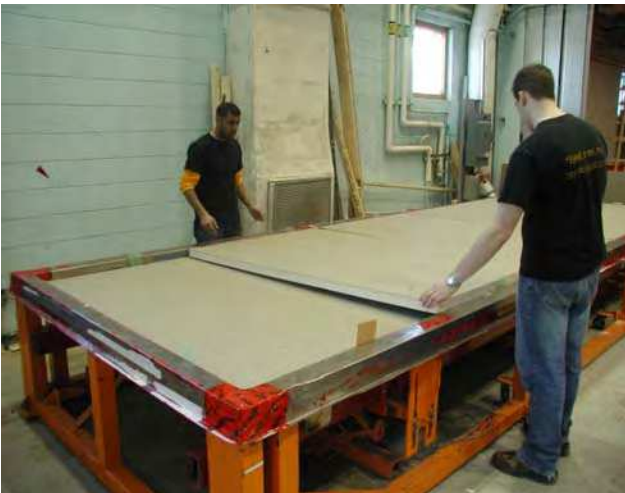
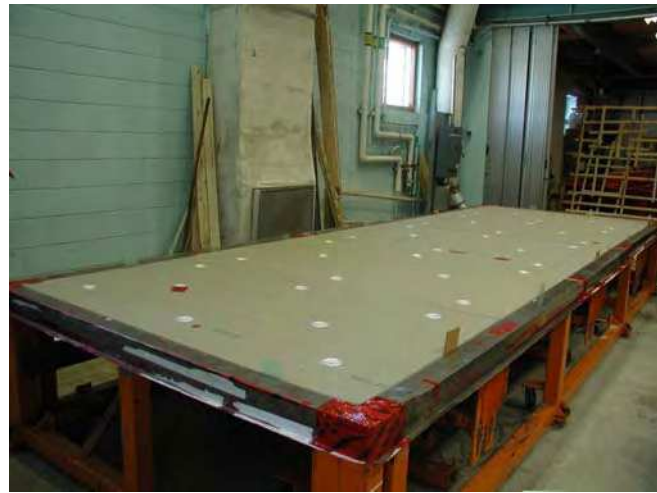
***Figure 5: Insulation installation***

Figure 5 illustrates the cross section view of the two-insulation layouts and Figure 6 shows the typical layout of insulation attachment. For all the five tested assemblies, 51 mm (2") thick polyisocyanurate boards with a compressive strength of 170 Kpa (25 psi) were used as the insulation. In **A1**, **A3**, **A4** and **A5** insulation configuration comprised of a layer of insulation with four full boards of 1219 mm x 2006 mm (48" x 79") and one partial board of 1118 mm x 2006 mm (44" x 79") installed with the long edges perpendicular to the deck flutes. In **A2**, the insulation layout is similar to the former assemblies except that it comprises of two layers of insulation in staggered arrangement. The insulation boards were mechanically fastened to the steel deck with 76 mm (3") diameter circular plastic plates and 127 mm (5") long fasteners. Each insulation board was attached with 8 fasteners, which has a fastener density of one fastener per 0.3 m<sup>2</sup> (3.3 ft<sup>2</sup>)

**(a) One Layer Insulation**

**(b) Two layer staggered insulation**

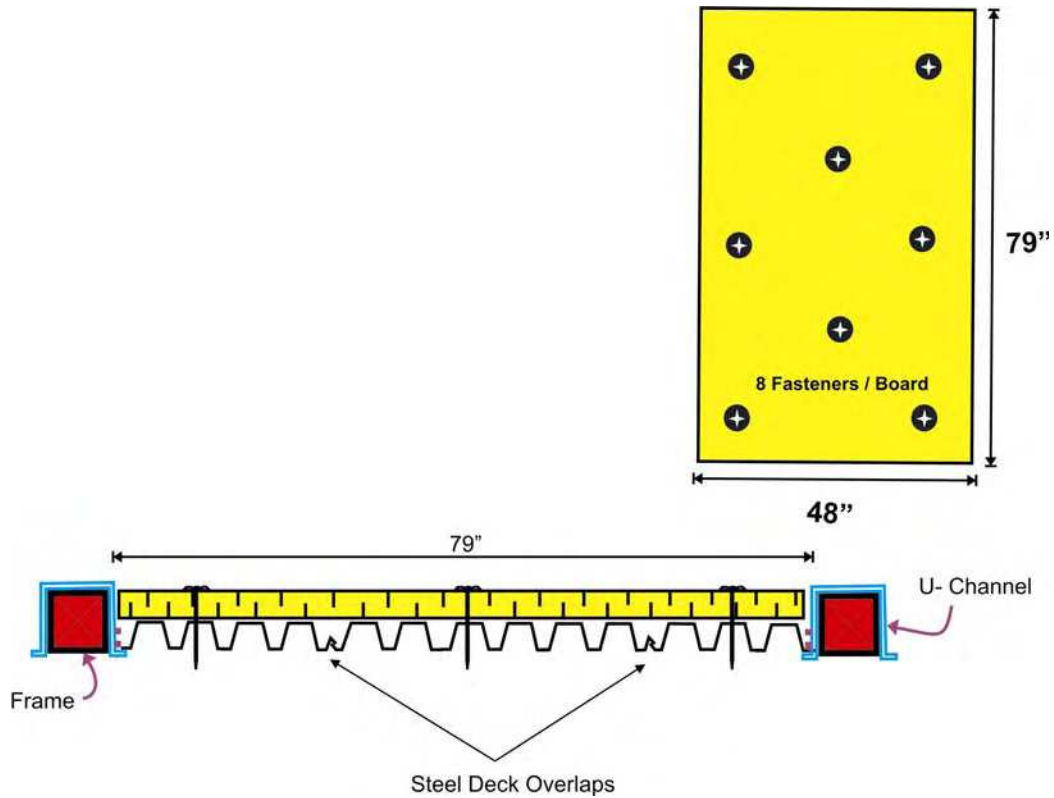
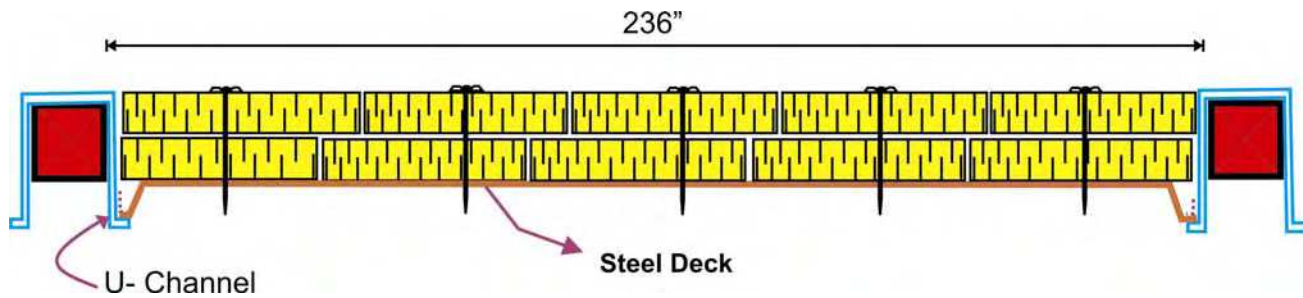
**Figure 6: Cross-sectional layout of the insulation installation**

**(a) One layer insulation layout (Front view along the table width)**

**(a) Two layer staggered insulation layout (Side view along the table length)**

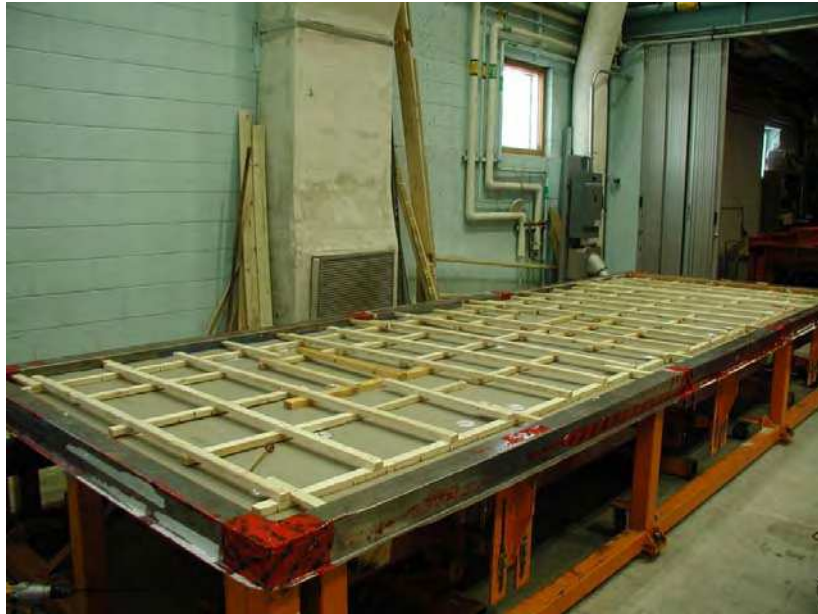
***Figure 7: Installation of the separator***

With the insulation in position and fastened to the deck, a square meshed wooden separator was installed on top of the insulation as shown in Figure 7. The role of the separator is to provide the gap or space between the test specimen and the impermeable cover for creating uniform differential pressure across the specimen and for allowing the airflow without any obstruction. A minimum gap of 50mm (2") was maintained for this purpose. After the completion of the separator installation, two pressure taps are installed on either ends of the test specimen. These pressure taps measure the differential pressure across the test specimen.

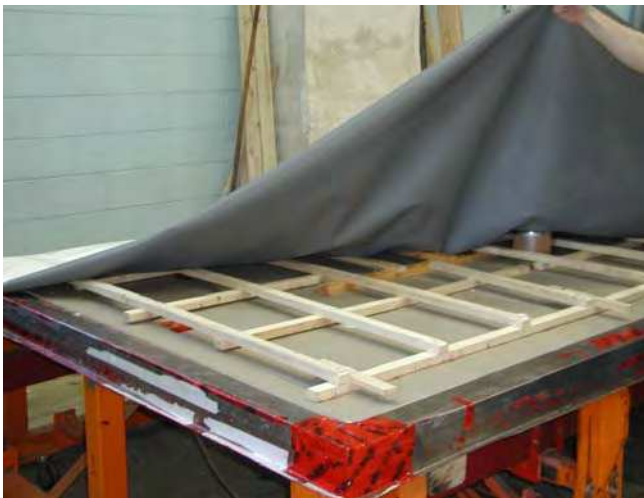
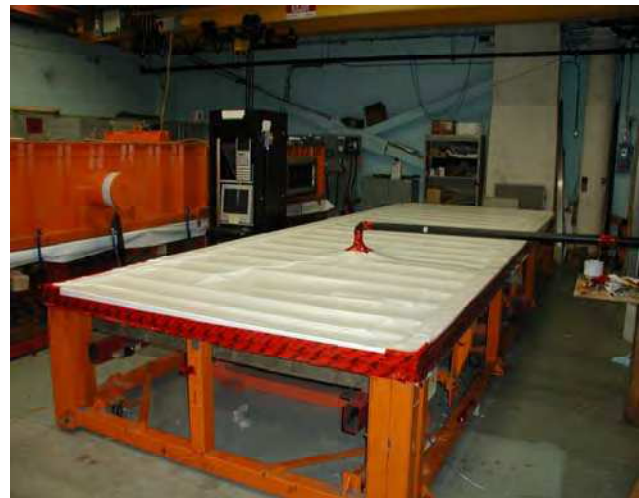
***Figure 8: Installation of the impermeable cover***

A continuous sheet of impermeable cover as shown in Figure 8, was laid on top of the

separator. The overhang edges of the impermeable cover were adhered to the frame edges, thus eliminating any extraneous airflow into the test specimen. Provisions were made to install the flow measurement setup by making a 50 mm (2") diameter opening on top of the impermeable cover. One end of the flow measurement setup has an air filter, which was inserted into the test specimen, and the other end was connected to the air system. In between them, the flow-measuring device and the adjustable control valve were installed. The former measures the airflow rate and the latter controls the applied pressure.

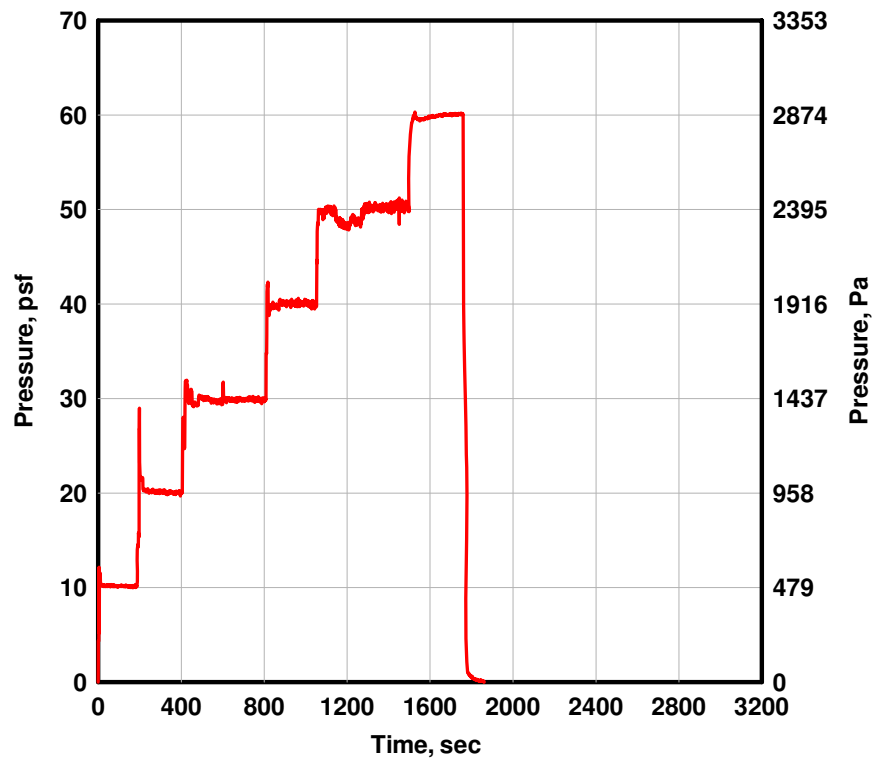
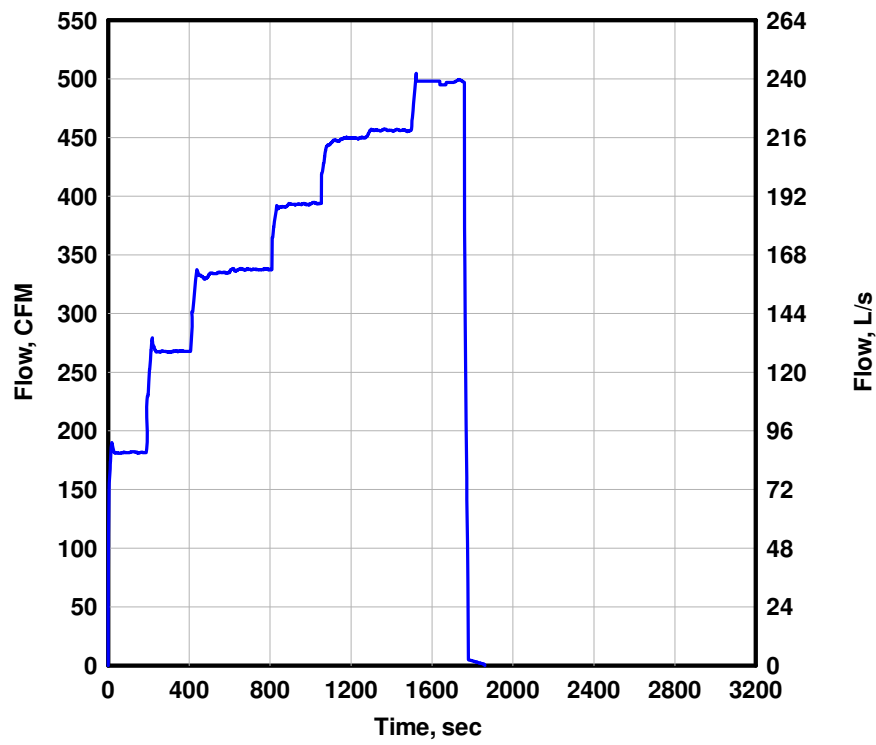
**Figure 9: Measured pressure and flow time histories of A1**

Figures 9 and 10 shows a typical measured pressure and flow time histories of two assemblies, one without barrier/retarder (**A1**) and other with barrier/retarder (**A5**) respectively. The pressure

time history is a measure to verify whether the applied pressure equals the target pressure of the test protocol. The applied pressure at each pressure level comprises of three parts: 1) Pressure Build-up 2) Pressure Stabilization 3) Pressure Measured (Molleti and Baskaran, 2006). As per the test procedure, the pressure is measured for a minimum duration of 60 secs after it stabilizes. The pressure stabilization varies from assembly to assembly and is dependent on the air tightness of the tested assemblies, which leads to varying testing time as shown on the X-axis of the Figures 9 and 10. Error analysis was performed between the target pressures and the measured pressure for all the assemblies. Data indicates that the measured pressure showed an error of 0.2% deviation from the target. As shown in Figure 10, the peaks in the pressure measurement for both the assemblies can be attributed to the manual operation of the control valve.

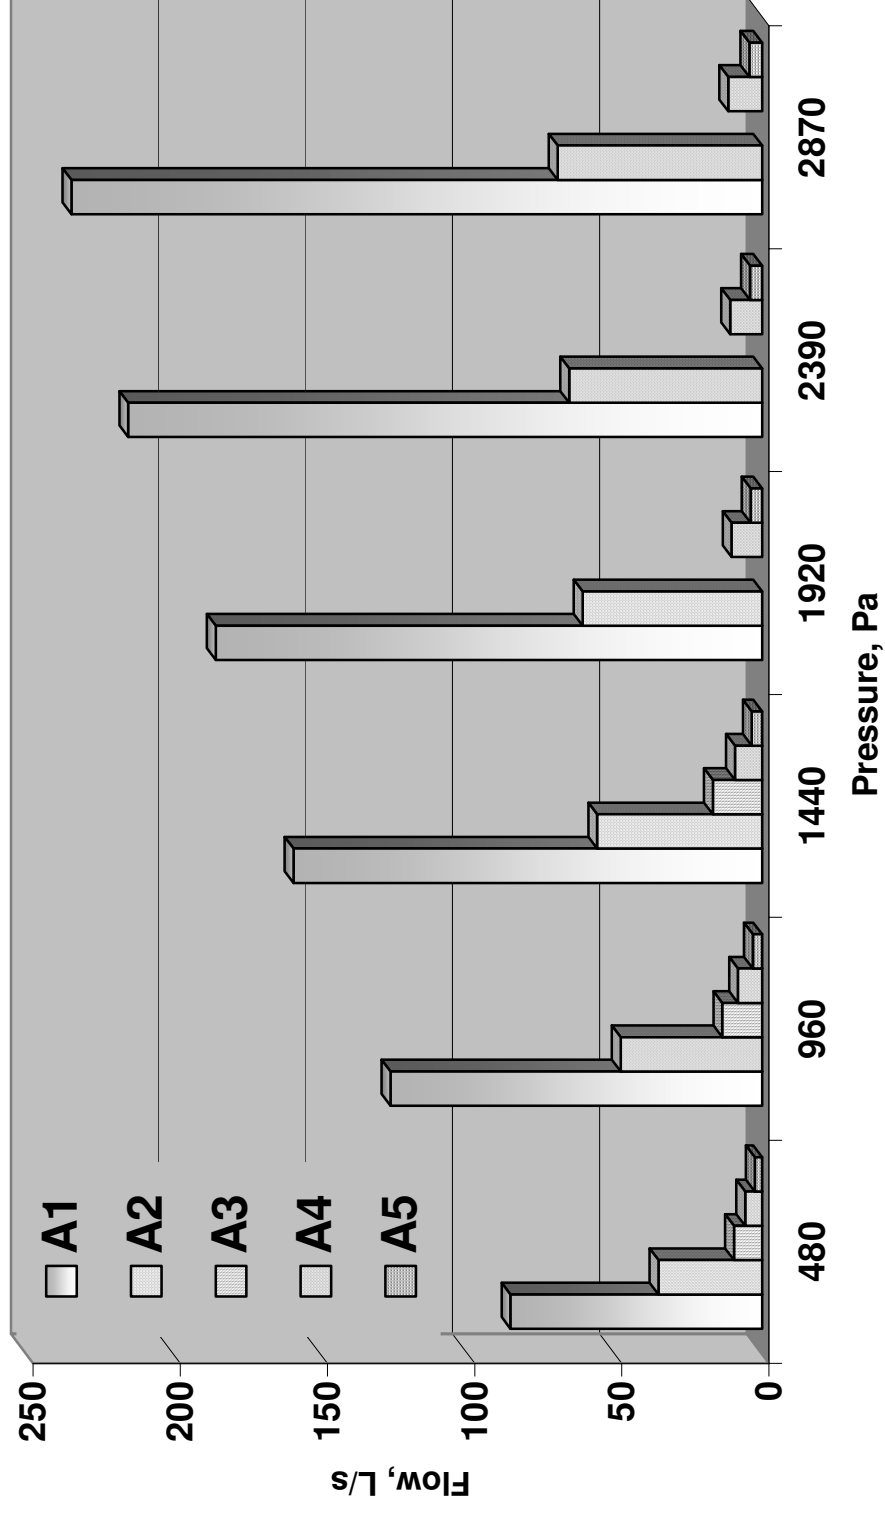
Figure 11: Air leakage rate of the five tested assemblies

Figure 11 presents the measured air leakage rate of the five assemblies. Data clearly indicates that **A1** and **A2** without barrier/retarder had a greater leakage rate when compared to the assemblies with barrier/retarder namely **A3**, **A4** and **A5**. The present study also attempts to answer whether the staggered arrangement of insulation boards as in **A2** can be as effective as that of having a barrier/retarder in an assembly. The comparison of the data from Figure 11 points out that the staggered arrangement of insulation in **A2** certainly provided the air retarding effect in comparison to **A1**, however it proved to be not as effective as the assemblies with

barrier/retarder (**A3**, **A4**, & **A5**). It is also to be noted that in Figure 11, no air leakage data is presented for **A3** (*with building paper*) beyond 1440 Pa (30 psf). The reason was, during the air leakage testing of **A3**, at one corner a 45° cut made in the building paper opened up or enlarged. This lead to a drastic increase in the airflow rate and as a result the test was stopped. Irrespective of this drawback **A3** provided a good air retarding effect upto 1440 Pa (30 psf).

High leakage rate of **A1** can be attributed to the channel flow occurring at the deck and insulation joints. With the inclusion of another layer of insulation, **A2**, did provide good air leakage resistance by reducing 65% of air intrusion, however it could not be as effective as assemblies with a barrier/retarder. The channel flow between the joints in the insulation boards was providing the necessary flow path for air movement into the assembly. **A4** and **A5** with self adhered film and polyethylene sheet as barriers/retarders, showed good air leakage resistance. The reduced air leakage resistance of **A3** could be mainly attributed to the seam joints and corner edge treatments of the building paper. It should be noted that the building paper being a soft material, if not properly installed has a tendency to tear. Within the assemblies with barrier/retarders, **A5** showed better air leakage resistance by reducing airflow by 75% and 60% compared to **A3** and **A4**. However, it should be noted here that the polyethylene sheet in **A5** was continuous without any seam joints, which represents the best-case scenario.

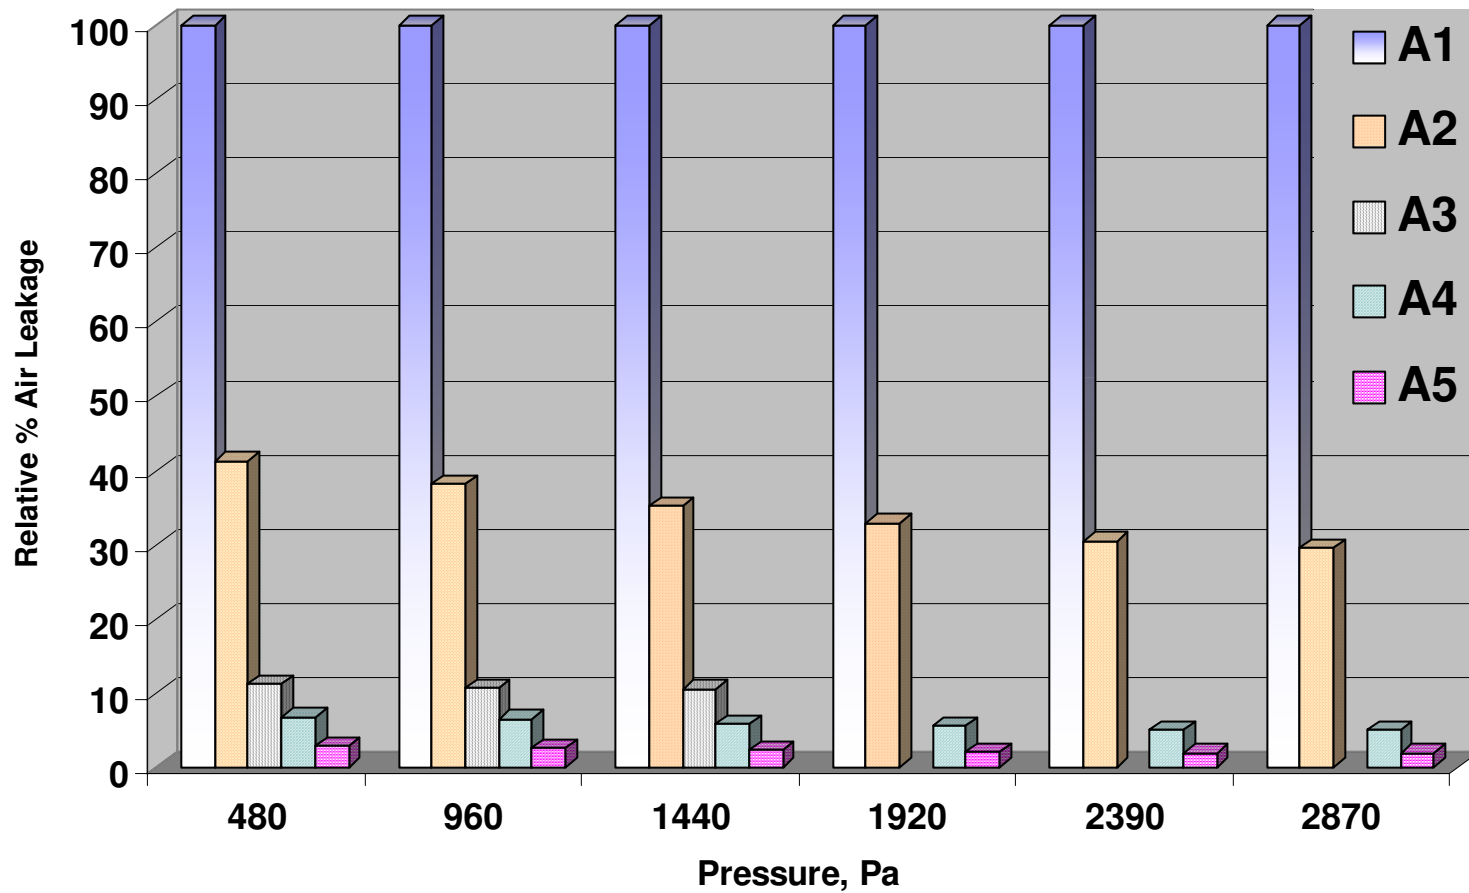
*Figure 12: Relative comparison of the air leakage resistance of the tested assemblies with respect to A1*

To further illustrate the relative performance of the air retarding effect of the different assemblies, Figure 12 presents the percentage air leakage of the assemblies relative to **A1**. To get a better understanding, a typical pressure of 1440 Pa (30 psf) was selected for the following discussion. If it is assumed that **A1** without any barrier/retarder had 100% air leakage, then relative to the air leakage of **A1**, observations can be summarized as follows:

- **A2** with staggered insulation has 35% of air leakage of **A1** or air leakage reduced by 65%
- **A3** with building paper has 10% of air leakage of **A1** or air leakage reduced by 90%
- **A4** with self-adhered film 6% of air leakage of **A1** or air leakage reduced by 94%,
- **A5** with polyethylene sheet has 2% of air leakage of **A1** or air leakage reduced by 98%

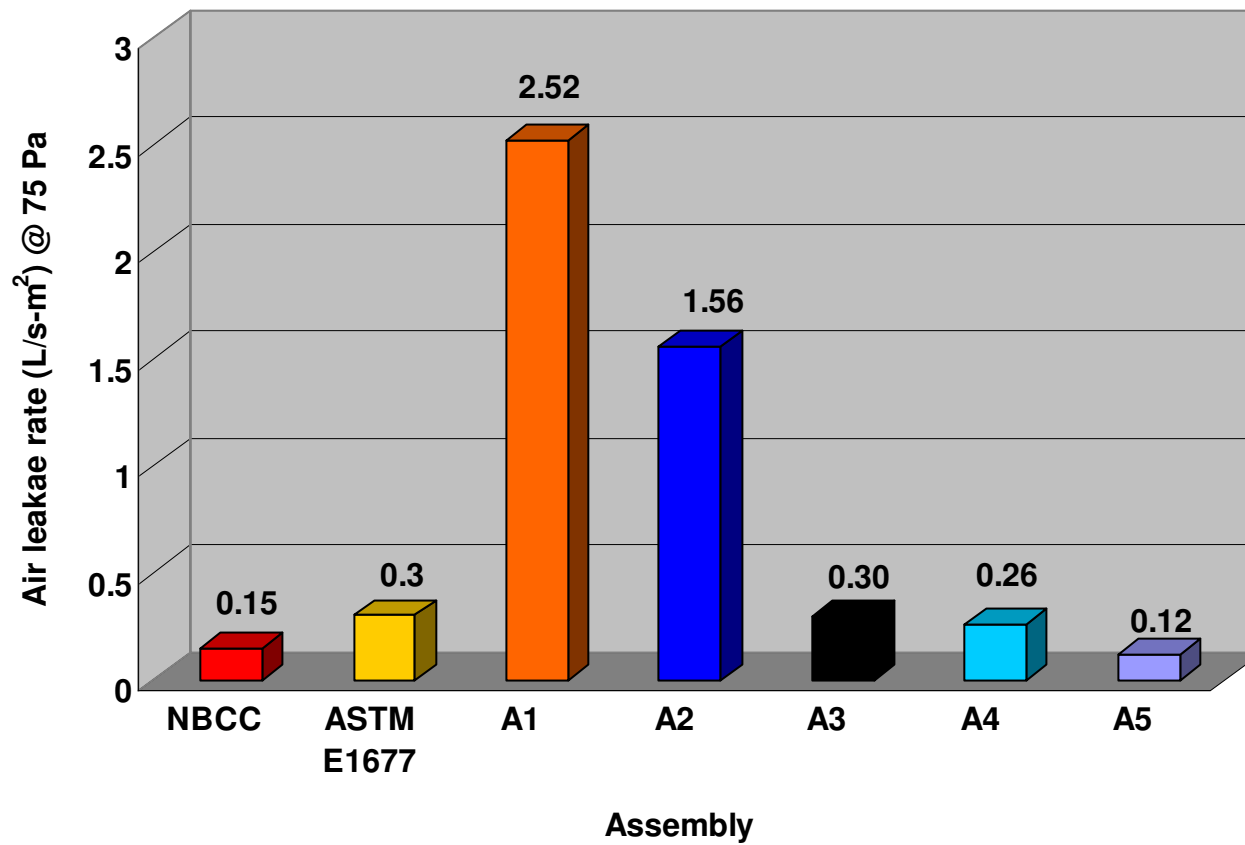
**Figure 13: Comparison of measured air leakage with the existing codes of practice and standard**

For an air barrier/retarder system in opaque, insulated portions of the building envelope, Part 5 of the NBCC (2005) recommends three permissible air leakage rates corresponding to various indoor humidity levels as shown in Table 1. To verify whether the tested assemblies comply with this code requirement, air leakage rates of the five assemblies were calculated at 75 Pa (1.56 psf) and compared with the NBCC [based on the laboratory testing condition 0.15 L/s.m<sup>2</sup> (0.03 ft<sup>3</sup>/min.ft<sup>2</sup>) was selected] as shown in Figure 13. **A1** had a leakage rate of 2.52 L/s.m<sup>2</sup> (0.5 ft<sup>3</sup>/min.ft<sup>2</sup>), **A2** had 1.56 L/s.m<sup>2</sup> (0.31 ft<sup>3</sup>/min.ft<sup>2</sup>), **A3** had 0.30 L/s.m<sup>2</sup> (0.06 ft<sup>3</sup>/min.ft<sup>2</sup>), **A4** had 0.26 L/s.m<sup>2</sup> (0.051 ft<sup>3</sup>/min.ft<sup>2</sup>) and **A5** had 0.12 L/s.m<sup>2</sup> (0.023 ft<sup>3</sup>/min.ft<sup>2</sup>) respectively. Comparison of these data with the NBCC indicates that none of the assemblies except **A5** comply with the NBCC code requirement. However, once again it should be remembered here that the assembly set-up of **A5** represents the idealistic construction procedure having proper edge treatment and no seam joints, which has achieved its end result demonstrating the significance of air intrusion. Similarly, ASTM E1677-2005, Standard Specification for an Air Barrier (AB) Material or System for Low-Rise Framed Building Walls, calls for an assembly air permeance requirement of 0.30 L/s.m<sup>2</sup> (0.06 ft<sup>3</sup>/min.ft<sup>2</sup>) at 75 Pa (1.5 psf). However, the standard restricts this permissible leakage rate to the opaque walls. Therefore, the comparison presented in Figure 13 relative to ASTM E1677 is not really applicable to roofing assemblies, however, it signifies the necessity of similar air leakage resistance requirement for roofing assemblies.

Analogous to the ASTM E1677, it should be noted here that the NBCC (2005) recommended air leakage rates are also the outcome of the research pertaining to walls, which have been generalized as a requirement for air barrier/retarder systems in opaque, insulated portions of the building envelope. Once again, though the comparison in Figure 13 might not reflect the air leakage resistance requirement of roofing assemblies, it has clearly achieved its end result clearly demonstrating the significance of air leakage into the roofing assembly and the necessity of developing air leakage test standard for roofing assemblies with recommended
