Tracking the elusive leak

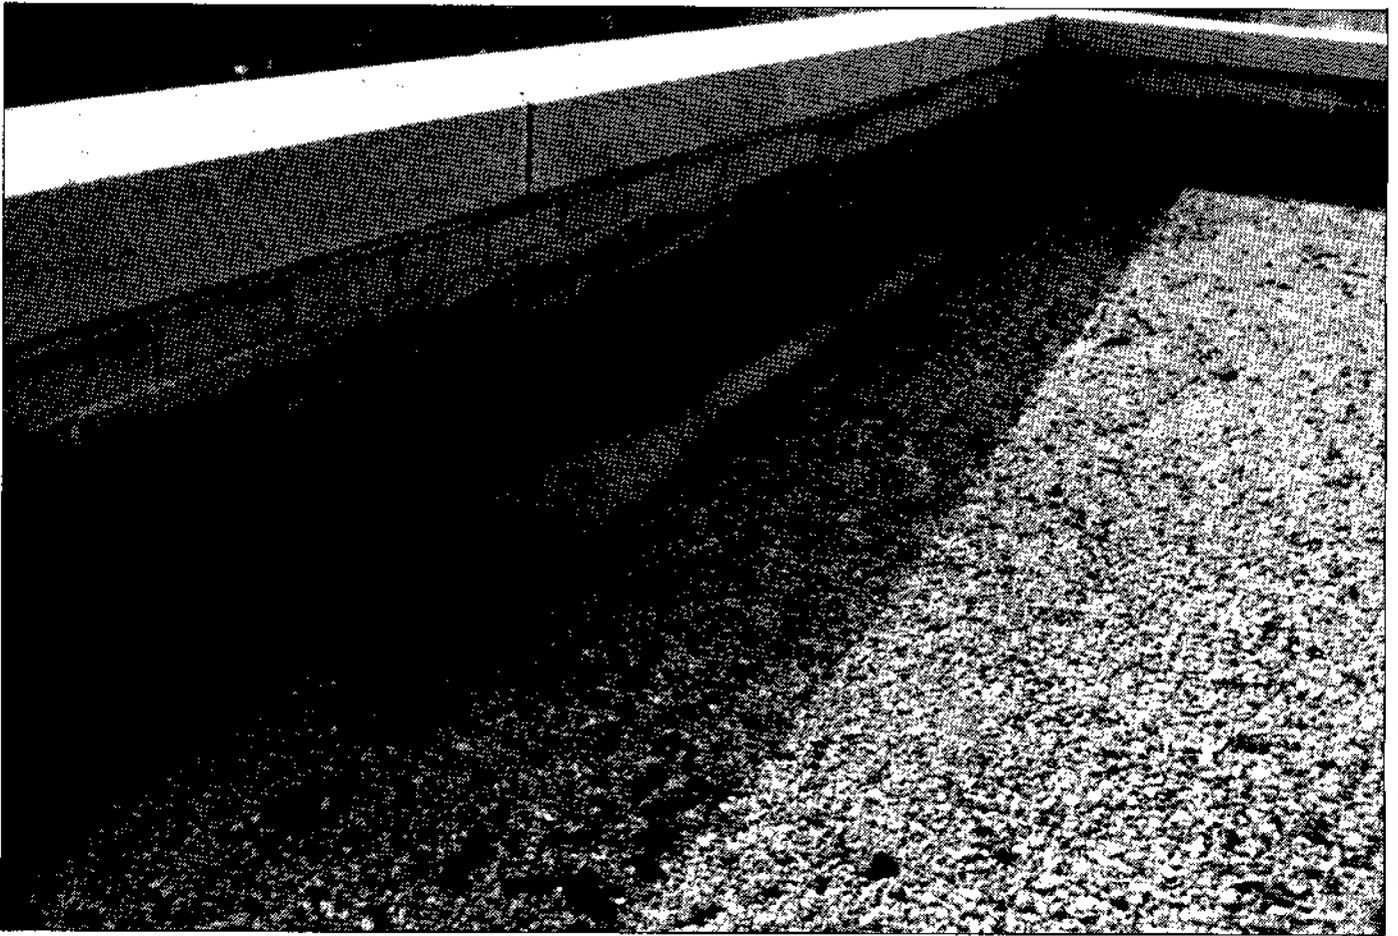
Sagging, open flashings are frequently found to be the leak's point of entry.

Sagging, open flashings are frequently found to be the leak's point of entry. Base flashings are also common sources of problems such as punctures, especially where there is heavy foot traffic. Opened or separated laps in the base flashing or diagonal wrinkles that have cracked may also allow water to enter. Some of these problems may be discovered if the investigator walks along the base flashing and presses on bulging areas.
