NRCC-49438

Molleti, S.; Baskaran, B.A.

A New Test Method for Quantifying Air Leakage of a Mechanically-Attached Roofing Assembly

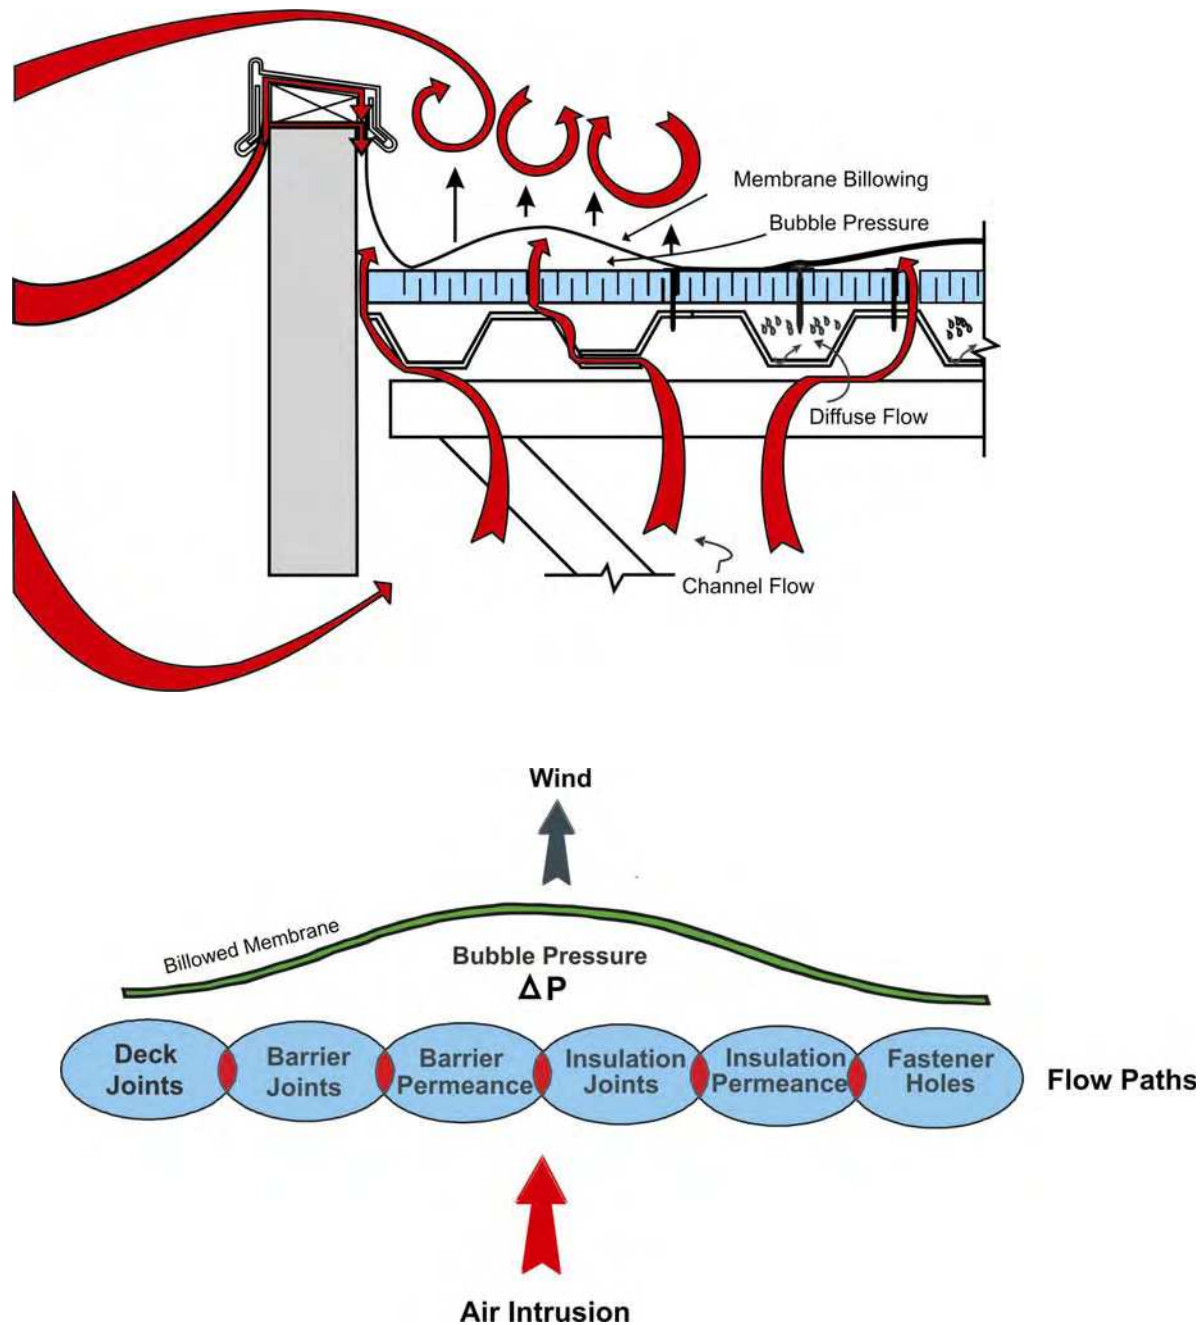
Figure 1: Air leakage mechanism of MAA during wind uplift

MAA meet these two prerequisites during wind uplift conditions. Figure 1 illustrates the airflow mechanism through MAA. The waterproof membrane, which acts as an air barrier/retarder, is placed on top of the insulation and attached to the structural steel deck using mechanical fasteners. The attachment locations are then overlapped and seamed. Wind induced suction lifts the membrane and causes membrane elongation and billowing between the attachments. The magnitude of the wind induced suction; the membrane's elastic properties and the fastening

pattern determine the deflection of the membrane billowing. The momentary displacement or billowing of the membrane creates a relative negative pressure below the lifted membrane and this draws indoor air into the roof, thereby satisfying the first prerequisite. The second prerequisite is met by the lack of airflow control at the deck level. Flow paths are created by the component's air permeability and joints/junctions/ penetrations in the roofing assembly.

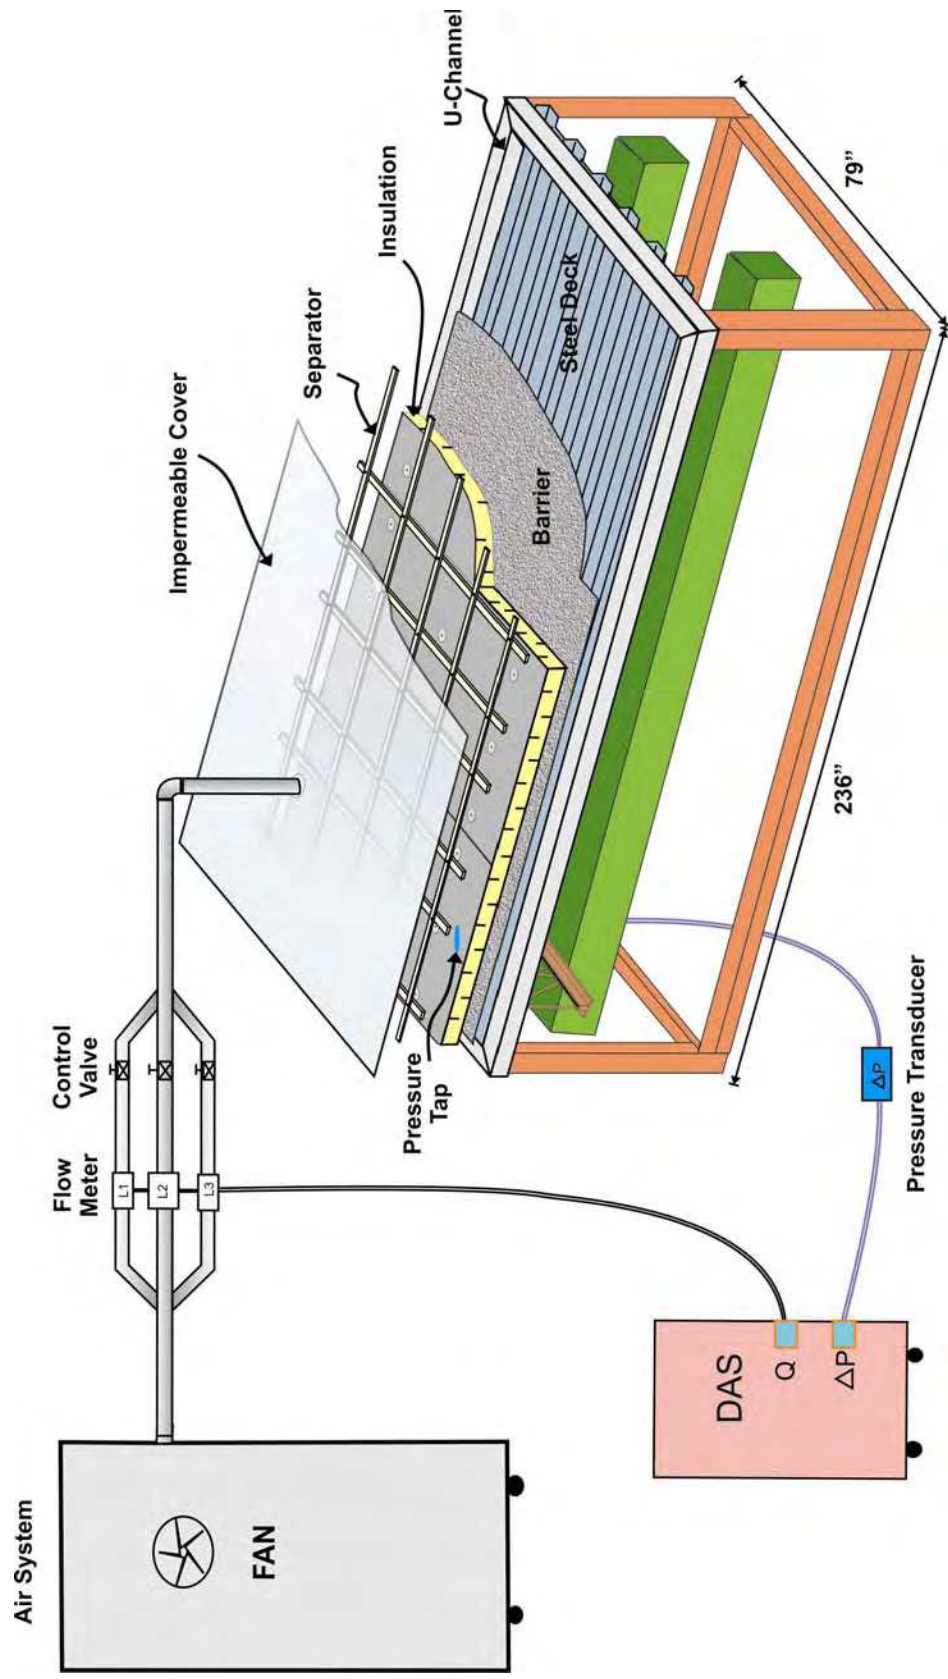
Figure 2: Experimental set-up for determination of air flow resistance of roofs

Recently, Molleti and Baskaran (2006) reported the details of the newly developed air leakage test method for roofing assemblies. Figure 2 illustrates the experimental setup developed for the air leakage quantification. As shown in Figure 2, the test frame has a dimension of 2 m x 6 m x 0.8 m (79" x 236" x 32"). The test specimen/roof assembly is installed in the frame, which is supported on a lifting mechanism with adjustable jacks. This feature allows for investigating different roofing assembly thicknesses accommodating different roofing components.

Following the above experimental setup (Figure 2) the present study quantified air leakage rate of five roofing assembly configurations. The five roofing assemblies are:

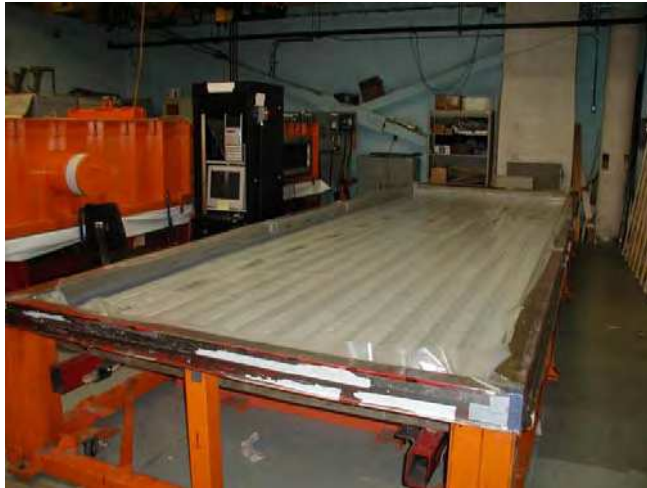
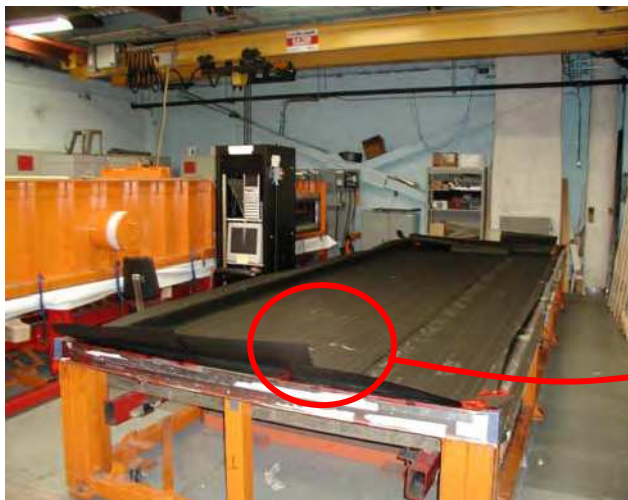
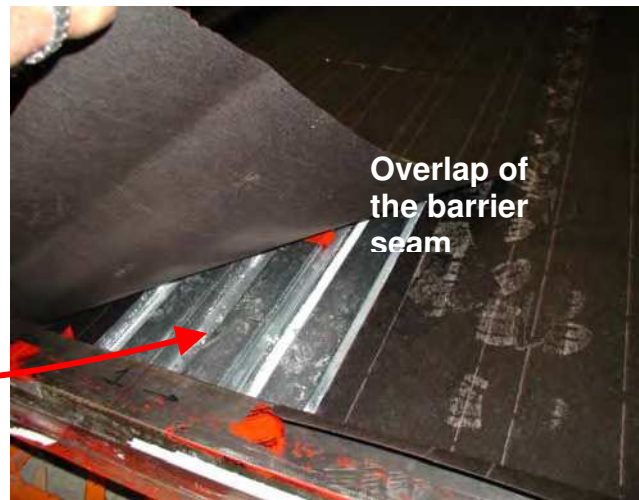
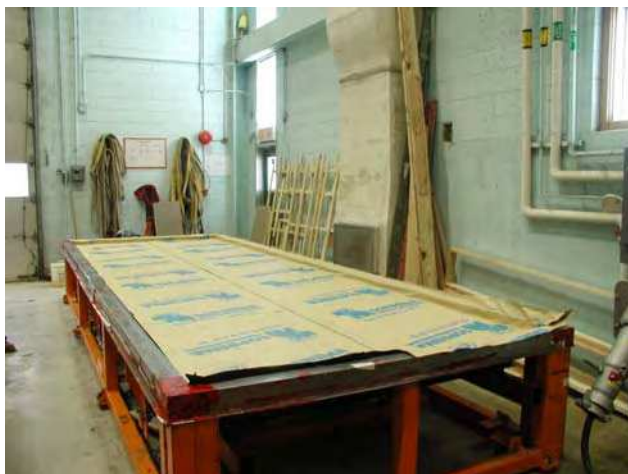
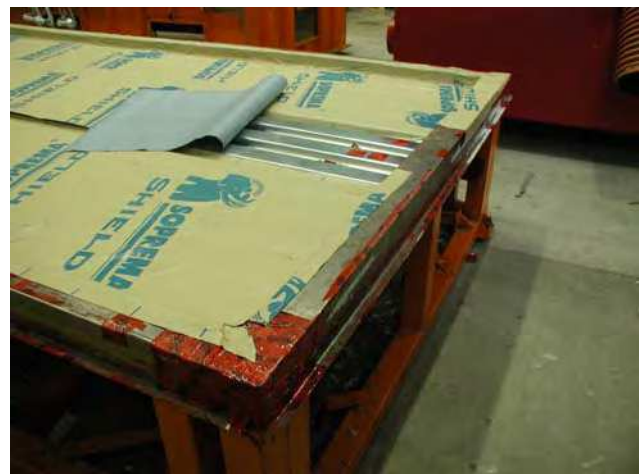
Figure 4: Barrier Installation

Figure 4 shows the installation of the three barriers/retarders. **A3** had building paper as the barrier/retarder and since the building paper comes in width of 914 mm (36") two full sheets of 914 mm (36") and one cut sheet of 457 mm (18") were laid on the steel deck. The sheets had an overlap of 152 mm (6") and by using adhesive (vapour-bloc glue) the overlaps were joined. The edges of the building paper were pulled and bent at 90° over the U channel and sealed to the U channel as shown in the Figure 4, and at the corners the building paper was cut at 45° and folded over the U-channel. **A4** had self adhered membrane sheet (SAM) as barrier/retarder and as SAM also comes in sheet widths of 914 mm (36") the installation procedure is similar to the building paper except this is a self-adhered film, which adheres directly to the top flange of the steel deck. For **A5**, a continuous sheet of polyethylene was

installed on the steel deck. The edges of the polyethylene sheet were pulled and bent at 90° over the U channel as shown in the Figure 4. The edge treatment of the polyethylene sheet was similar to the building paper in **A3**.

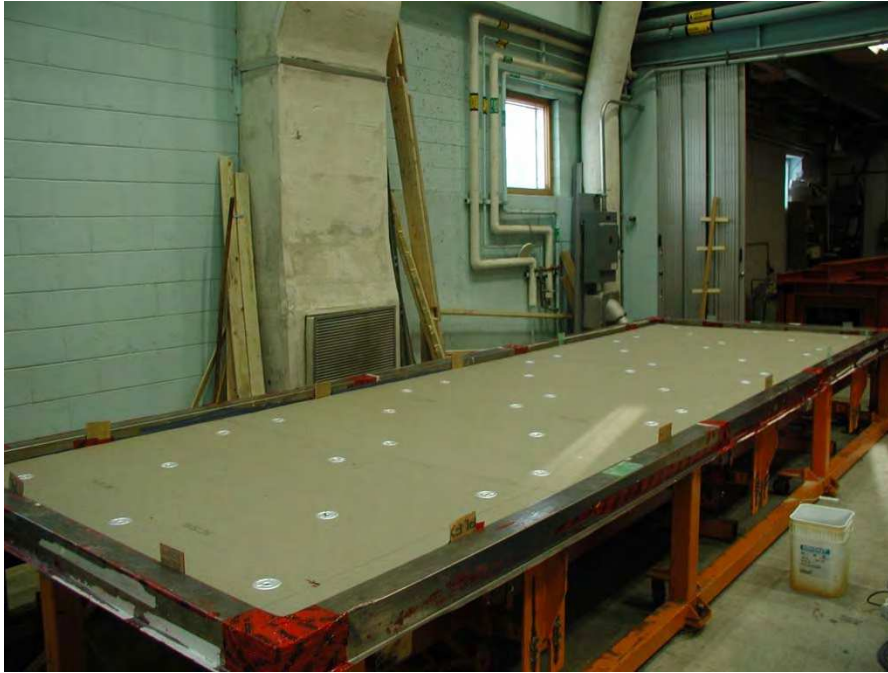
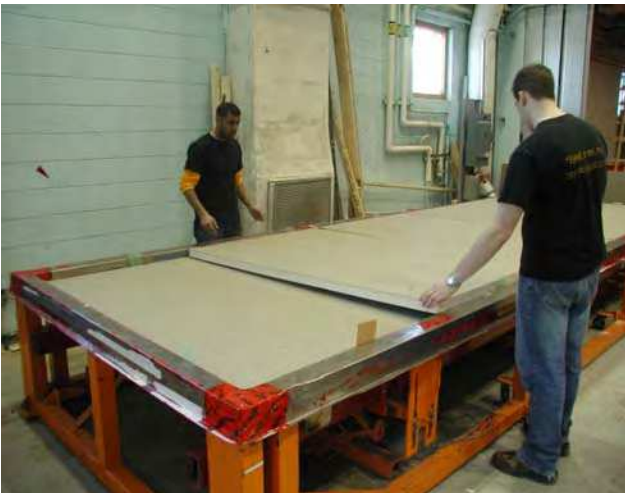
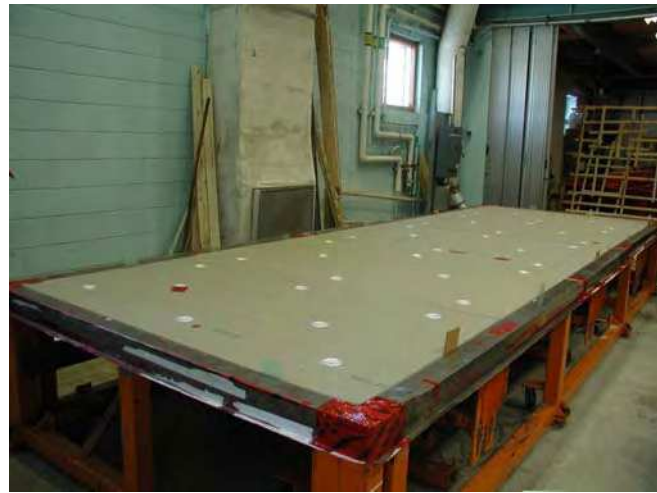
(a) One Layer Insulation

(b) Two layer staggered insulation

Figure 5: Insulation installation

Figure 5 illustrates the cross section view of the two-insulation layouts and Figure 6 shows the typical layout of insulation attachment. For all the five tested assemblies, 51 mm (2") thick polyisocyanurate boards with a compressive strength of 170 Kpa (25 psi) were used as the insulation. In **A1**, **A3**, **A4** and **A5** insulation configuration comprised of a layer of insulation with four full boards of 1219 mm x 2006 mm (48" x 79") and one partial board of 1118 mm x 2006 mm (44" x 79") installed with the long edges perpendicular to the deck flutes. In **A2**, the insulation layout is similar to the former assemblies except that it comprises of two layers of insulation in staggered arrangement. The insulation boards were mechanically fastened to the steel deck with 76 mm (3") diameter circular plastic plates and 127 mm (5") long fasteners. Each insulation board was attached with 8 fasteners, which has a fastener density of one fastener per 0.3 m² (3.3 ft²)

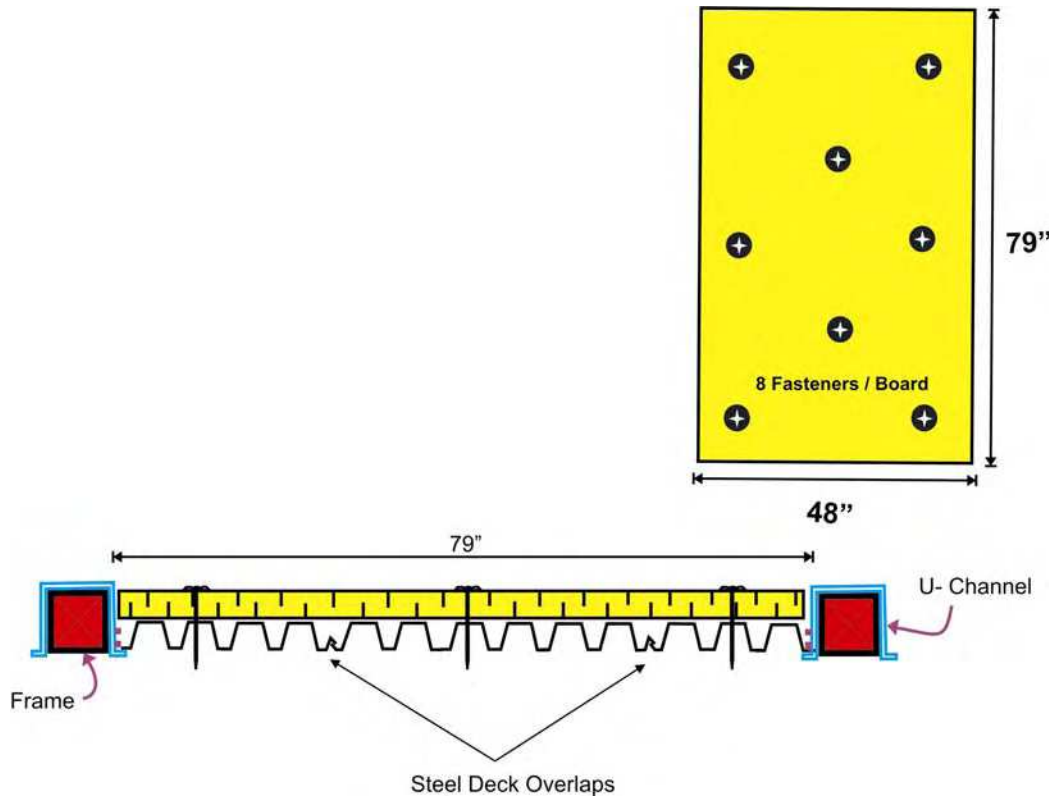
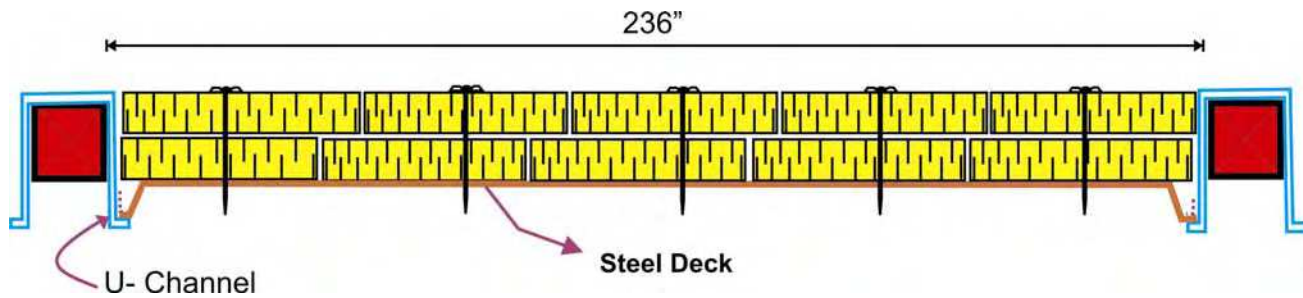
(a) One layer insulation layout (Front view along the table width)

(a) Two layer staggered insulation layout (Side view along the table length)

Figure 6: Cross-sectional layout of the insulation installation

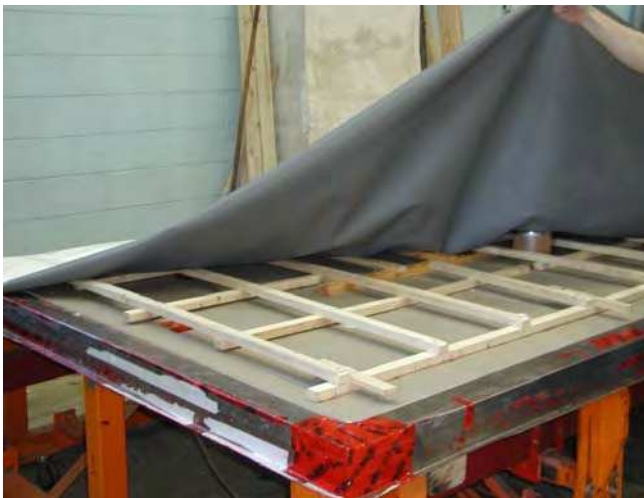
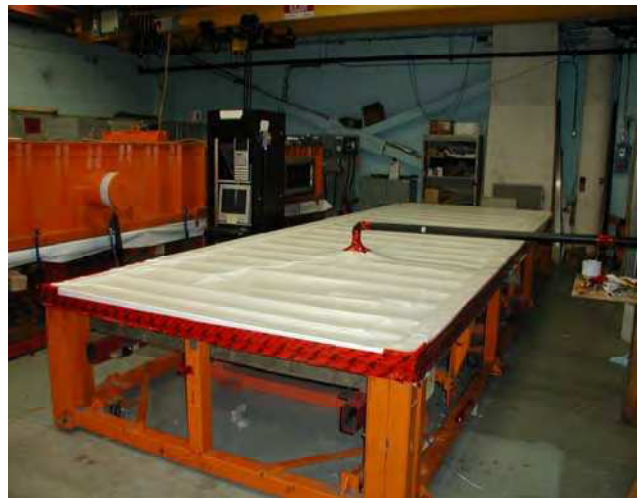
Figure 8: Installation of the impermeable cover

A continuous sheet of impermeable cover as shown in Figure 8, was laid on top of the

separator. The overhang edges of the impermeable cover were adhered to the frame edges, thus eliminating any extraneous airflow into the test specimen. Provisions were made to install the flow measurement setup by making a 50 mm (2") diameter opening on top of the impermeable cover. One end of the flow measurement setup has an air filter, which was inserted into the test specimen, and the other end was connected to the air system. In between them, the flow-measuring device and the adjustable control valve were installed. The former measures the airflow rate and the latter controls the applied pressure.

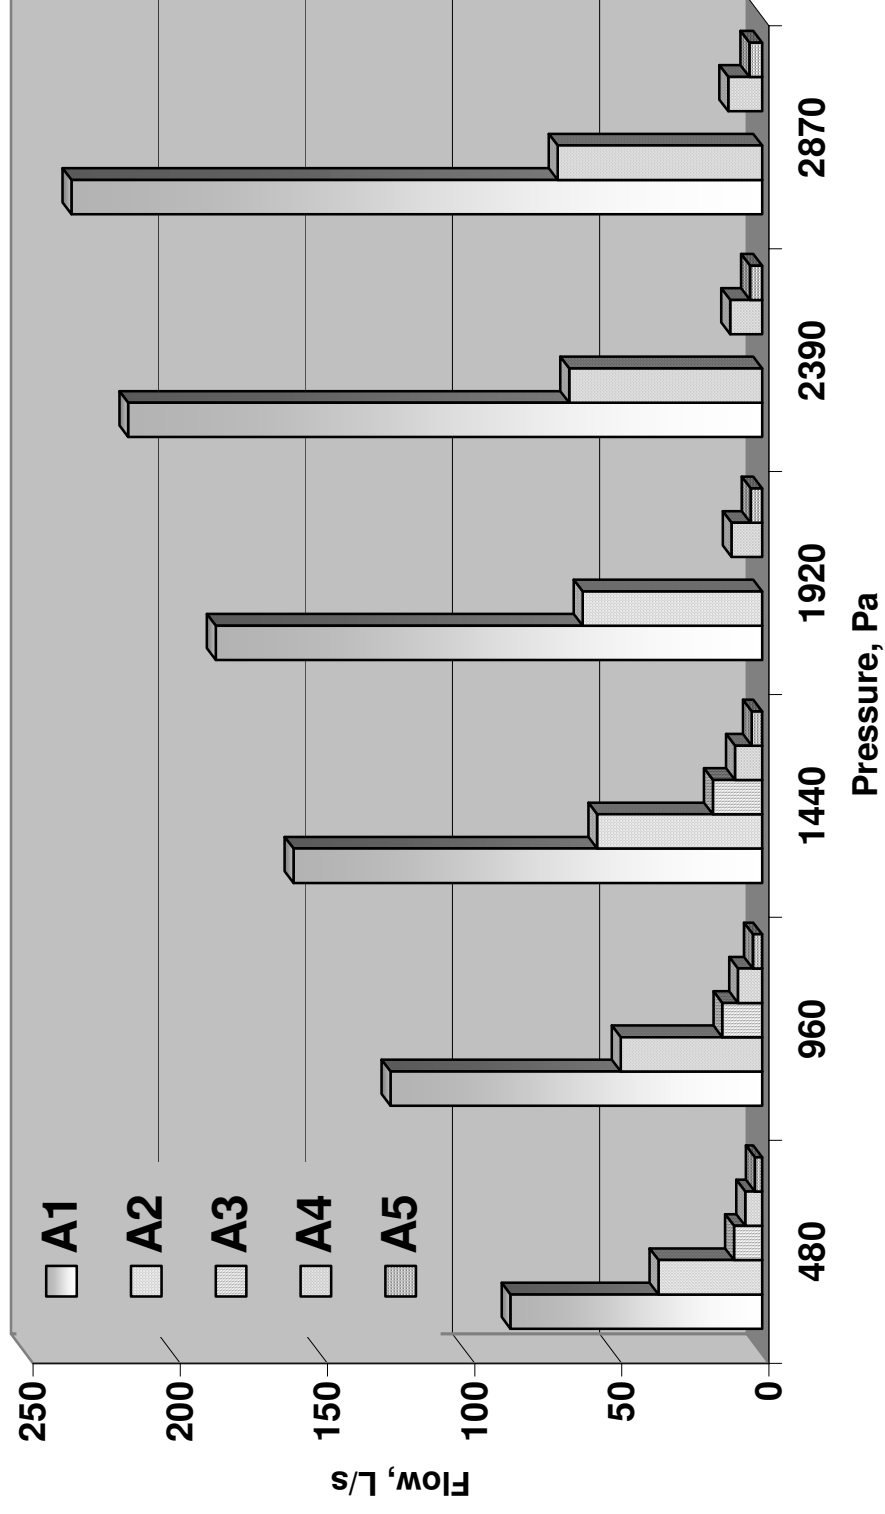
Figure 11: Air leakage rate of the five tested assemblies

Figure 11 presents the measured air leakage rate of the five assemblies. Data clearly indicates that **A1** and **A2** without barrier/retarder had a greater leakage rate when compared to the assemblies with barrier/retarder namely **A3**, **A4** and **A5**. The present study also attempts to answer whether the staggered arrangement of insulation boards as in **A2** can be as effective as that of having a barrier/retarder in an assembly. The comparison of the data from Figure 11 points out that the staggered arrangement of insulation in **A2** certainly provided the air retarding effect in comparison to **A1**, however it proved to be not as effective as the assemblies with

barrier/retarder (**A3**, **A4**, & **A5**). It is also to be noted that in Figure 11, no air leakage data is presented for **A3** (*with building paper*) beyond 1440 Pa (30 psf). The reason was, during the air leakage testing of **A3**, at one corner a 45° cut made in the building paper opened up or enlarged. This lead to a drastic increase in the airflow rate and as a result the test was stopped. Irrespective of this drawback **A3** provided a good air retarding effect upto 1440 Pa (30 psf).

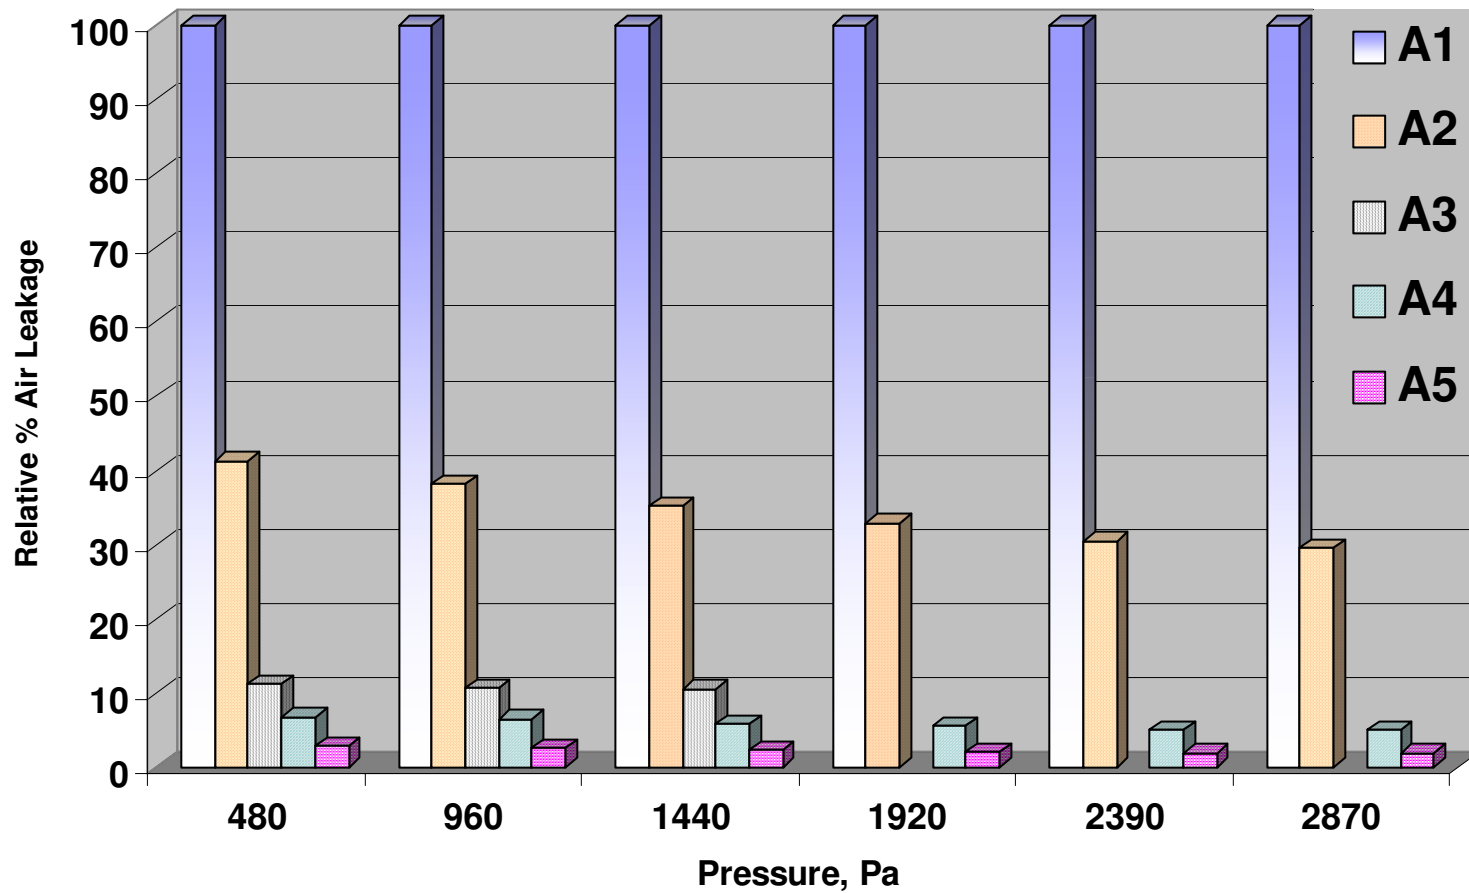
Figure 12: Relative comparison of the air leakage resistance of the tested assemblies with respect to A1

To further illustrate the relative performance of the air retarding effect of the different assemblies, Figure 12 presents the percentage air leakage of the assemblies relative to **A1**. To get a better understanding, a typical pressure of 1440 Pa (30 psf) was selected for the following discussion. If it is assumed that **A1** without any barrier/retarder had 100% air leakage, then relative to the air leakage of **A1**, observations can be summarized as follows:

- **A2** with staggered insulation has 35% of air leakage of **A1** or air leakage reduced by 65%
- **A3** with building paper has 10% of air leakage of **A1** or air leakage reduced by 90%
- **A4** with self-adhered film 6% of air leakage of **A1** or air leakage reduced by 94%,
- **A5** with polyethylene sheet has 2% of air leakage of **A1** or air leakage reduced by 98%

High leakage rate of A1 can be attributed to the channel flow occurring at the deck and insulation joints. With the inclusion of another layer of insulation, **A2**, did provide good air leakage resistance by reducing 65% of air intrusion, however it could not be as effective as assemblies with a barrier/retarder. The channel flow between the joints in the insulation boards was providing the necessary flow path for air movement into the assembly. **A4** and **A5** with self adhered film and polyethylene sheet as barriers/retarders, showed good air leakage resistance. The reduced air leakage resistance of **A3** could be mainly attributed to the seam joints and corner edge treatments of the building paper. It should be noted that the building paper being a soft material, if not properly installed has a tendency to tear. Within the assemblies with barrier/retarders, **A5** showed better air leakage resistance by reducing airflow by 75% and 60% compared to **A3** and **A4**. However, it should be noted here that the polyethylene sheet in **A5** was continuous without any seam joints, which represents the best-case scenario.

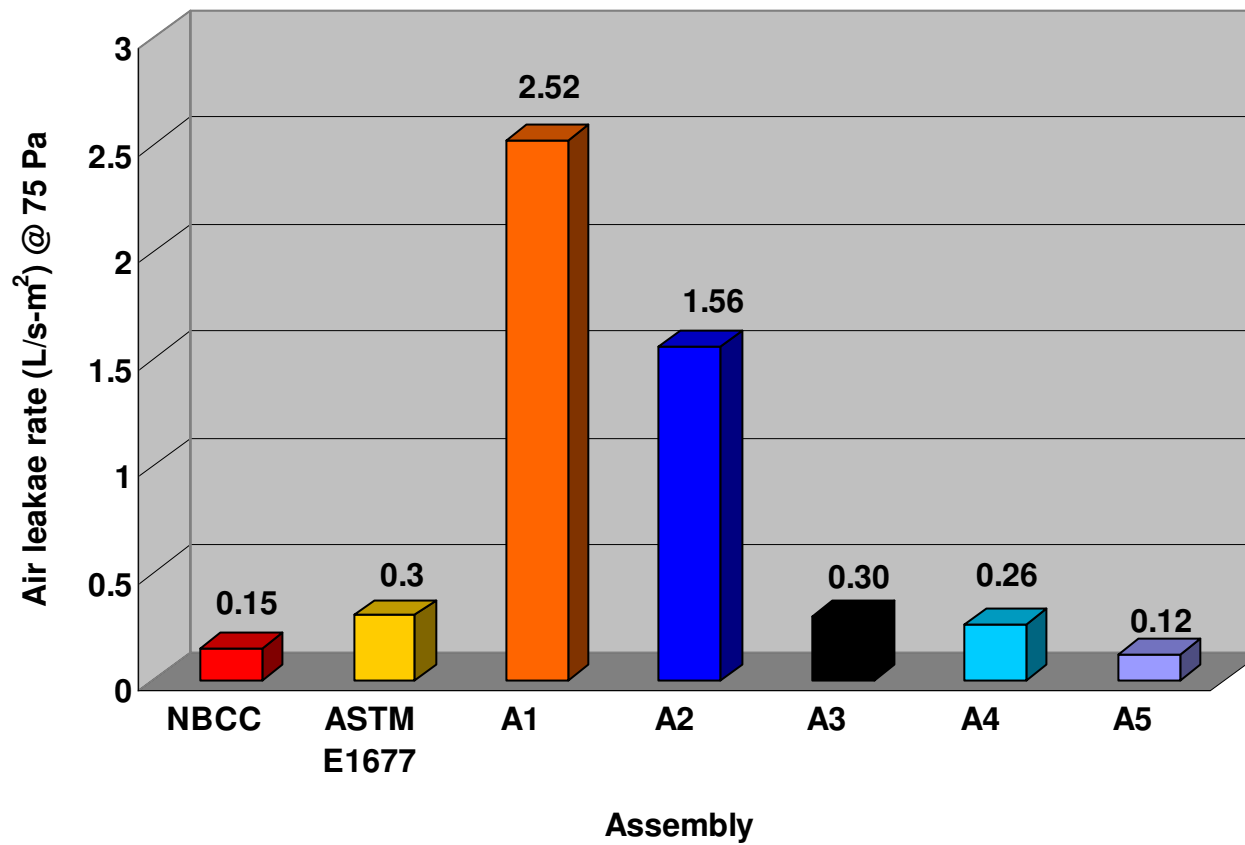
Figure 13: Comparison of measured air leakage with the existing codes of practice and standard

For an air barrier/retarder system in opaque, insulated portions of the building envelope, Part 5 of the NBCC (2005) recommends three permissible air leakage rates corresponding to various indoor humidity levels as shown in Table 1. To verify whether the tested assemblies comply with this code requirement, air leakage rates of the five assemblies were calculated at 75 Pa (1.56 psf) and compared with the NBCC [based on the laboratory testing condition 0.15 L/s.m² (0.03 ft³/min.ft²) was selected] as shown in Figure 13. **A1** had a leakage rate of 2.52 L/s.m² (0.5 ft³/min.ft²) , **A2** had 1.56 L/s.m² (0.31 ft³/min.ft²), **A3** had 0.30 L/s.m² (0.06 ft³/min.ft²), **A4** had 0.26 L/s.m² (0.051 ft³/min.ft²) and **A5** had 0.12 L/s.m² (0.023 ft³/min.ft²) respectively. Comparison of these data with the NBCC indicates that none of the assemblies except **A5** comply with the NBCC code requirement. However, once again it should be remembered here that the assembly set-up of **A5** represents the idealistic construction procedure having proper edge treatment and no seam joints, which has achieved its end result demonstrating the significance of air intrusion. Similarly, ASTM E1677-2005, Standard Specification for an Air Barrier (AB) Material or System for Low-Rise Framed Building Walls, calls for an assembly air permeance requirement of 0.30 L/s.m² (0.06 ft³/min.ft²) at 75 Pa (1.5 psf). However, the standard restricts this permissible leakage rate to the opaque walls. Therefore, the comparison presented in Figure 13 relative to ASTM E1677 is not really applicable to roofing assemblies, however, it signifies the necessity of similar air leakage resistance requirement for roofing assemblies.
