## Factors determine number of core cuts needed for reroofing

by Terrance R. Simmons, RRC

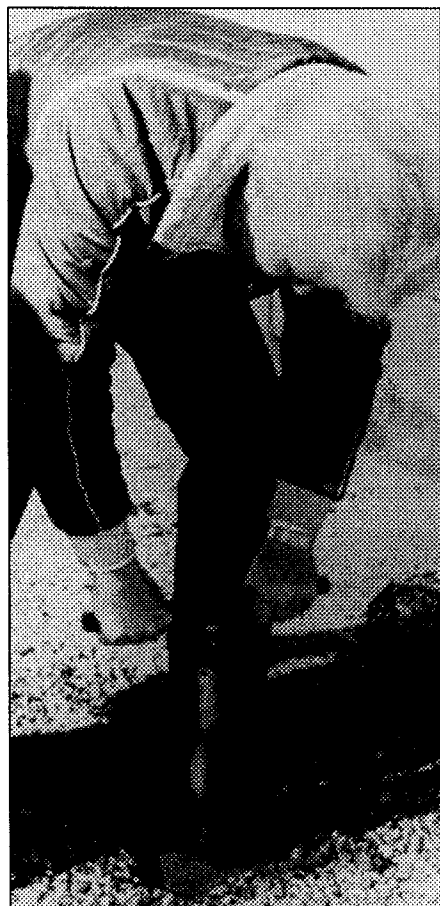
A roofing professional takes a core cut from a built-up roof system.
